## CONSTRUCTION ADDENDUM: 1

**NAME:** Eastridge House HVAC Improvements

RE: Limited Asbestos and Lead Containing Materials Survey Report – Piping Renovation Pathway  
Areas Surveyed Include all Common Areas and Units 111, 113, 211, 213, 311 and 313

# **Limited Asbestos and Lead Containing Materials Survey Report – Piping Renovation Pathway**

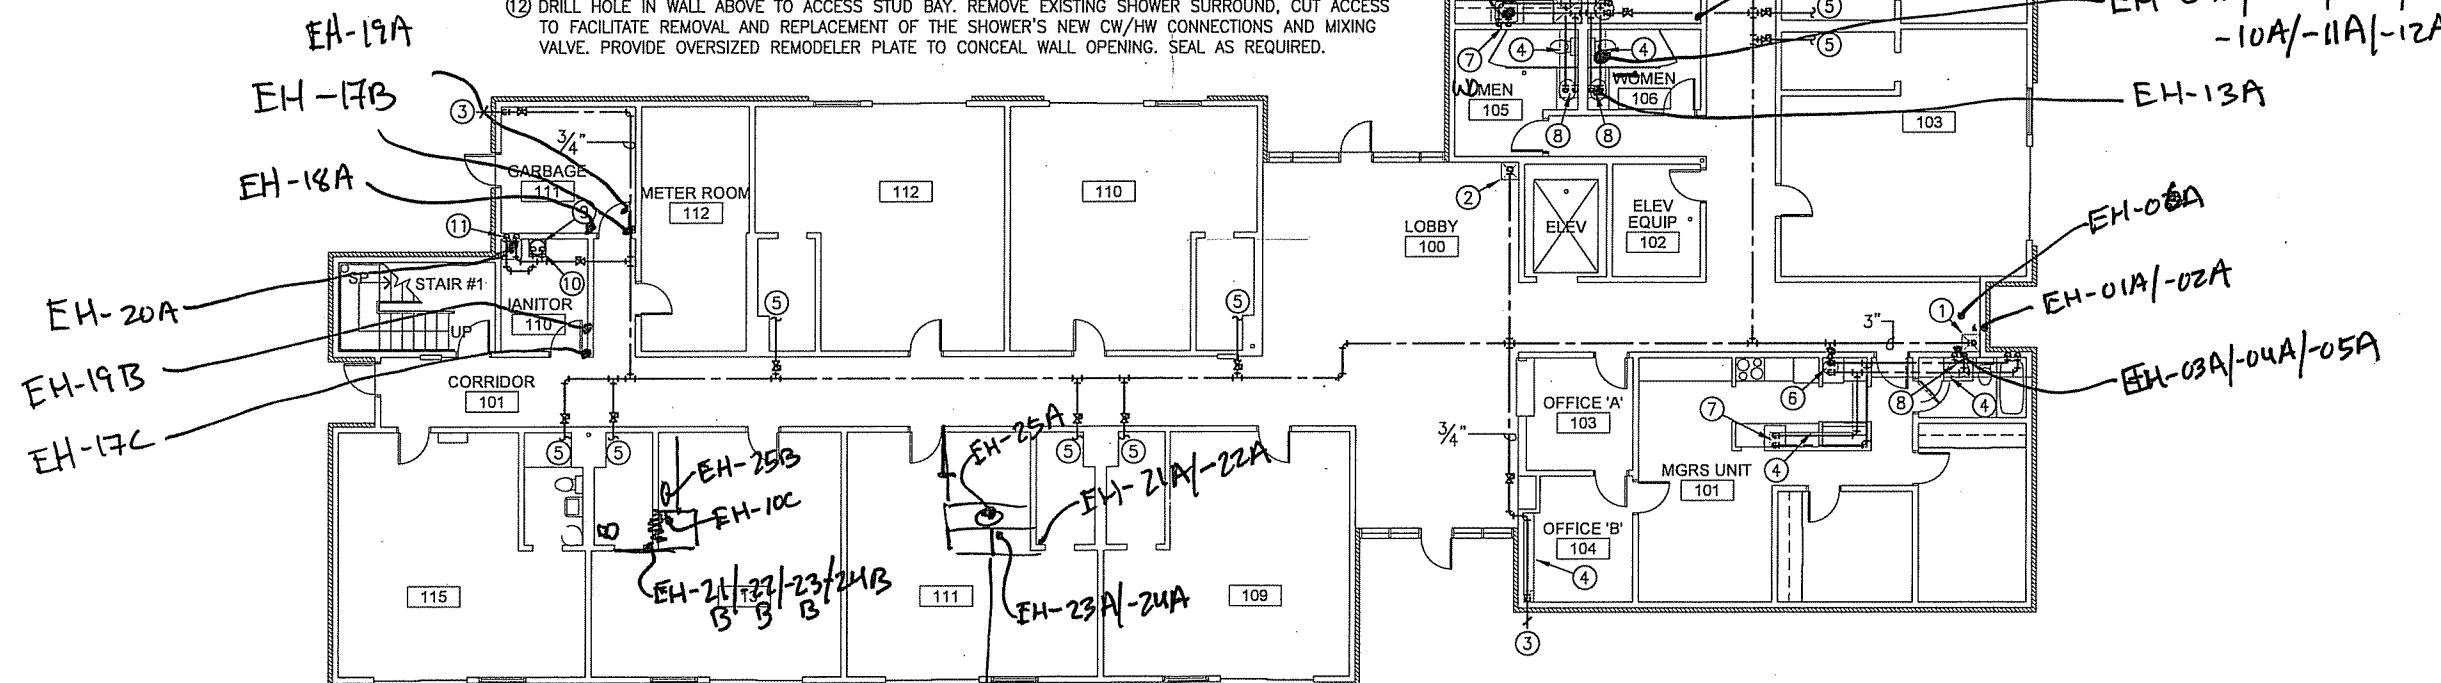
1 FIRST FLOOR PLUMBING PLAN  
SCALE: 1/8"=1-0"

Assumed Mats - Mens RR - 4" Beige CWT w/grout + mortar  
- Garbage Room - White FRP on walls (to ~4')  
- Unit 111 - Bathroom - CWT @ Bath (~10 ft)  
- Unit 113 - Bathroom - Matte @ Shower surround (~80 ft)
