## REPORT OF GEOTECHNICAL ENGINEERING SERVICES

Wayland Arms Apartments  
307 South Division Street  
Auburn, Washington

**Site Observations and Review  
First Floor Concrete Slab Repair Recommendations  
Wayland Arms Apartments  
307 South Division Street  
Auburn, Washington**

Subject: Site Observations and Review  
First Floor Concrete Slab Repair Recommendations  
Wayland Arms Apartments  
307 South Division Street  
Auburn, Washington

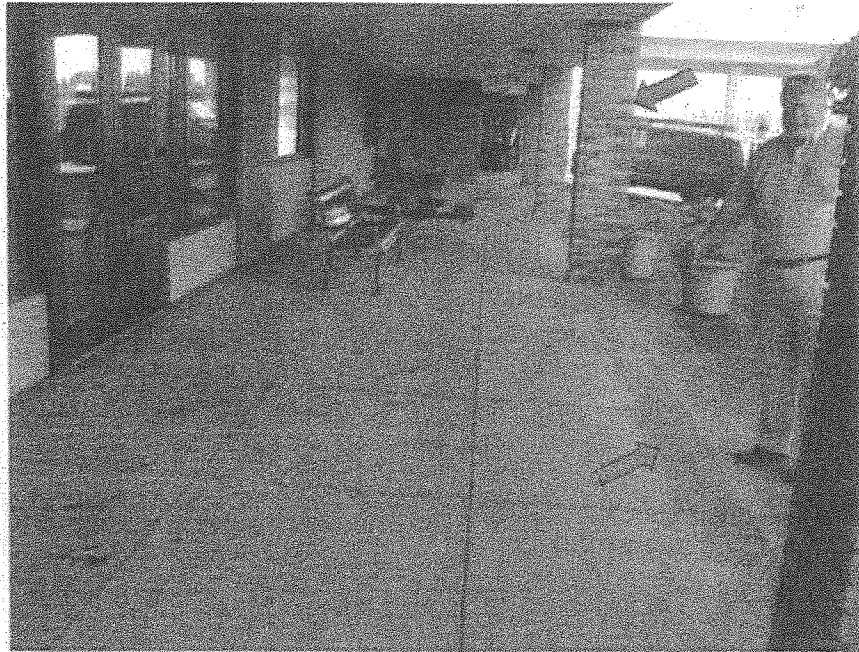
3. This photograph was taken looking south along the patio located along the west side of the community lounge. The upper arrow points to a support column. The lower arrow points to a prior repair made to the patio slab.

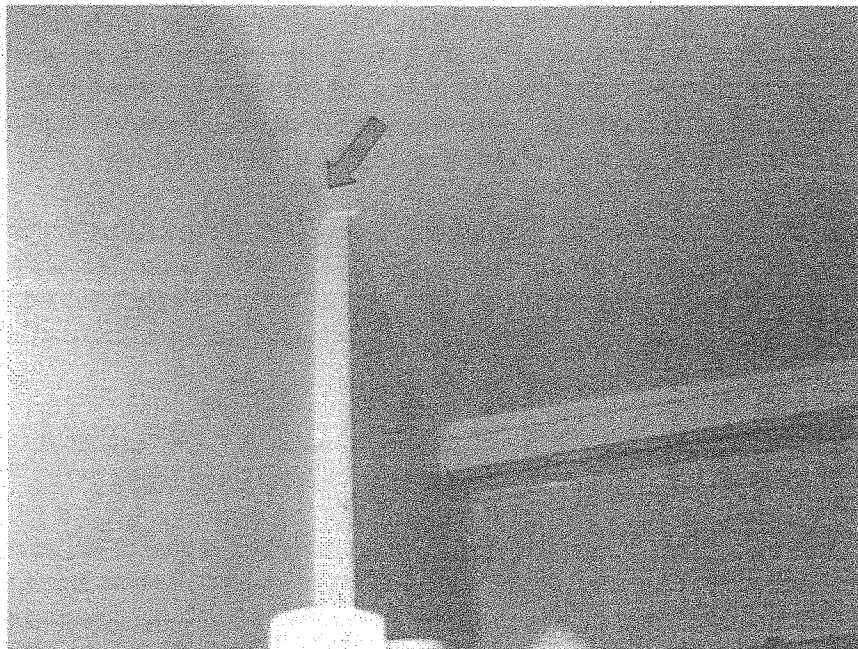
4. This photograph was taken in apartment Unit 104 in the north wing. The arrow points to separation between the second floor ceiling and interior wall due to downward displacement of the first floor below.

At all slab areas that it is decided to remove the slab, the existing slab should be removed and replaced with a new slab supported on 3" diameter pin piles having the required spacing to support the code required loads as recommended by GeoDesign, Inc. This will require that the first floor be vacated, temporary access be provided to the upper floors of the building while the work is being performed, or the building vacated, and the first floor areas reconstructed with the new pin pile supported slab including having the interiors built back to their original configuration. The interior walls, which are non-bearing walls, can be temporarily supported off the second floor while the concrete floor slab is removed and replaced.

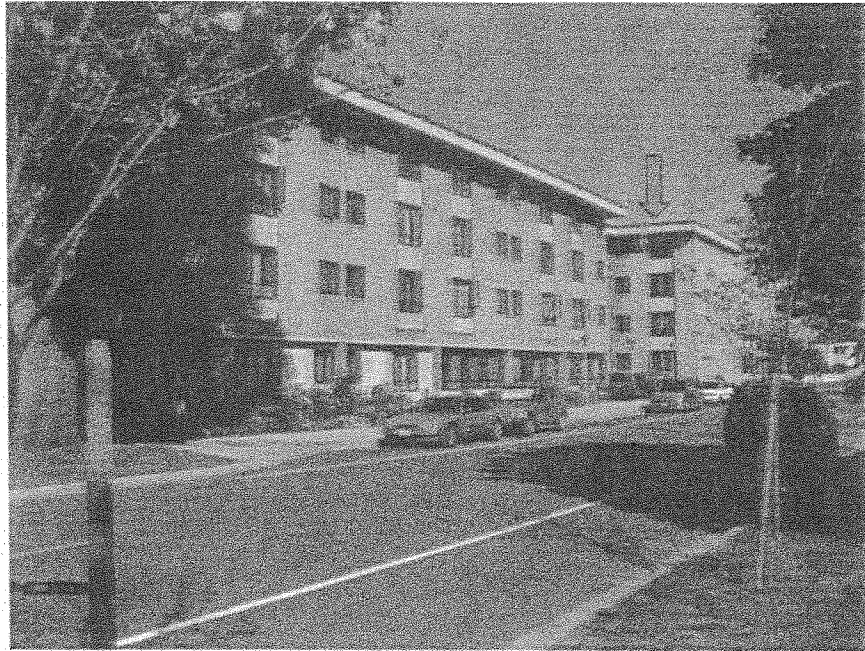
1. This is a photograph of the Wayland Arms Apartments as viewed from across South Division Street. The south wing appears in the foreground. The north wing is identified by the arrow.

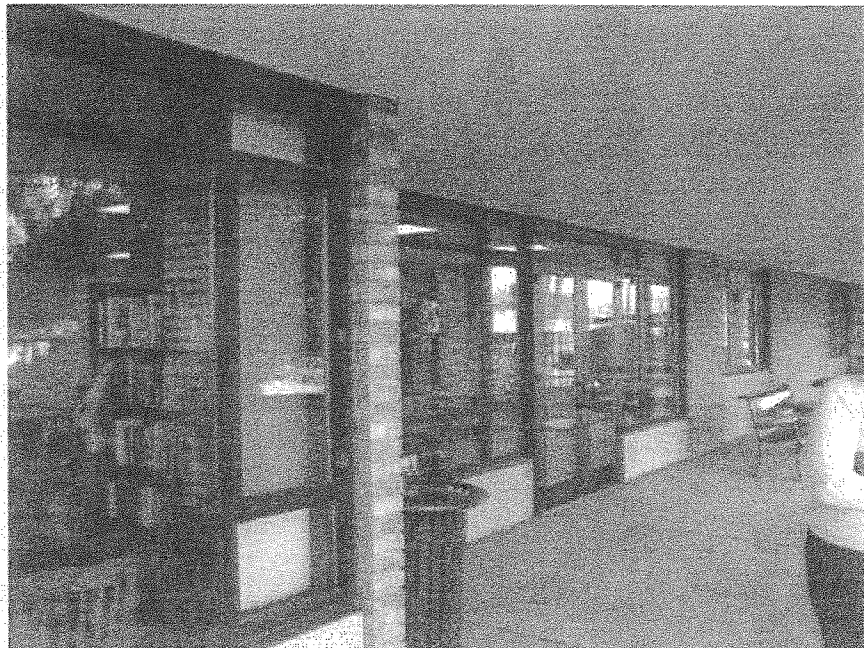
2. This photograph was taken along the west side of the building from the patio area outside the community lounge.

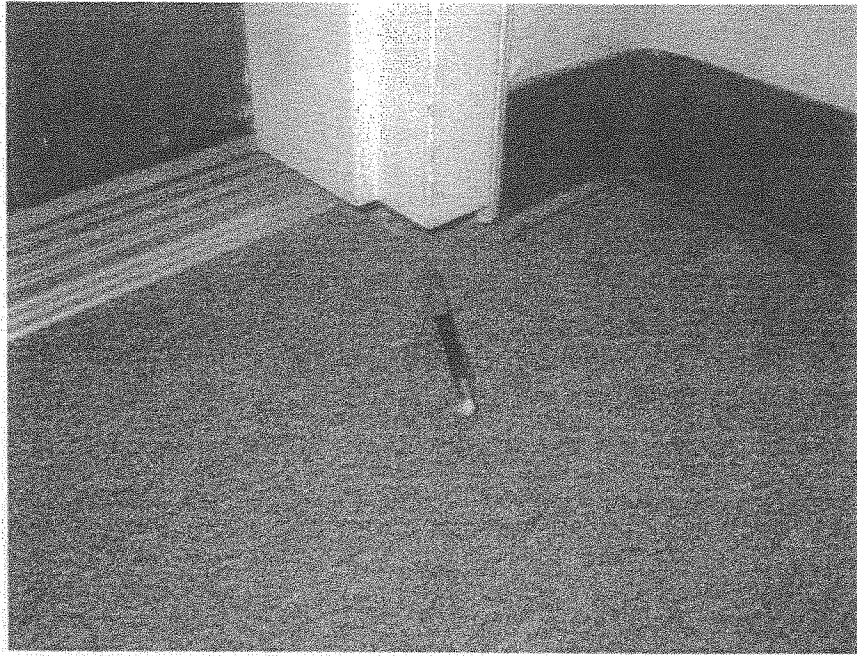
5. The pencil in this photograph points to a separation between the base of the door jamb where an approximately  $\frac{3}{4}$ " high gap has developed. The floor slab has subsided away from the door jamb at this location.

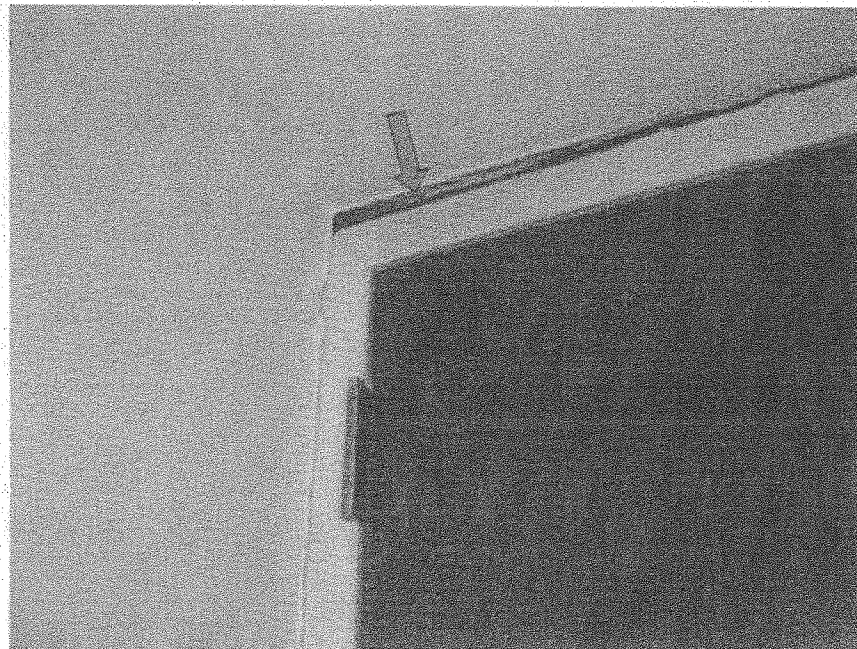
6. This photograph was taken at one of the doors to an apartment unit in the north wing at the first floor. The arrow points to downward displacement of the door frame with respect to the ceiling.

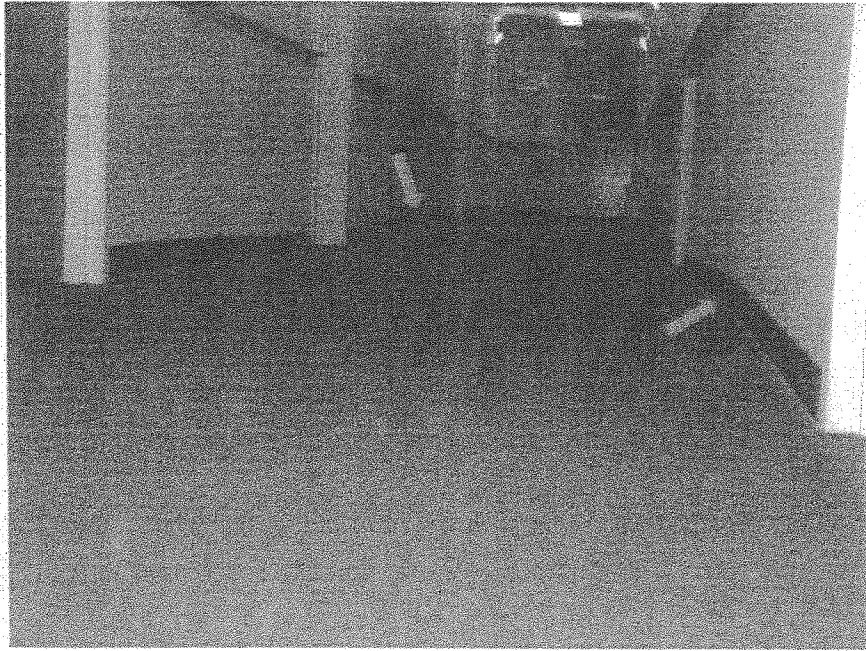
7. This photograph was taken looking west along the corridor at the first floor in the north wing. The arrows point to where the wall base follows the slope of the floor likely when new carpet was added to the corridor floor in past years.

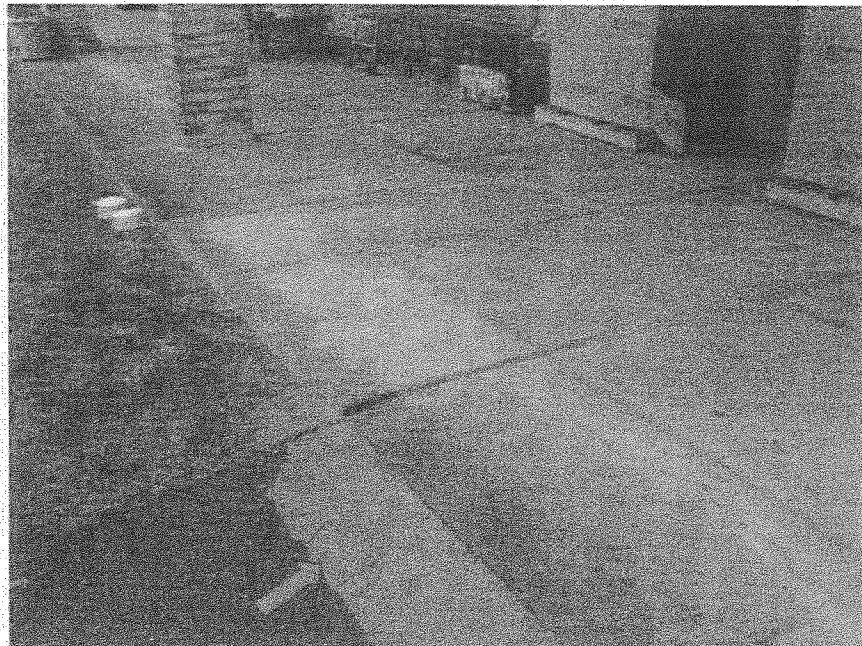
During our first site visit on September 8, 2009, we were able to access the building and observe and document conditions at the first floor. It was noted that at the first floor, there are noticeable undulations in the surface of the floor. Cracks and gaps have formed where the first floor slab has subsided with respect to the wall base, bottom of door frames, or at wall intersections at many locations at the first floor area. The cracks and gaps indicate that subsidence of the first floor has occurred at many places (refer Photographs 4, 5 and 6). Also, the wall base along the corridor walls in the north wing had been installed along the slopes in the floor indicating the floor was undulated in the corridor when the wall base was installed (refer Photograph 7). It was reported that numerous repairs including realigning doors at the first floor and repairing wall cracks and distress has occurred over a number of years as a result of the uneven floor condition at the first floor. Along the concrete patio along the west side of the south wing, and along the concrete walkways poured on grade along the west side of the property, there are numerous areas where the slabs have subsided and cracked. Some areas have been patched in to prevent trip hazards for people walking on the patio or walkways. At the location where the driveway meets the patio near the south end of the south wing, a small section concrete was placed over the asphalt to create a ramp driveway between the patio and asphalt pavement (refer Photograph 8).

8. This photograph was taken along the west side of the south wing looking at the patio. The arrow points to where concrete was placed over asphalt to provide a better transition between the patio and asphalt driveway.
