RE: *Wayland Arms Apartments Structural Upgrade Summary – Auburn, Washington*

FOR WAYLAND ARMS SLAB REPAIR & SEISMIC UPGRADE RFQ

WAYLAND ARMS APARTMENT - CONCEPTUAL SEISMIC UPGRADE

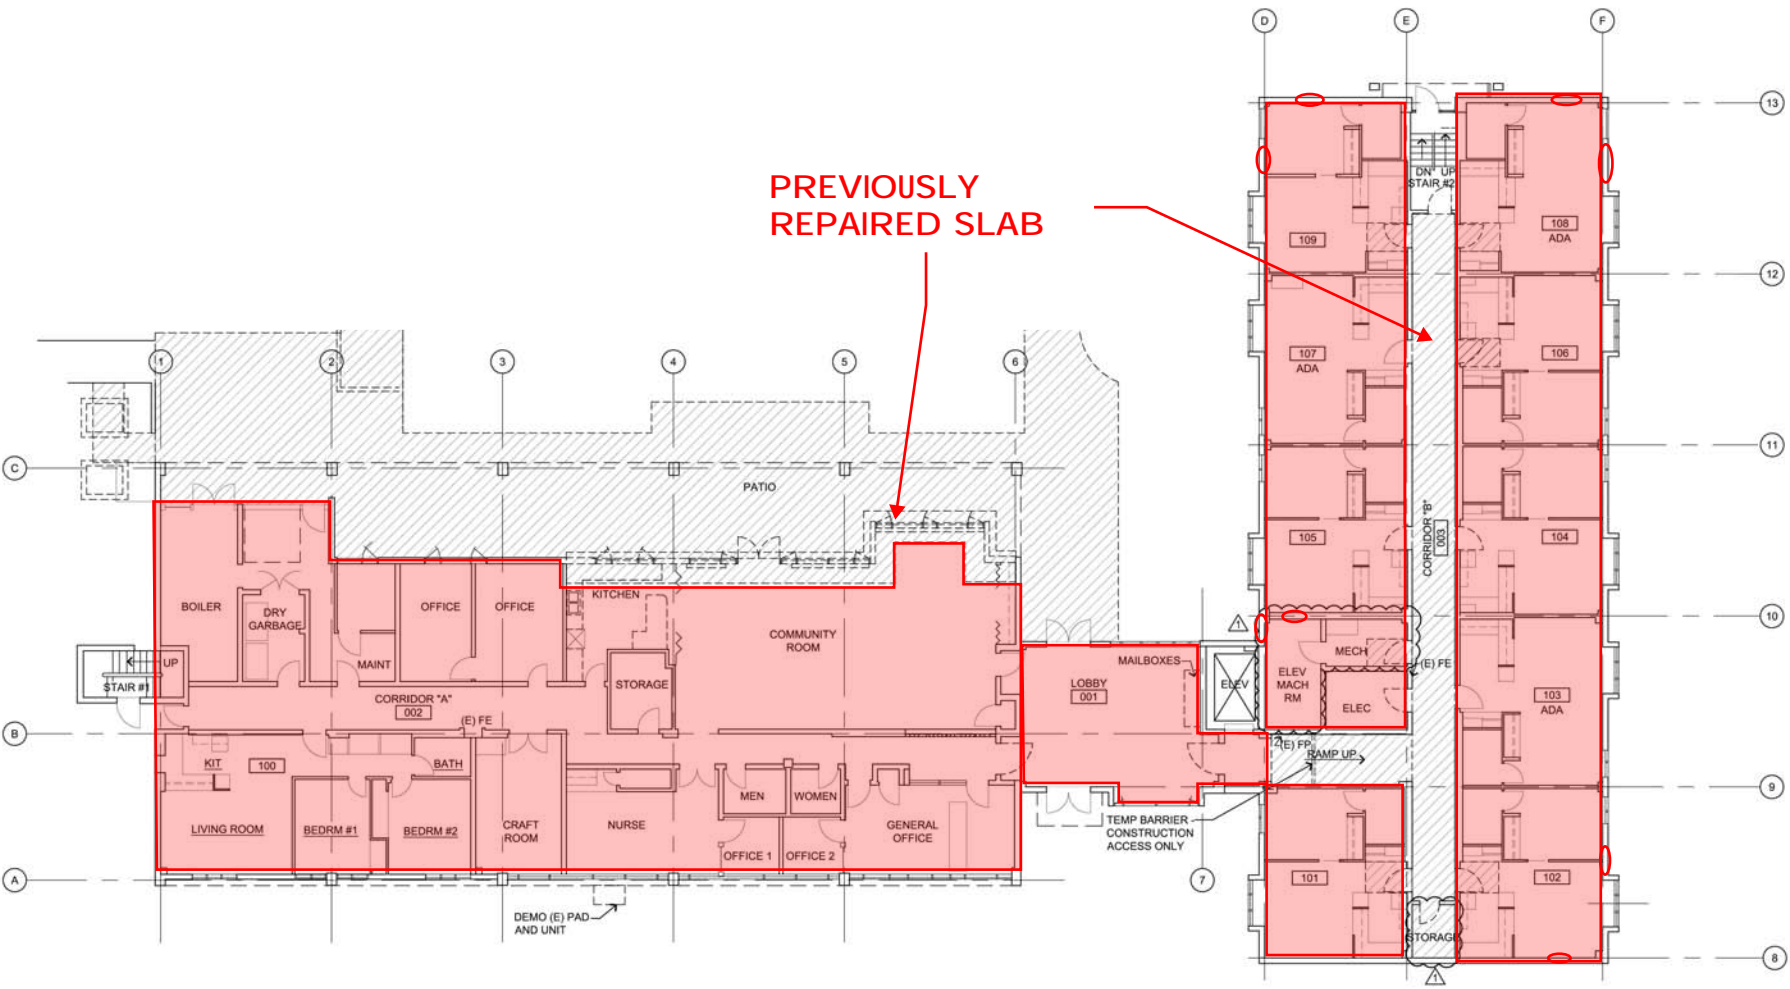
SLAB REPAIR SCOPE

- We observed 1" approximately of slab settlement at the south end of the building at the first floor. The non-bearing metal stud walls and masonry walls had gaps at the bottom of the walls and appeared to be suspended from the 2nd floor.

- In 2013, the first-floor corridor at the north end of the building was resupported with steel pin piles and concrete grade beams. We observed that the slab had settled approximately 1". The non-bearing metal stud walls appeared to be suspended from the 2nd floor and had gaps below the wall.

Indicates location of new concrete structural slab with pin piles

- The existing slab could be replaced with a new structural slab with pin piles at the first floor. The interior partitions would need to be removed and re-installed. The corridor slab at the north building wing could remain as this is already supported. The existing utilities could be supported from the new structural slab. The scope of work would be similar to the 2013 work that was done. An alternate fix could be to re-shore all of the walls, but this would be a temporary fix.
- A voluntary seismic upgrade is highly recommended due to the overstressed steel moment frames. The upgrade options are as follows:
 - Option 1: Seismically upgrade only the first floor by adding steel buckling restrained brace frames.
 - Option 2: Seismically upgrade the entire building by adding steel buckling restrained brace frames to each floor.

We recommend that the slab be mitigated with a permanent solution to minimize future settlement. See the attached enclosures to for depiction of the anticipated renovations.

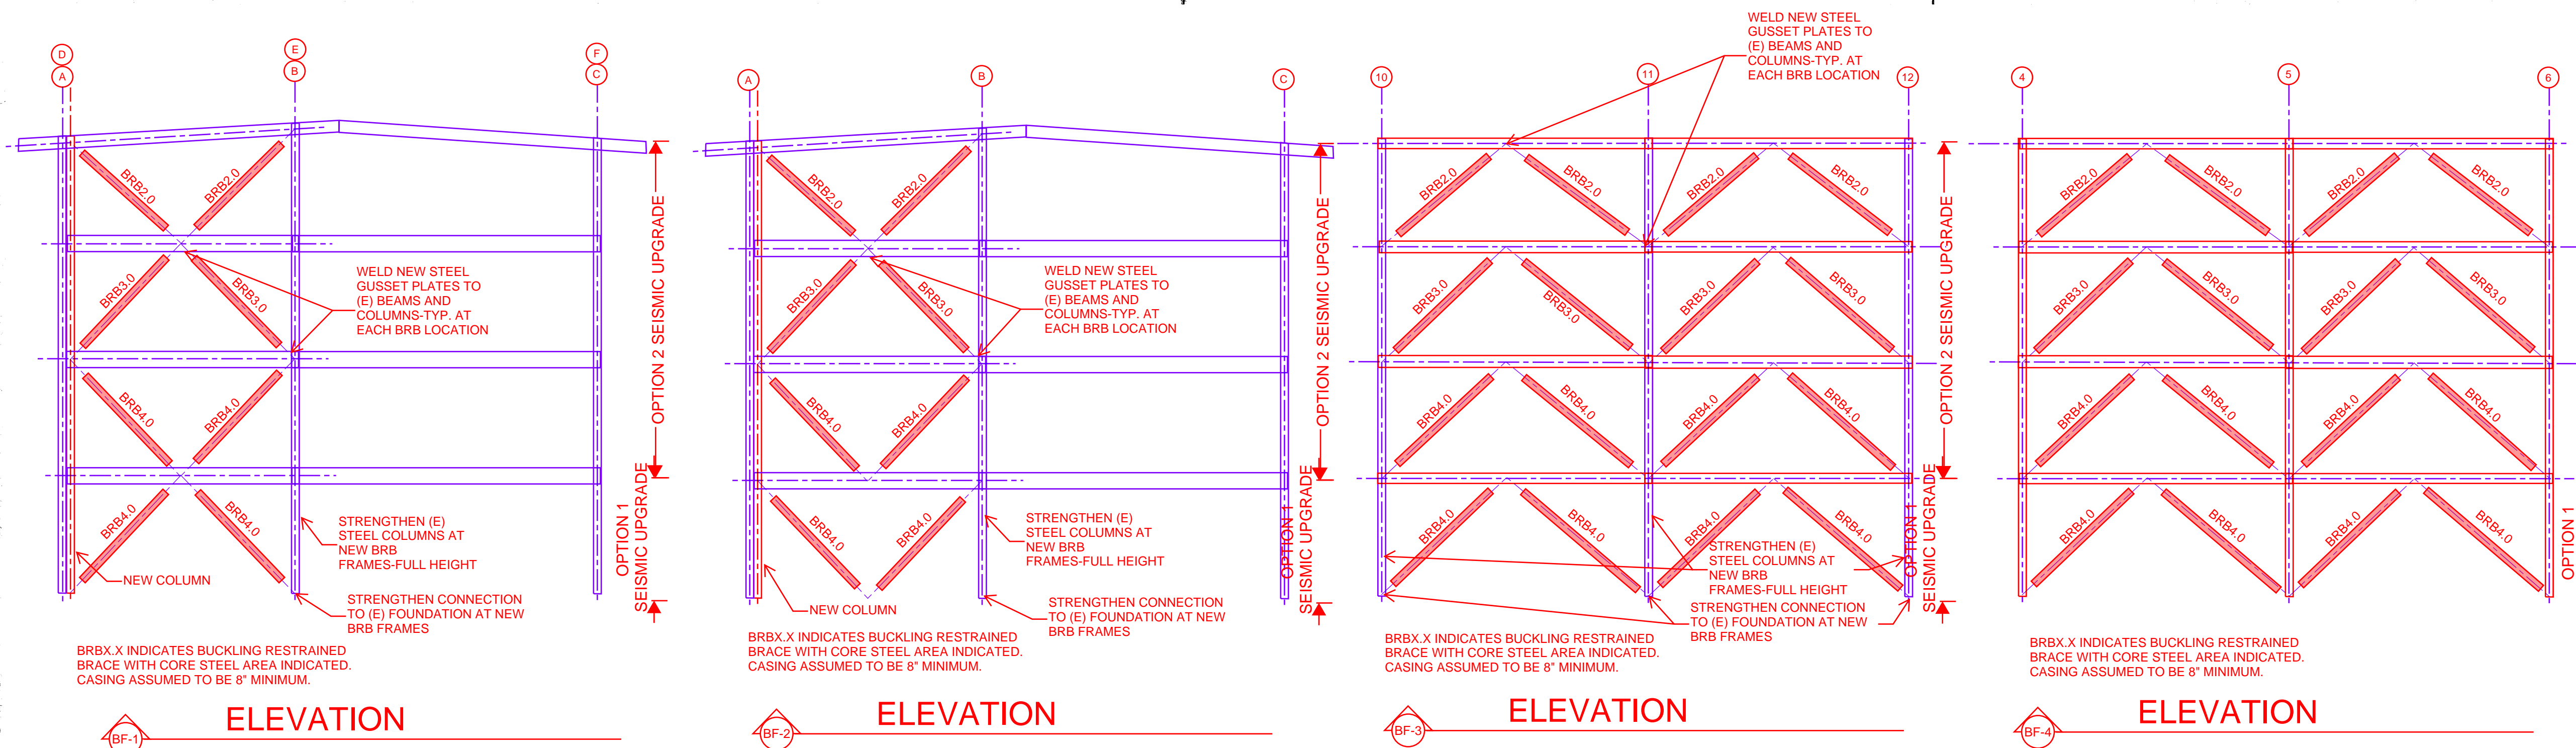
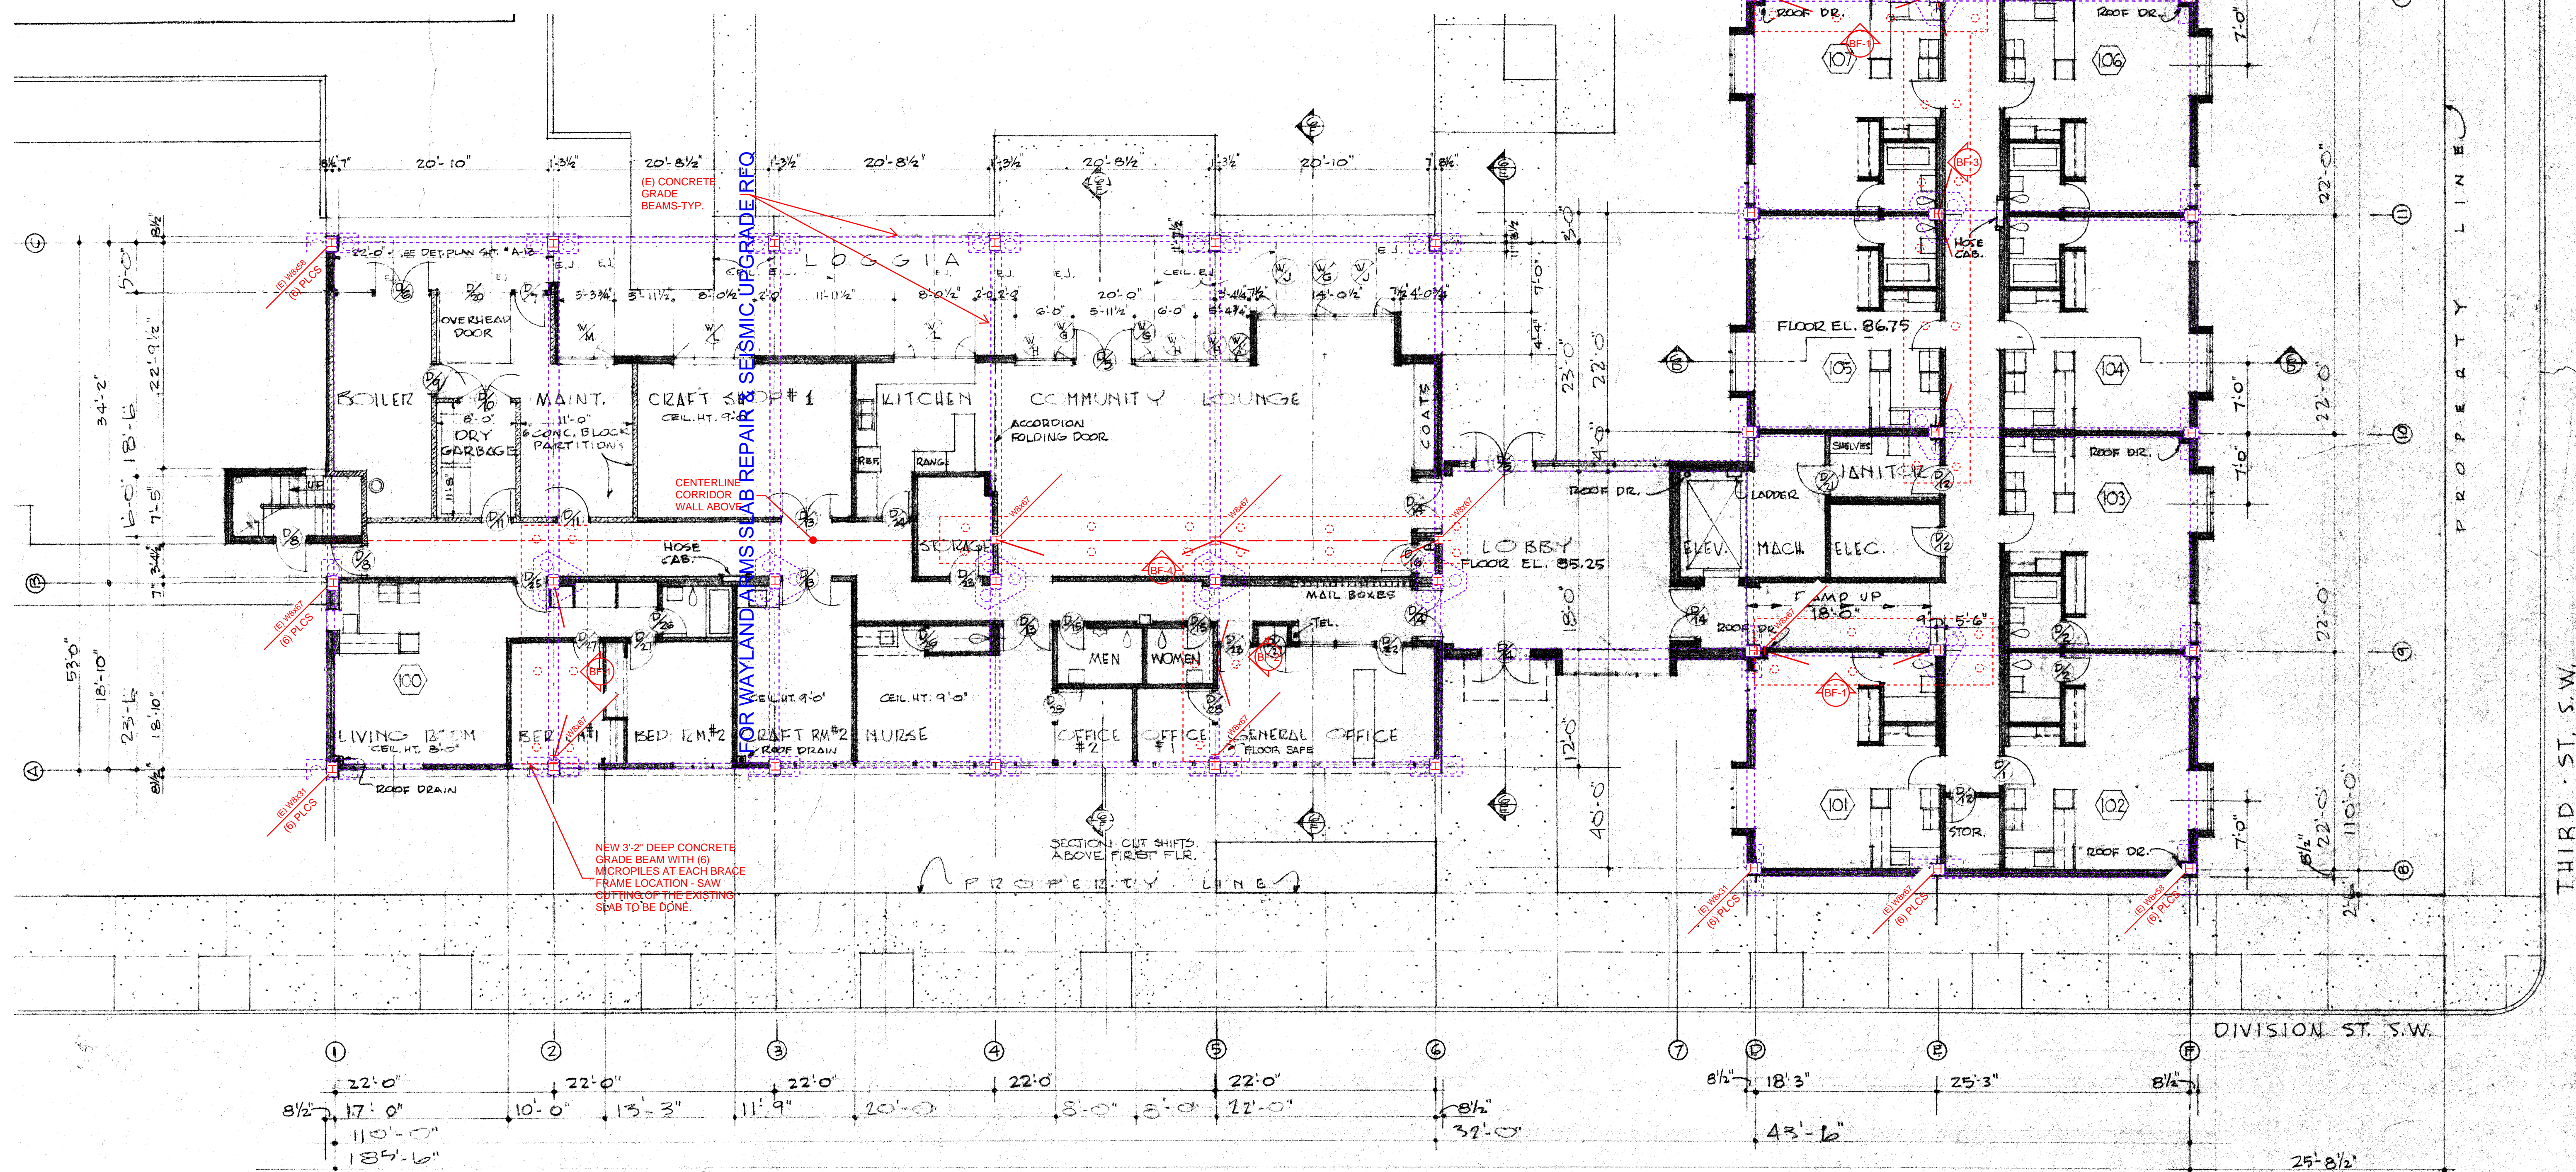
FOUNDATION PLAN 1/8"=1'-0"

- The steel moment frames are overstressed and do not meet the building code drift requirements from a lateral standpoint.
- No signs of settlement are being observed at the masonry veneer walls nor at the second and third floor. The main building is supported by timber piles and concrete grade beams.

1. THE SHOWN CONCEPTUAL DRAWINGS ARE FOR A VOLUNTARY SEISMIC UPGRADE. THE CURRENT BUILDING DOES NOT MEET STRENGTH OR DRIFT REQUIREMENTS OF THE CURRENT BUILDING CODE OR 75% OF THE FORCES OF THE CURRENT BUILDING CODES.
2. THE PROPOSED UPGRADE IS MEET THE CURRENT BUILDING CODE STANDARDS.
3. THE PROPOSED LOCATIONS OF THE BRACE FRAMES ARE ABLE TO MOVE AND WE RECOGNIZE THAT THE SOUTH WING DOESN'T STACK WITH THE 2ND AND 3RD FLOORS, WHICH ADDS SOME COMPLICATIONS.
4. THE PURPOSE OF THE CONCEPTUAL UPGRADE IS TO FACILITATE DIALOG ON FUTURE UPGRADES. THE SEISMIC UPGRADES COULD BE DONE JUST ON THE FIRST FLOOR IF DESIRED. NOT ALL MEMBERS ARE SHOWN AND UPGRADES ARE SHOWN.
5. SLAB REPAIR IS NOT SHOWN AT THIS TIME.
6. ARCHITECTURAL, MECHANICAL, AND ELECTRICAL IMPACTS ARE NOT INDICATED AND WILL NEED TO BE ACCOUNTED FOR.
