Project Name:	Wayland Arms Apartments - Settlement Monitoring		Report: 002
GeoDesign # :	KCHA-13-04		Date: 03/05/2024
Reports with Unresolved Nonconformance Issues:			Permit:
Distribution:	Heath MacCoy <HeathM@kcha.org>		
	David Curtice <DavidC@kcha.org>		
	Kevin Johnson <KevinJ@kcha.org>		
	Patrick Kaapana <PatrickK@kcha.org>		
	Michael Cuadra <MichaelC@kcha.org>		
	Weather: NA, indoors	Arrival/Departure: 0850/0915	Prepared By:

SUMMARY OF CRACK MONITORING GAGE INSTALLATION AND READINGS:

MONITORING POINT LOCATIONS

WAYLAND ARMS APARTMENTS
AUBURN, WA

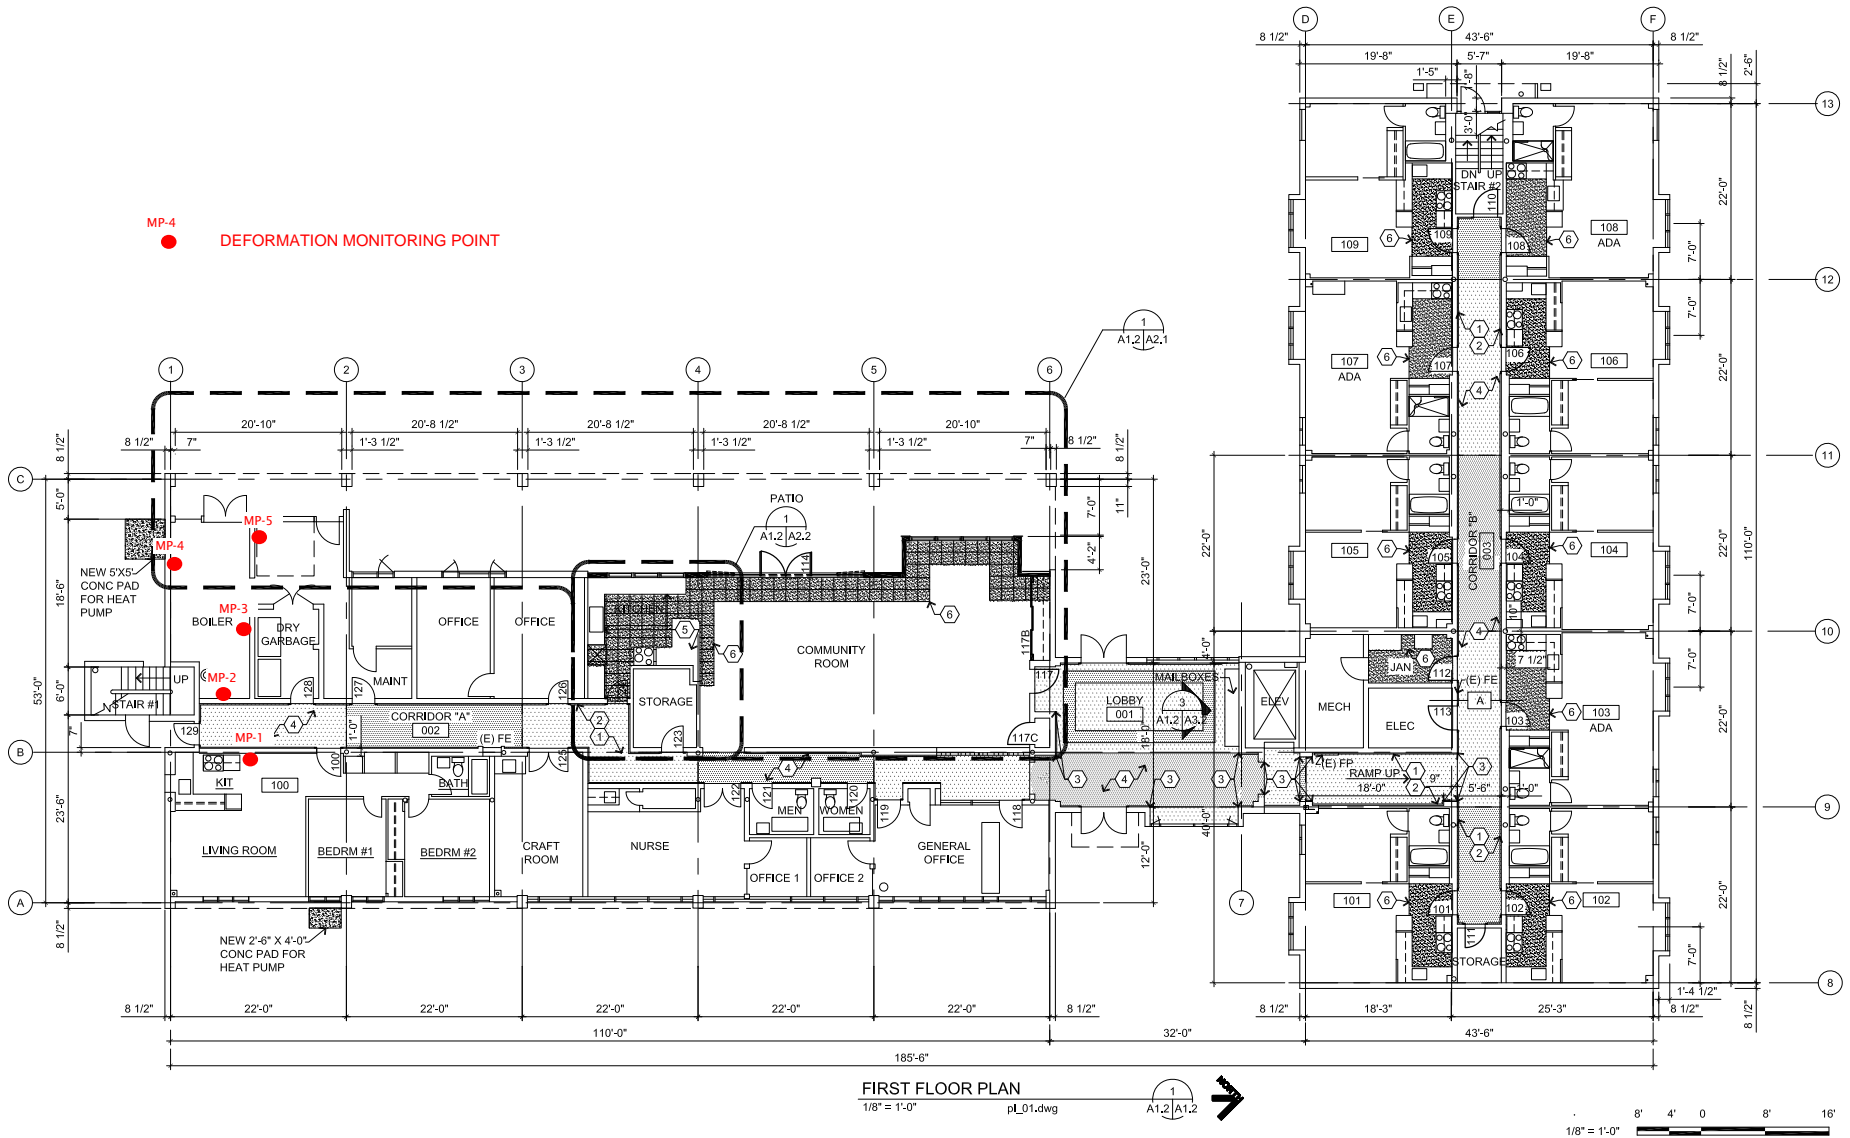
FIGURE 1

NV5 installs 5 crack monitoring gages at Wayland Arms Apartments in Auburn at the following locations and as shown on Figure 1.

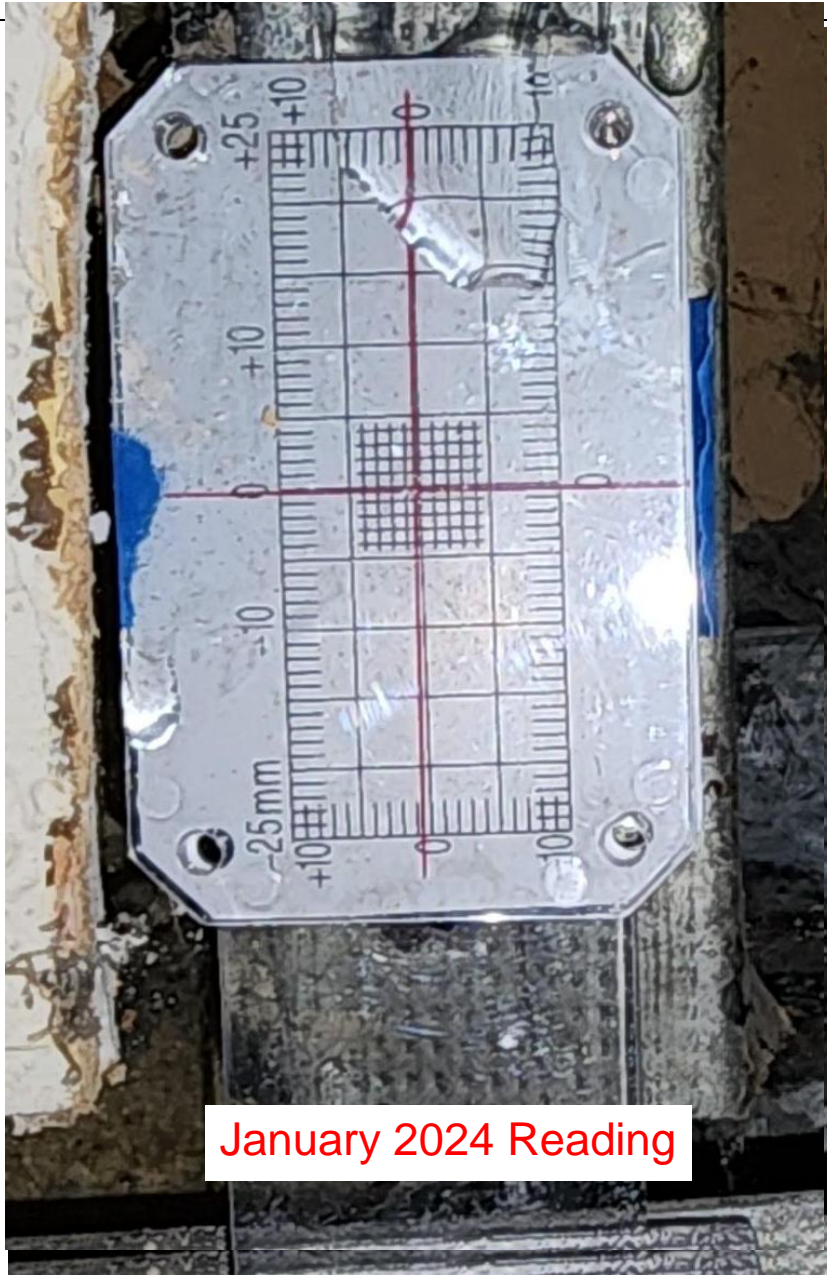
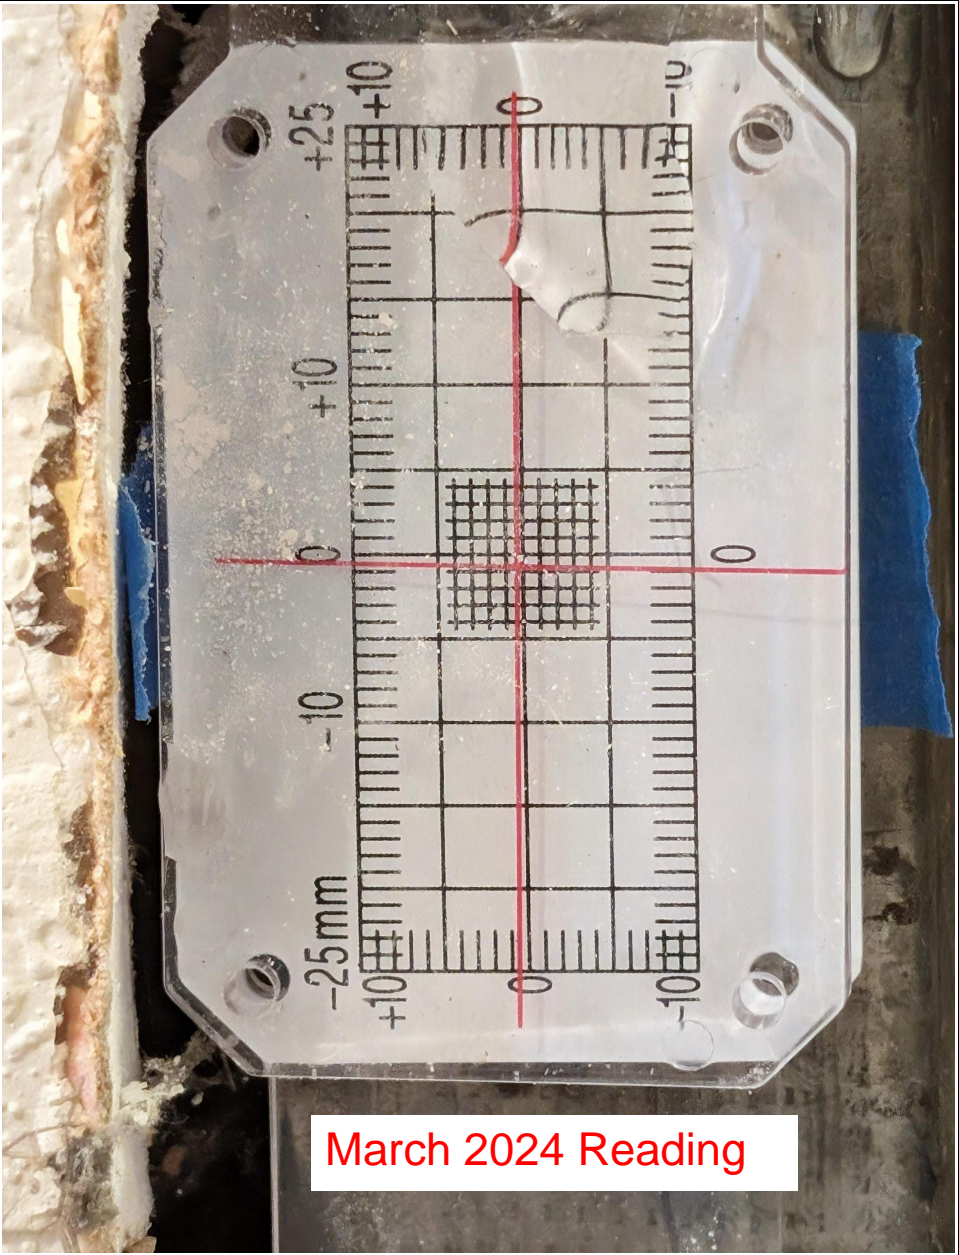
FIGURE 2

MP-1 - Suite 100 central wall opposite interior hallway between floor and wall stud. Wall studs are hanging from 2nd floor joist and there is an existing gap between the floor slab and base plate.

MP-1 : 1mm vertical movement, no horizontal movement since January 2024 readings

Based on the first round of readings, we do not have enough data to determine if the slab is stable. It is too early to determine if the slab requires stabilization. We recommend continuing to read the gages on a 3-month interval for first year (until December 2024) and revise monitoring interval based on past readings.

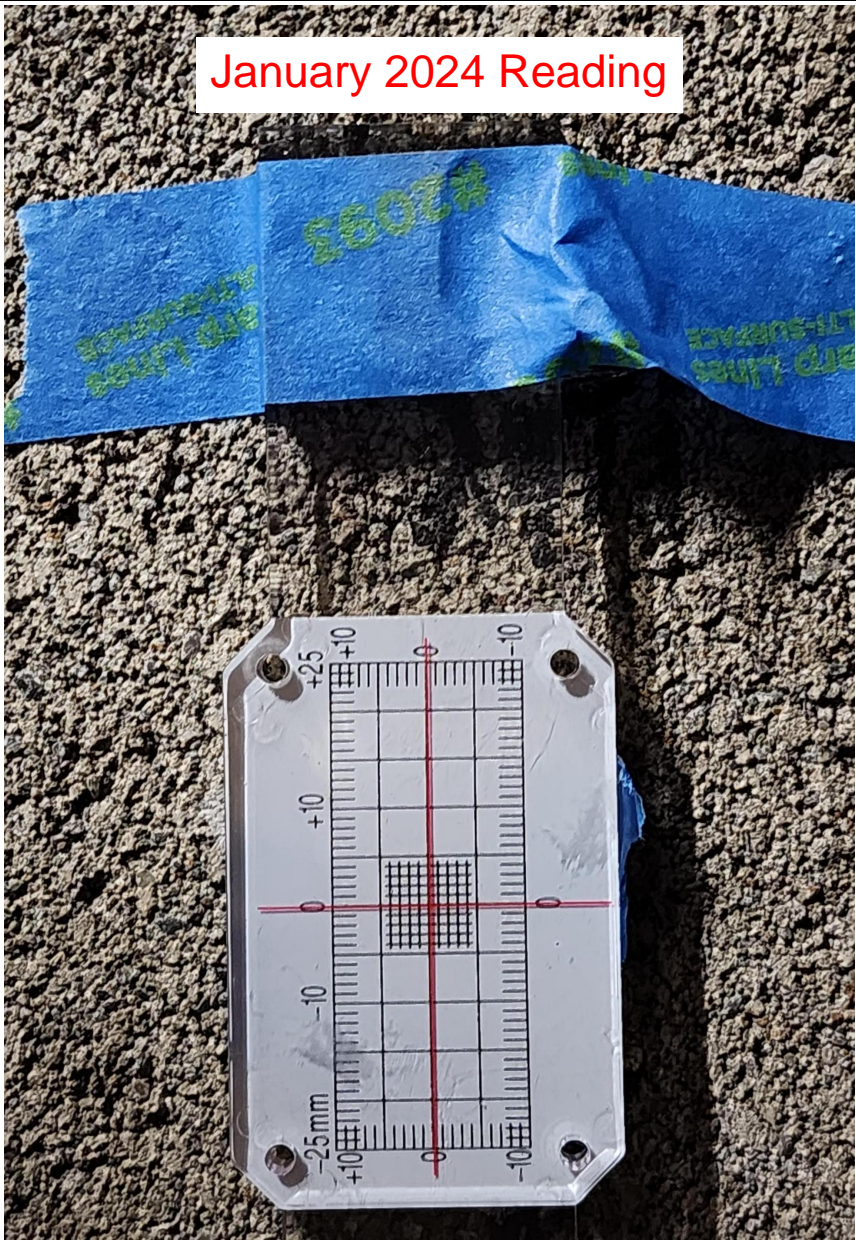
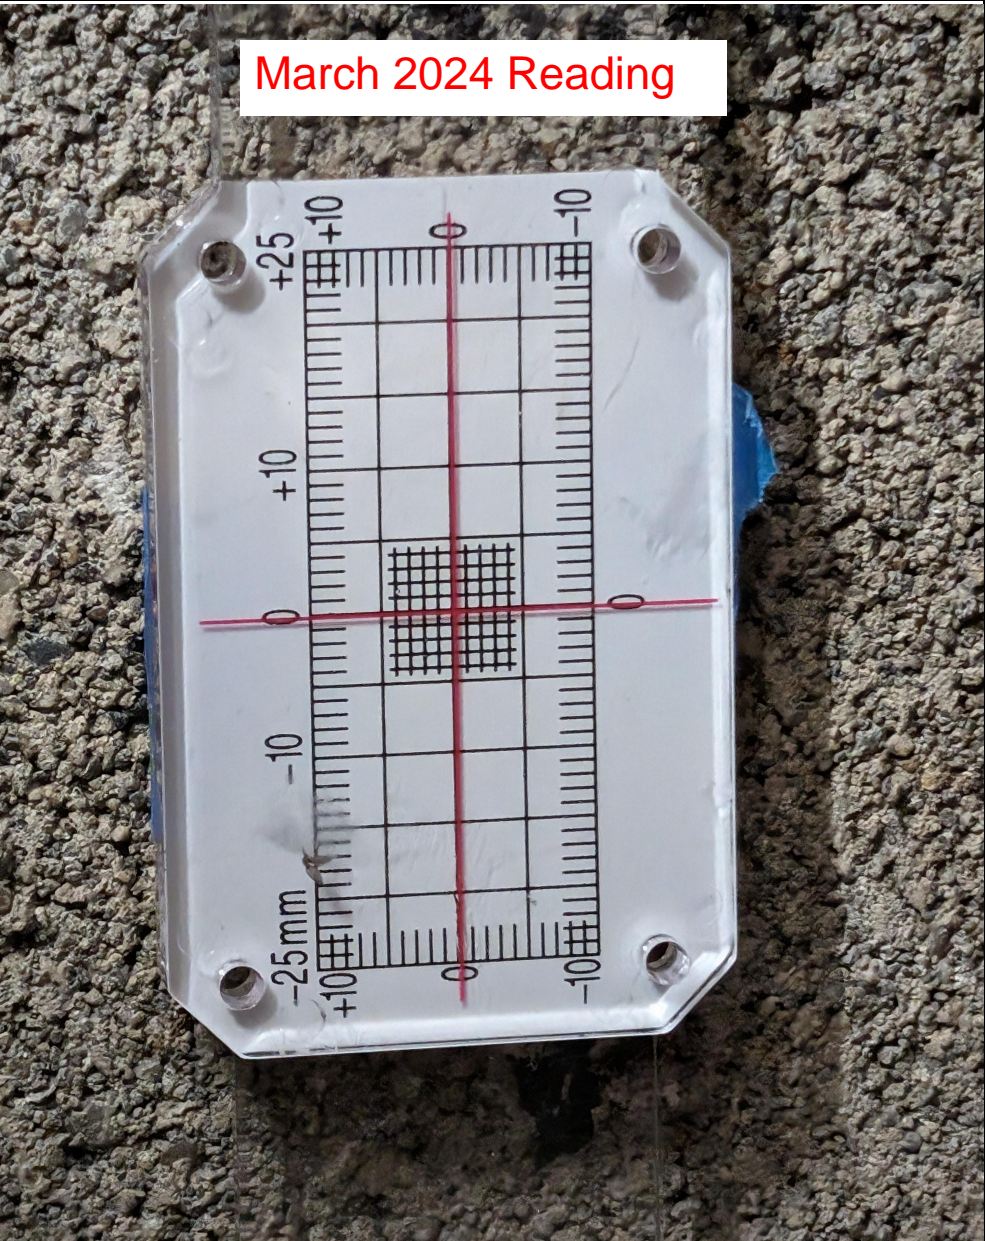
KCHA-13-04	MONITORING POINT READINGS - MP2	
	MARCH 2024	WAYLAND ARMS APARTMENTS AUBURN, WA	FIGURE 3

MP-2 - Mechanical room central wall opposite interior hallway, between floor and cinder block wall.

MP-2 : No vertical or horizontal movement since January 2024 readings.

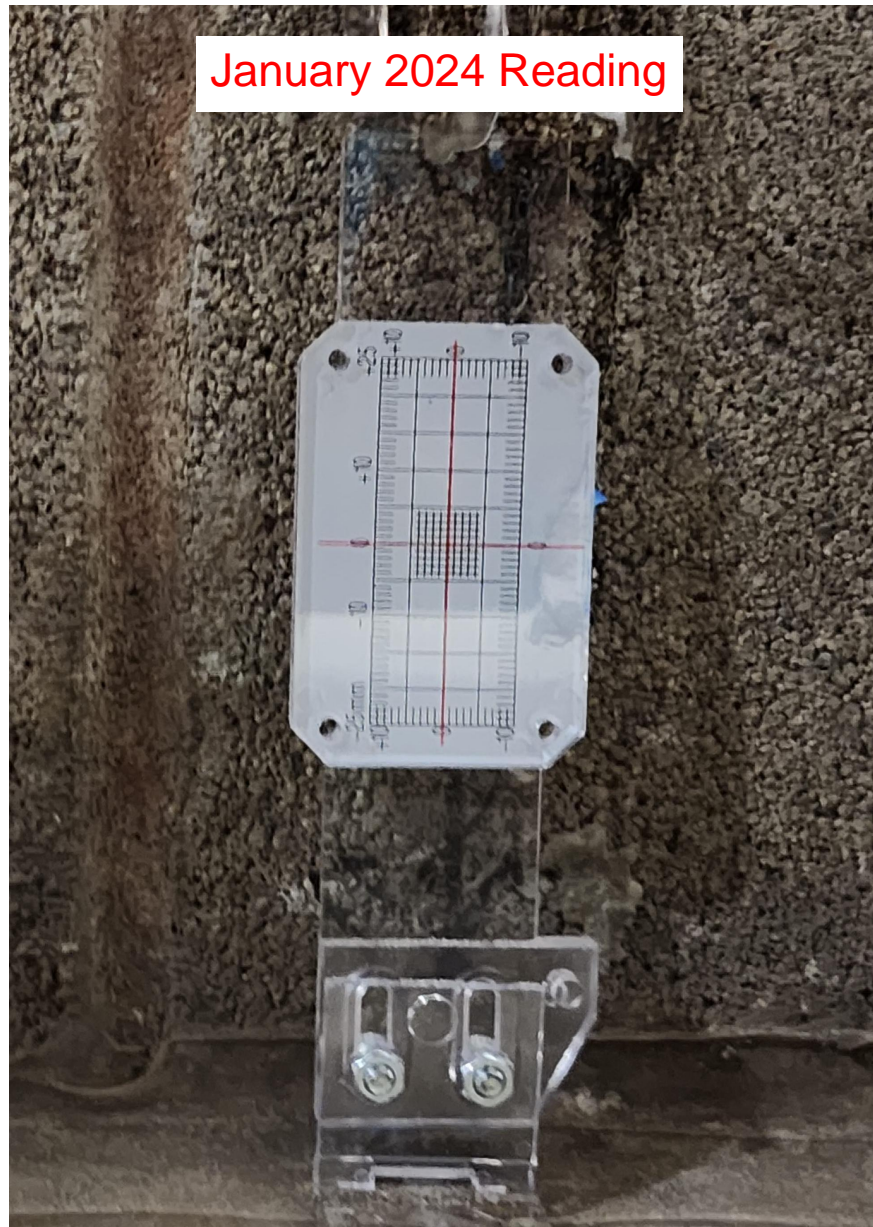
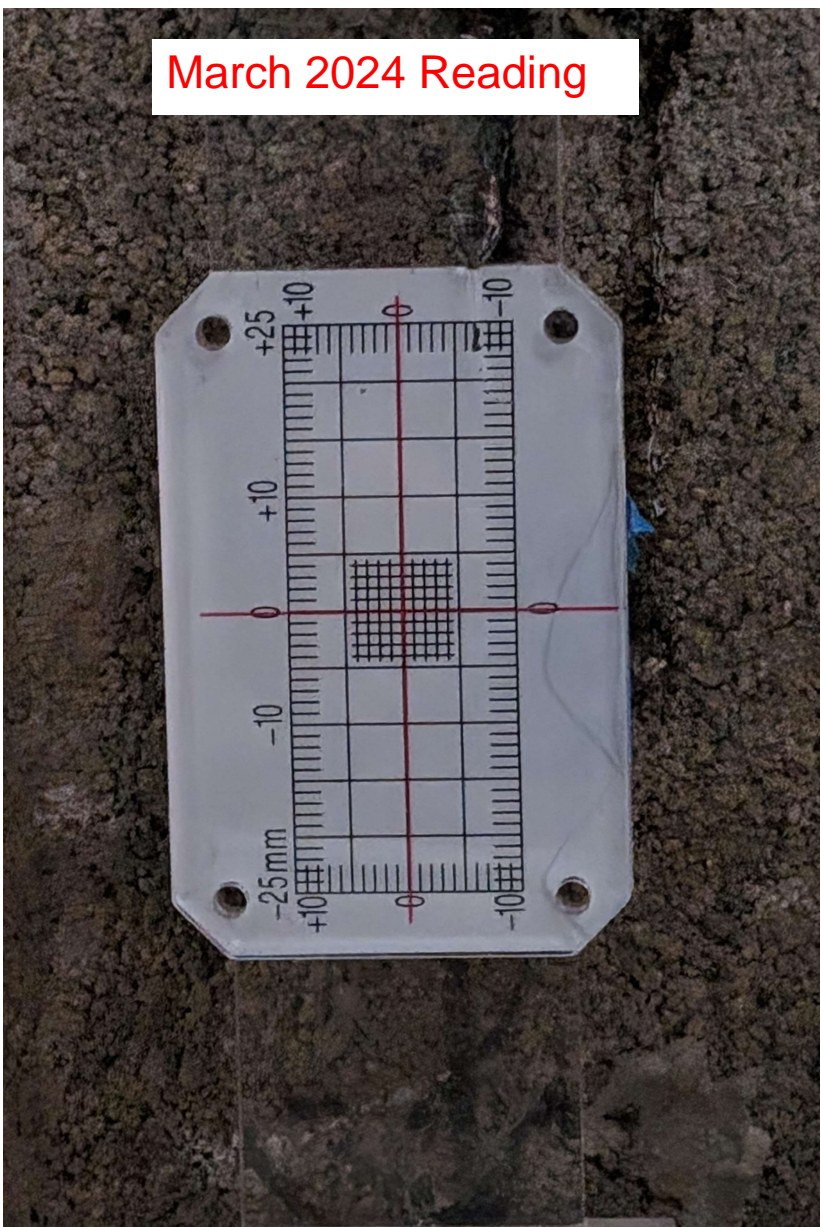
FIGURE 4

MP-3 - Mechanical Room north wall behind fire water pipes between floor slab and cinder block wall.

MP-3 : No vertical or horizontal movement since January 2024 readings.

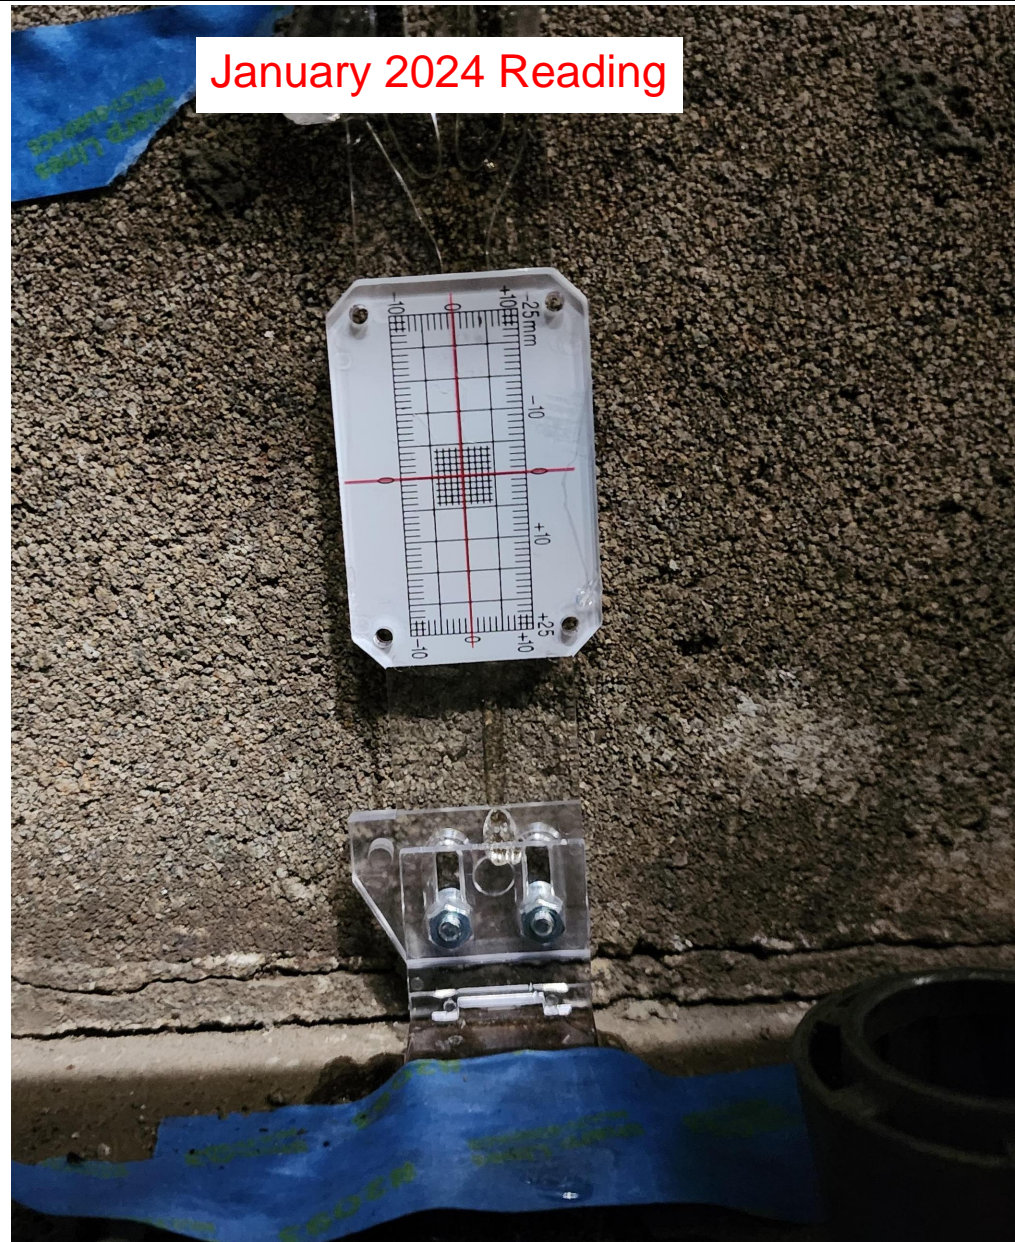
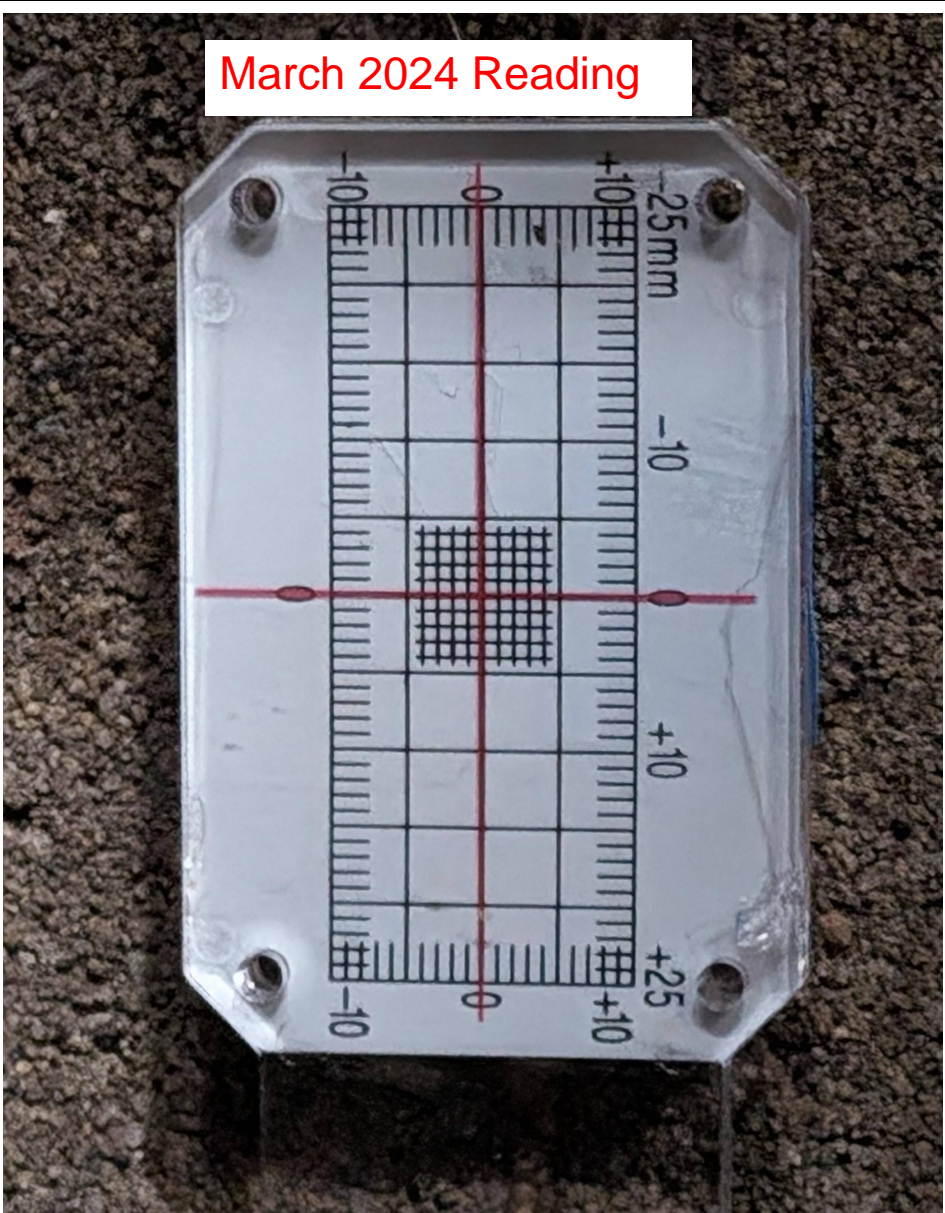
FIGURE 5

MP-4 - Mechanical Room south wall west of boiler behind 6-inch metal ducting pipe, between floor slab and wall.

MP-4 : No vertical or horizontal movement since January 2024 readings.

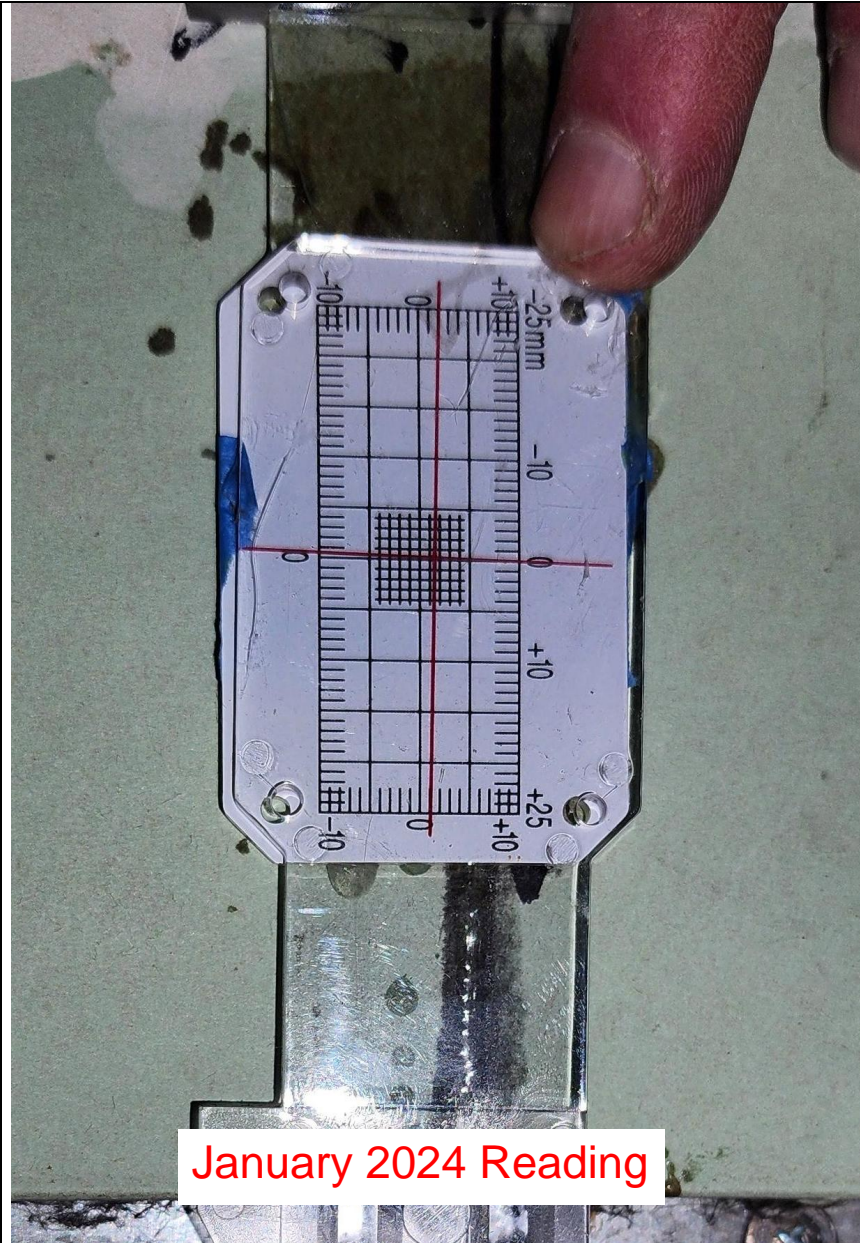
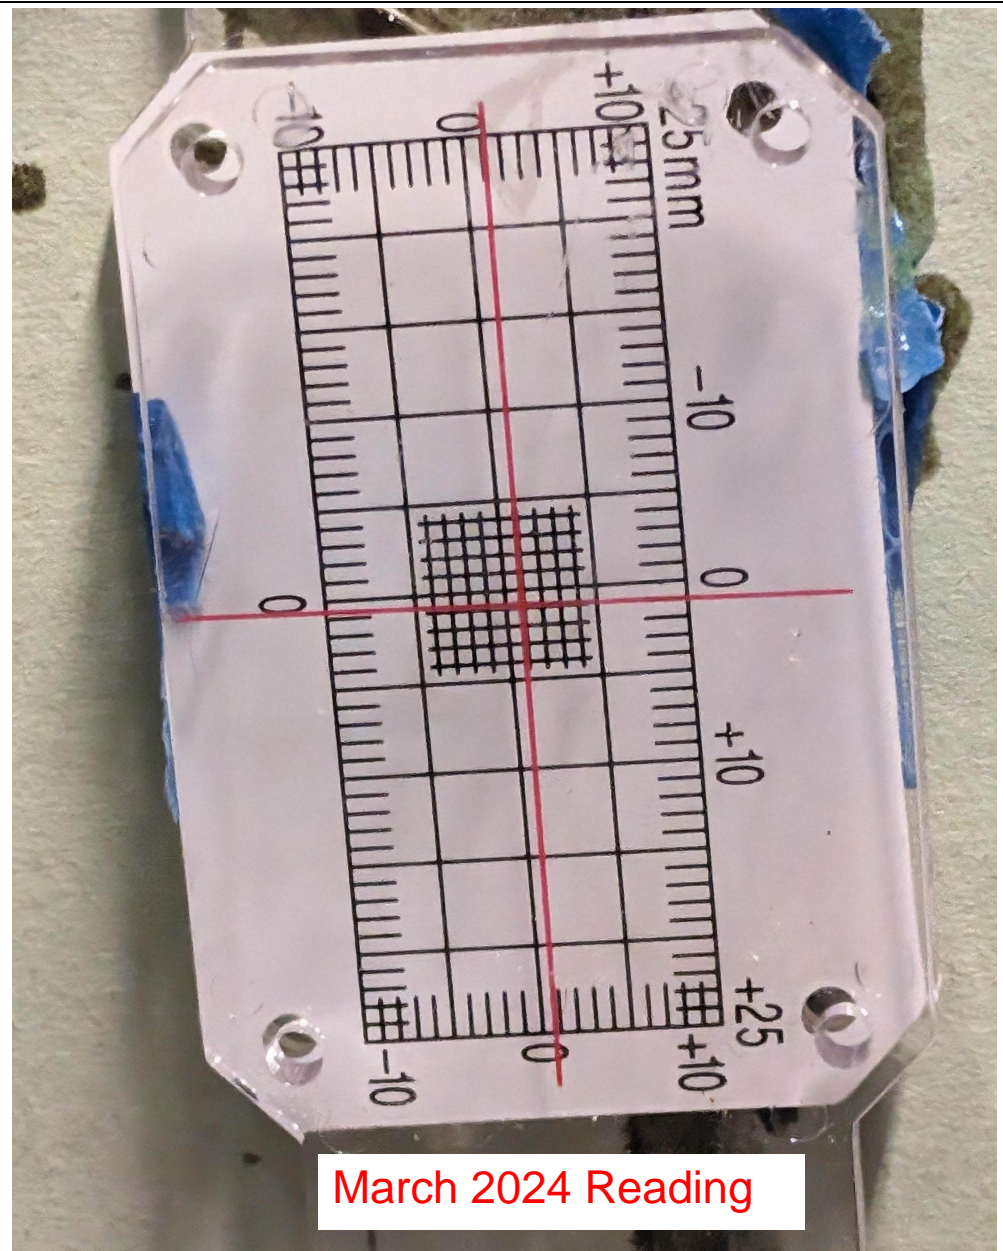
FIGURE 6

MP-5 - Water Tank room, west side of building just north of mechanical room accessed through exterior doors.

MP-5 : 1mm vertical movement, no horizontal movement since January 2024 readings
