# FOR WAYLAND ARMS SLAB REPAIR & SEISMIC UPGRADE RFQ

<b>Project Name:</b>	Wayland Arms Apartments - Settlement Monitoring	<b>Report:</b> 001	
<b>GeoDesign # :</b>	KCHA-13-04	<b>Date:</b> 01/09/2024	
<b>Reports with Unresolved Nonconformance Issues:</b>		<b>Permit:</b>	
<b>Distribution:</b>	Heath MacCoy <HeathM@kcha.org>		
	<b>Weather:</b>	<b>Arrival/Departure:</b>	<b>Prepared By:</b> <i>Ken J. Lamb</i>
<b>Attachments:</b>	<input checked="" type="checkbox"/> Site Plan(s)	<input type="checkbox"/> Density Test Summary	<b>Signature:</b>
	<input type="checkbox"/> Installation Records	<input type="checkbox"/> Other	<b>Reviewed By:</b> <i>Ken J. Lamb</i>

## SUMMARY OF CRACK MONITORING GAGE INSTALLATION:

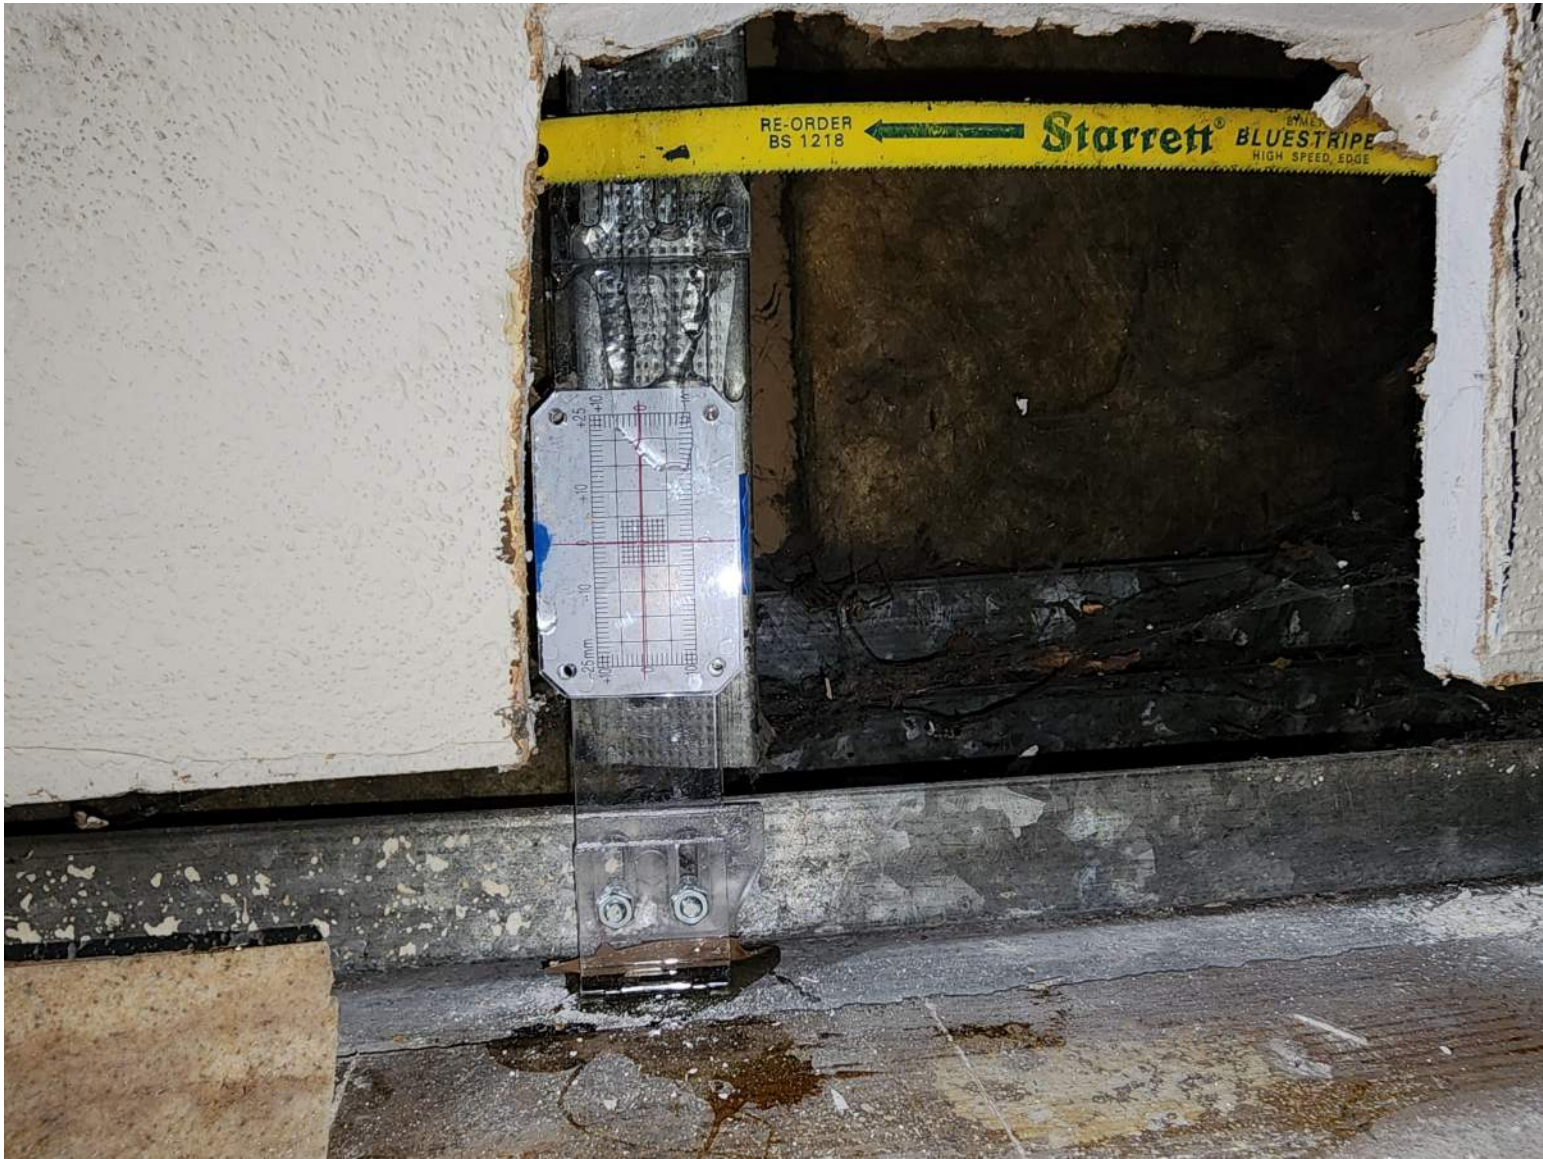
FIGURE 2

MP-1 - Suite 100 central wall opposite interior hallway between floor and wall stud. Wall studs are hanging from 2nd floor joist and there is an existing gap between the floor slab and base plate.

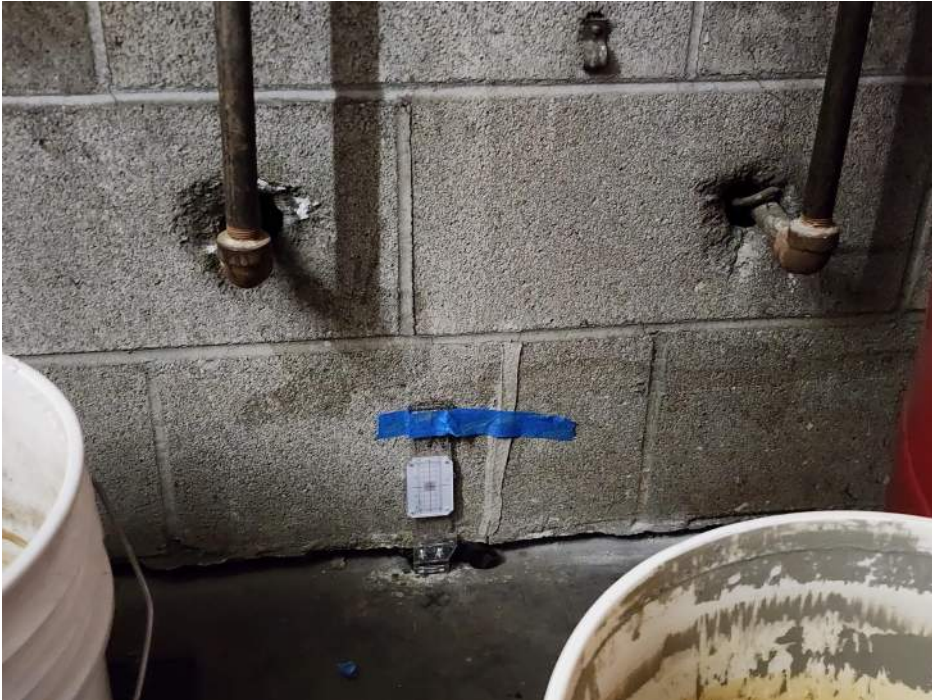
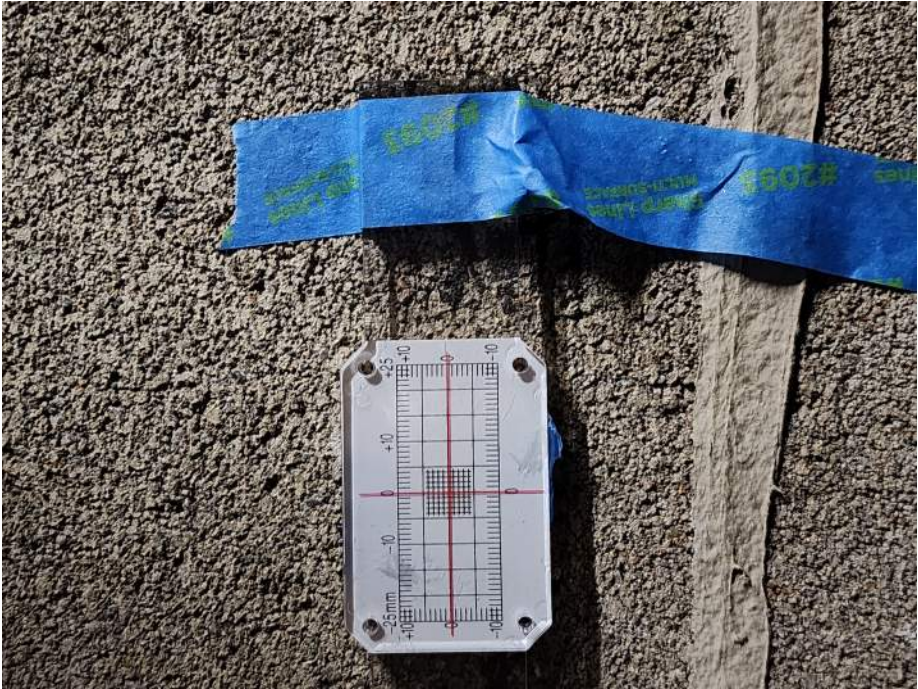
FIGURE 3

MP-2 - Mechanical room central wall opposite interior hallway, between floor and cinder block wall.

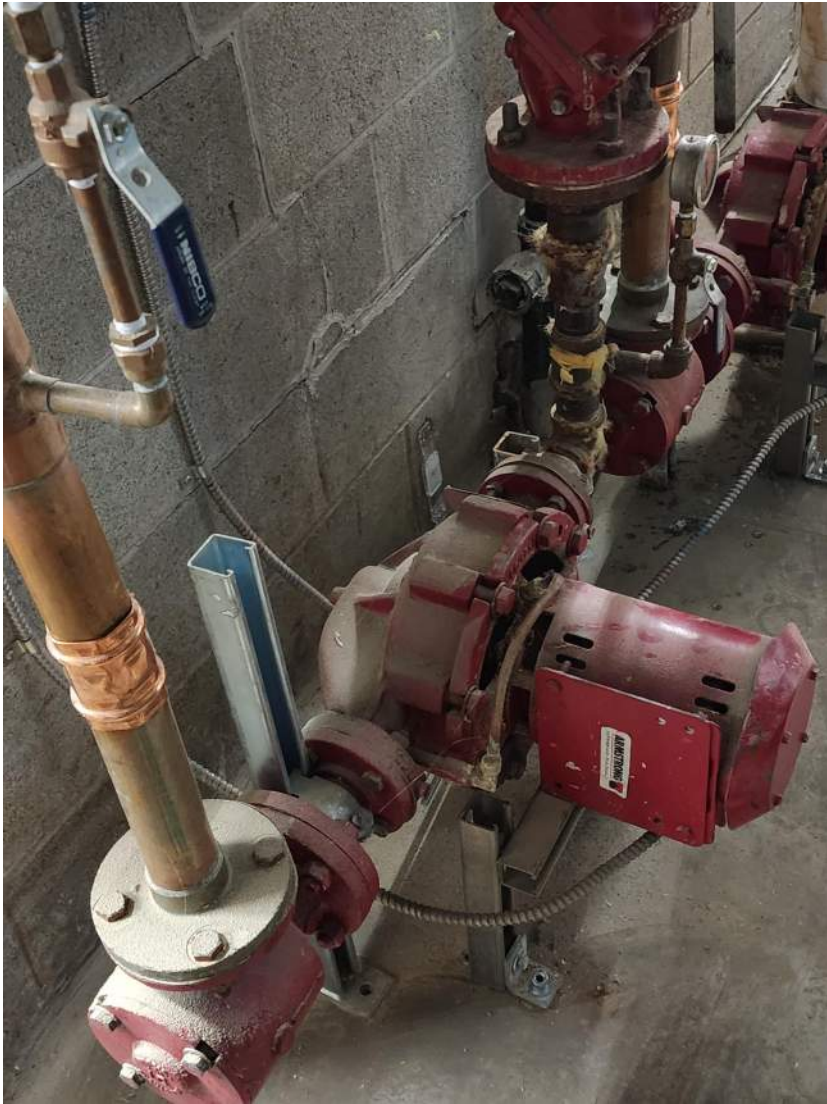
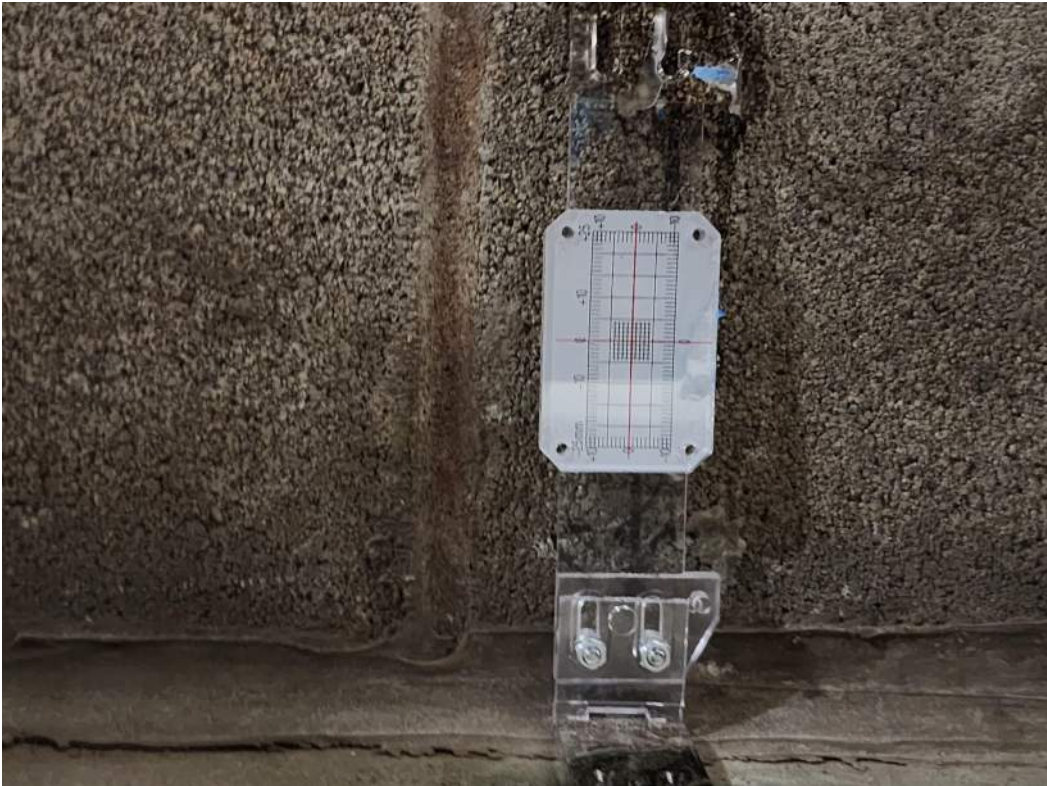
KCHA-13-04	MONITORING POINT LOCATION - MP3	
	JANUARY 2024	WAYLAND ARMS APARTMENTS AUBURN, WA	FIGURE 4

MP-3 - Mechanical Room north wall behind fire water pipes between floor slab and cinder block wall.

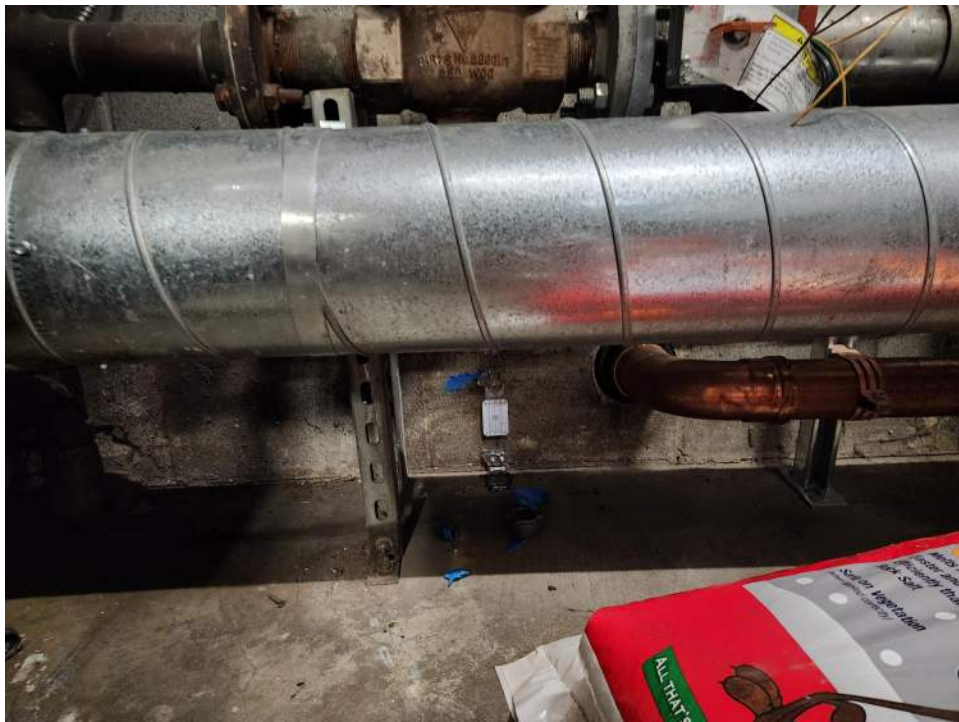
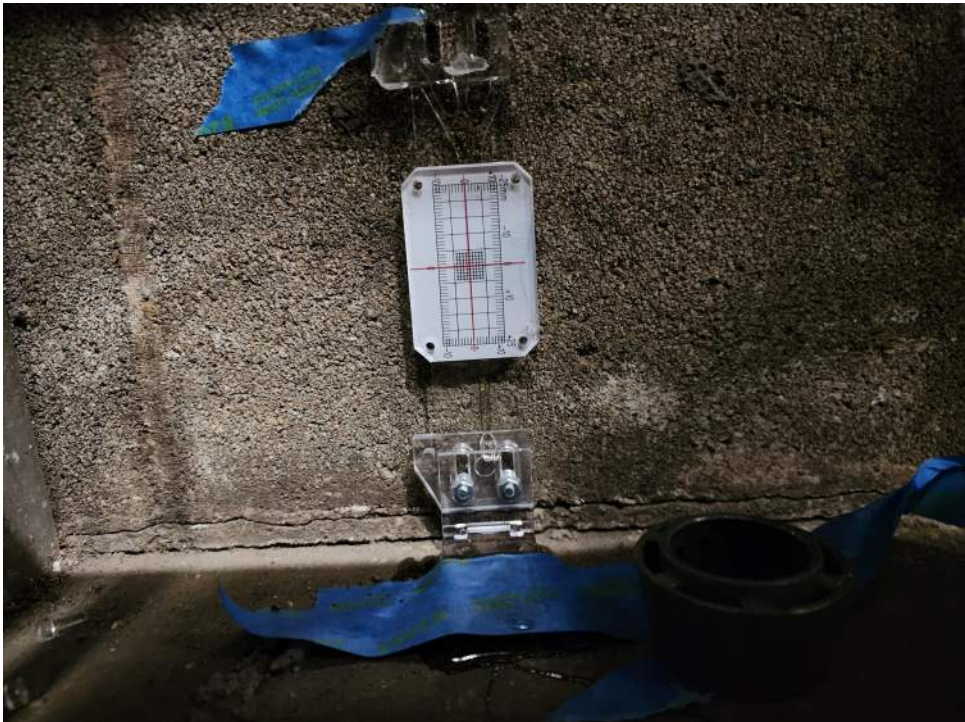
FIGURE 5

MP-4 - Mechanical Room south wall west of boiler behind 6-inch metal ducting pipe, between floor slab and wall.

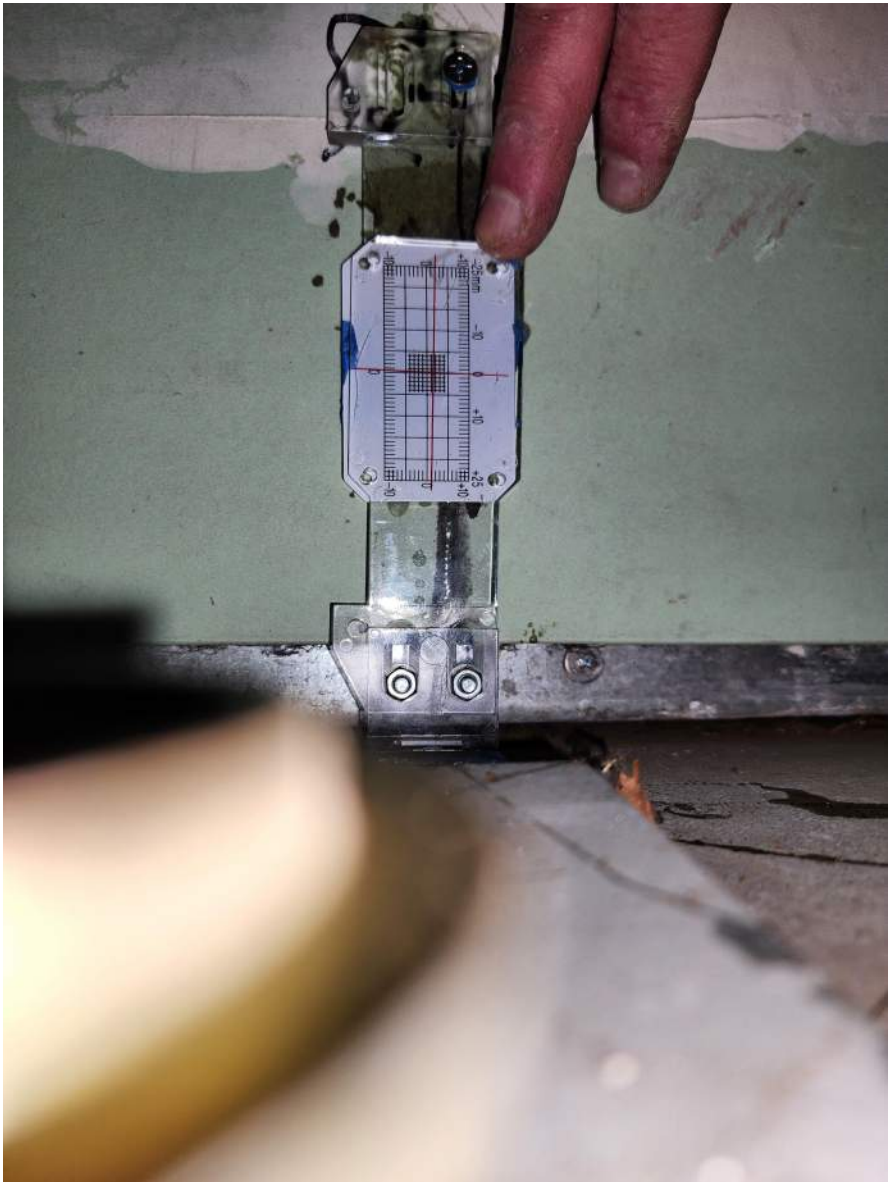
FIGURE 6

MP-5 - Water Tank room, west side of building just north of mechanical room accessed through exterior doors.
