August 30, 2023

RE: *Structural Evaluation – Wayland Arms Apartments – Auburn, Washington*

**WAYLAND ARMS APARTMENTS
AUBURN, WASHINGTON
APPENDIX – PHOTOGRAPHS**

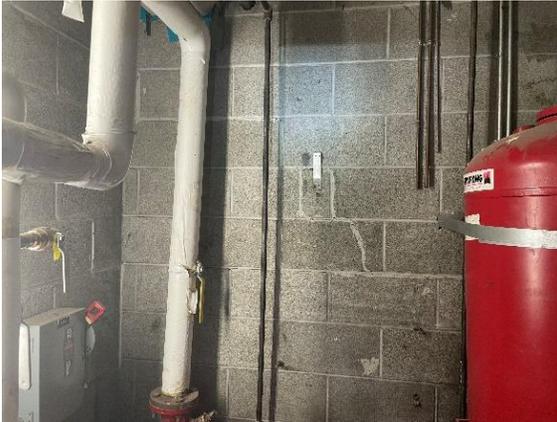
- The 6" nonbearing masonry walls at the mechanical walls had vertical and diagonal cracks in the walls. The slab on grade at this area had settlement of 2" in some locations.

Photo 1. Typical cracks at masonry wall – Mechanical Room

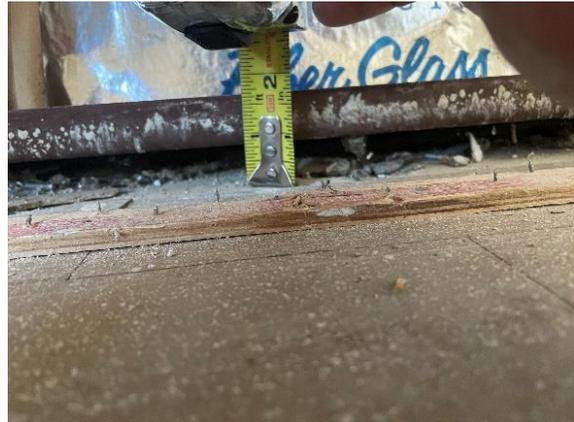
- We observed that the non-bearing metal studs had separated from the concrete slab on grade. There was an approximate gap of 1" between the wall and the concrete slab on grade. The powder actuated fasteners that were used to attach the metal stud track to the concrete were spalled out of the concrete. We observed cracking in the sheet rock for the light gage non-bearing metal stud wall.

Photo 2. Metal Stud Wall separated from the concrete slab on grade approximately 3/4".

We would recommend shimming metal stud walls that have pulled apart from the slab on grade to limit further damage to the sheet rock.

Overall, the slab settling, the displacement of the stud walls from the slab on grade and the cracks in the masonry and non-bearing metal stud walls doesn't pose a significant life safety risk, but we do recommend making next steps to mitigate the issue at hand. The metal stud walls should be shimmed as soon as possible and re-anchored to the foundation.

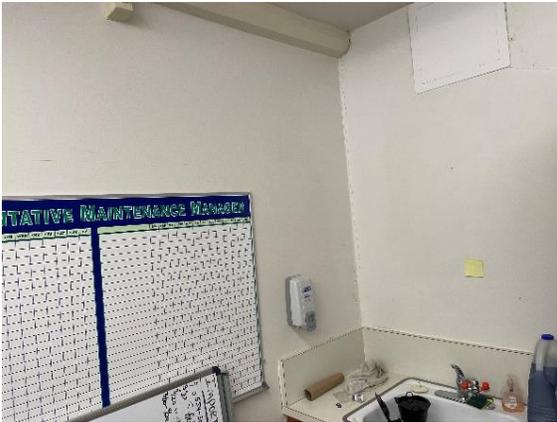
Photo 3. Typical cracks at dry wall
