Lead-Based Paint Inspection and Risk Assessment Report

Illahee Creekside Apartments
14049 NE Bel-Red Road
Bellevue, Washington 98007

March 8, 2021
PBS Project No. 40573.214

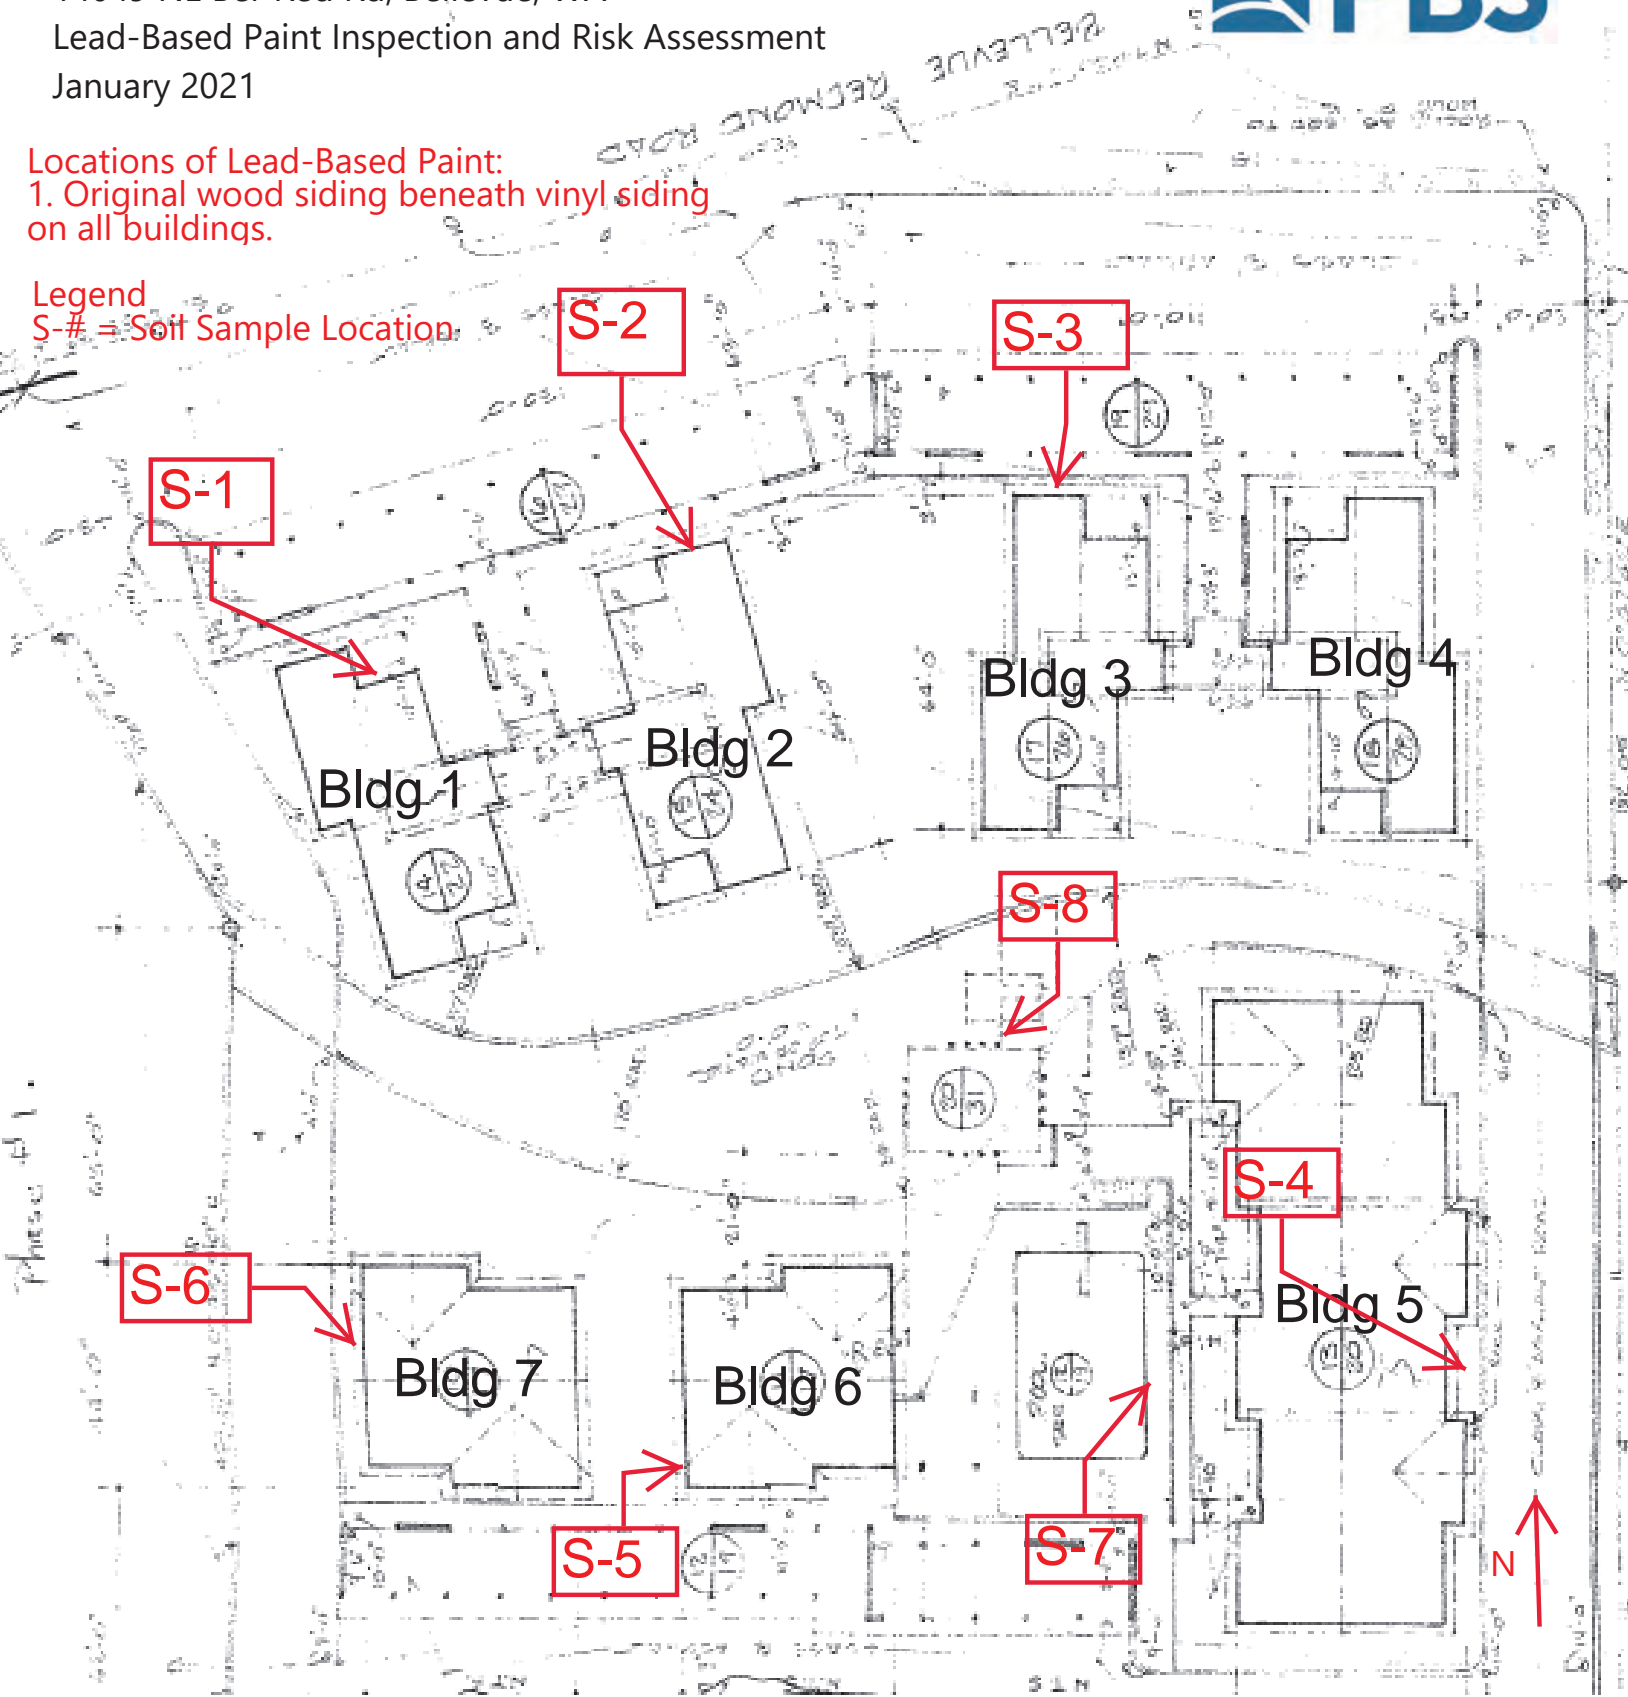
Locations of Lead-Based Paint:
1. Original wood siding beneath vinyl siding
on all buildings.

- Although lead dust and soil hazards were not identified at this property, PBS recommends on-going monitoring and use of lead-safe work practices associated with the lead-based paint beneath the vinyl siding at Building 1, 2, 3, 5, 6 and 7. See below for additional information.
