Kirkland Heights Apartments Building 8 Renovation

Contract No. AM2200131

Project Manual Volume 1: Divisions 00-02

Lead Based Paint Inspection

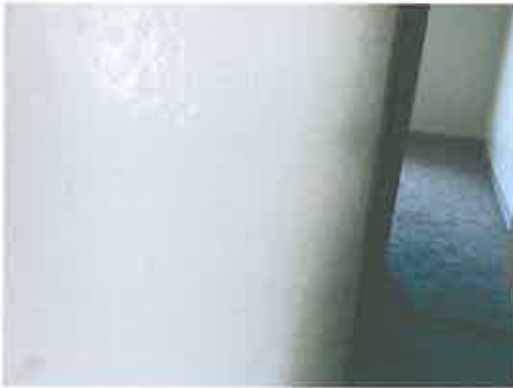
1. Wall Texture (Friable)

Sample numbers: 2013-771-1-1 through 1-27

There is approximately 120,000 square feet of asbestos containing wall texture associated with the wall systems of all the structures.

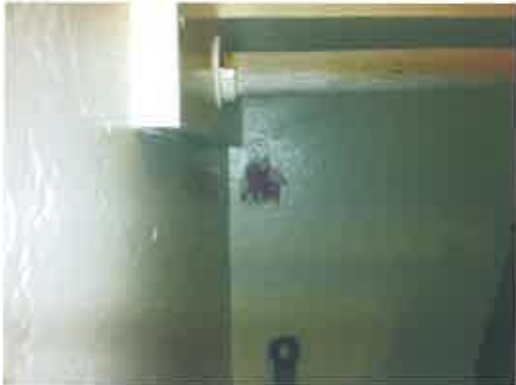
2. Joint compound (Friable)

Sample numbers: 2013-771-3-1 through 3-27

There is an unknown quantity of asbestos-containing joint compound with paint associated with the wall system of all the structures.

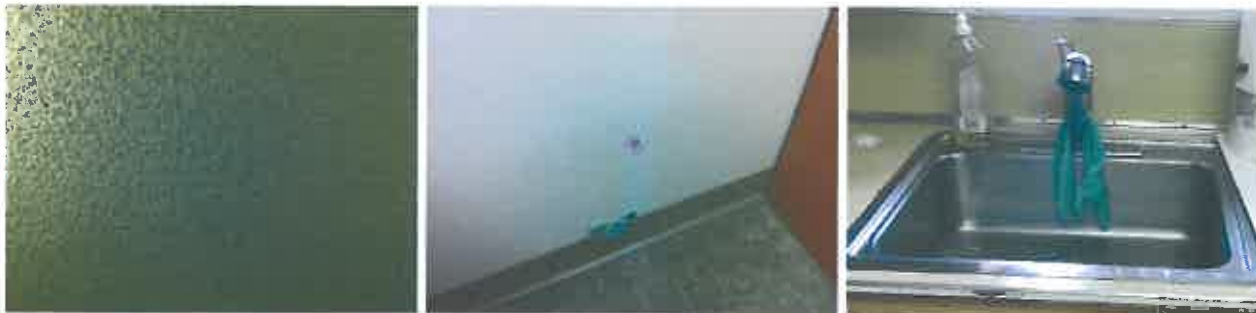
Please note the following suspect materials were not sampled, therefore shall not be disturbed by any means or circumstances.

Popcorn ceiling, Vinyl cove base with mastic, Aluminum sink undercoat and Sheet vinyl floorings with backing/mastic.

Contractors should be aware that concealed suspect asbestos-containing building materials may be uncovered during the course of demolition or renovation work. Contractors should have contingency plans that include stopping work, evacuation of the immediate area and sampling by a certified AHERA Building Inspector whenever these materials are found. Concealed suspect materials may include, but are not limited to: non-fiberglass pipe or roof drain insulation; spray-applied coatings; cement board; asphalt or paper vapor barriers; floorings and adhesives.

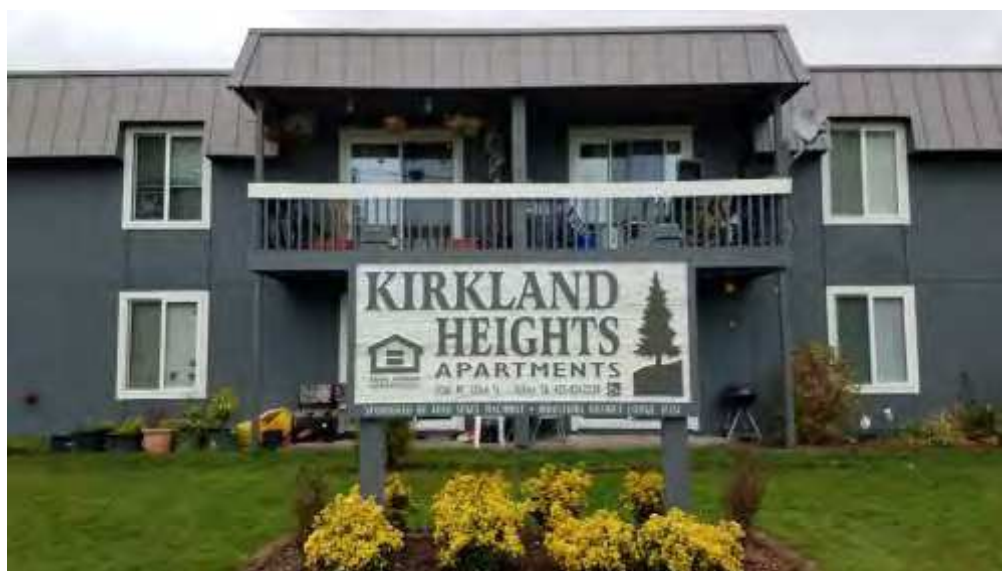
Photo 1. Building 24 on the south property boundary.

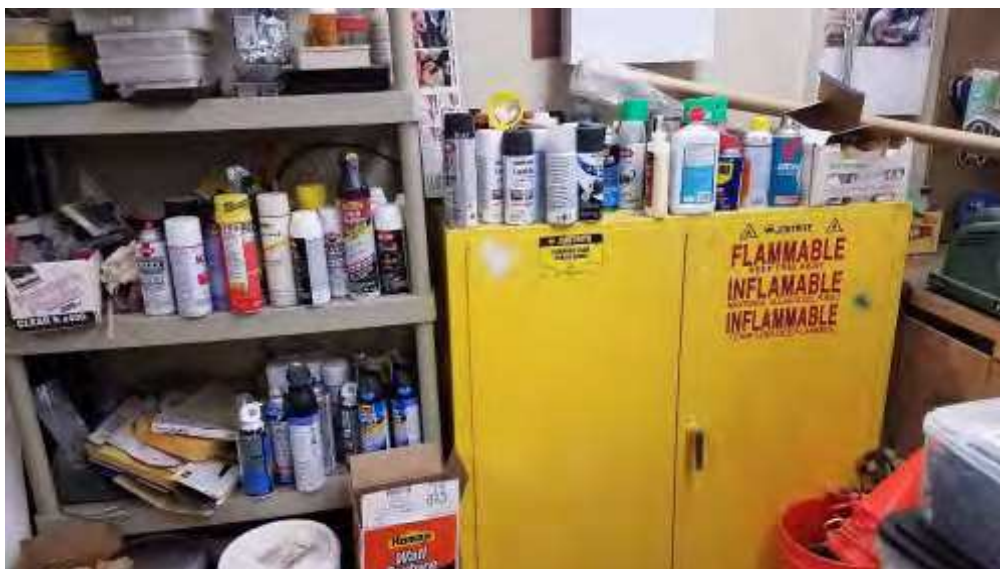
Photo 4. Chemical and flammables storage in the on-site shop.

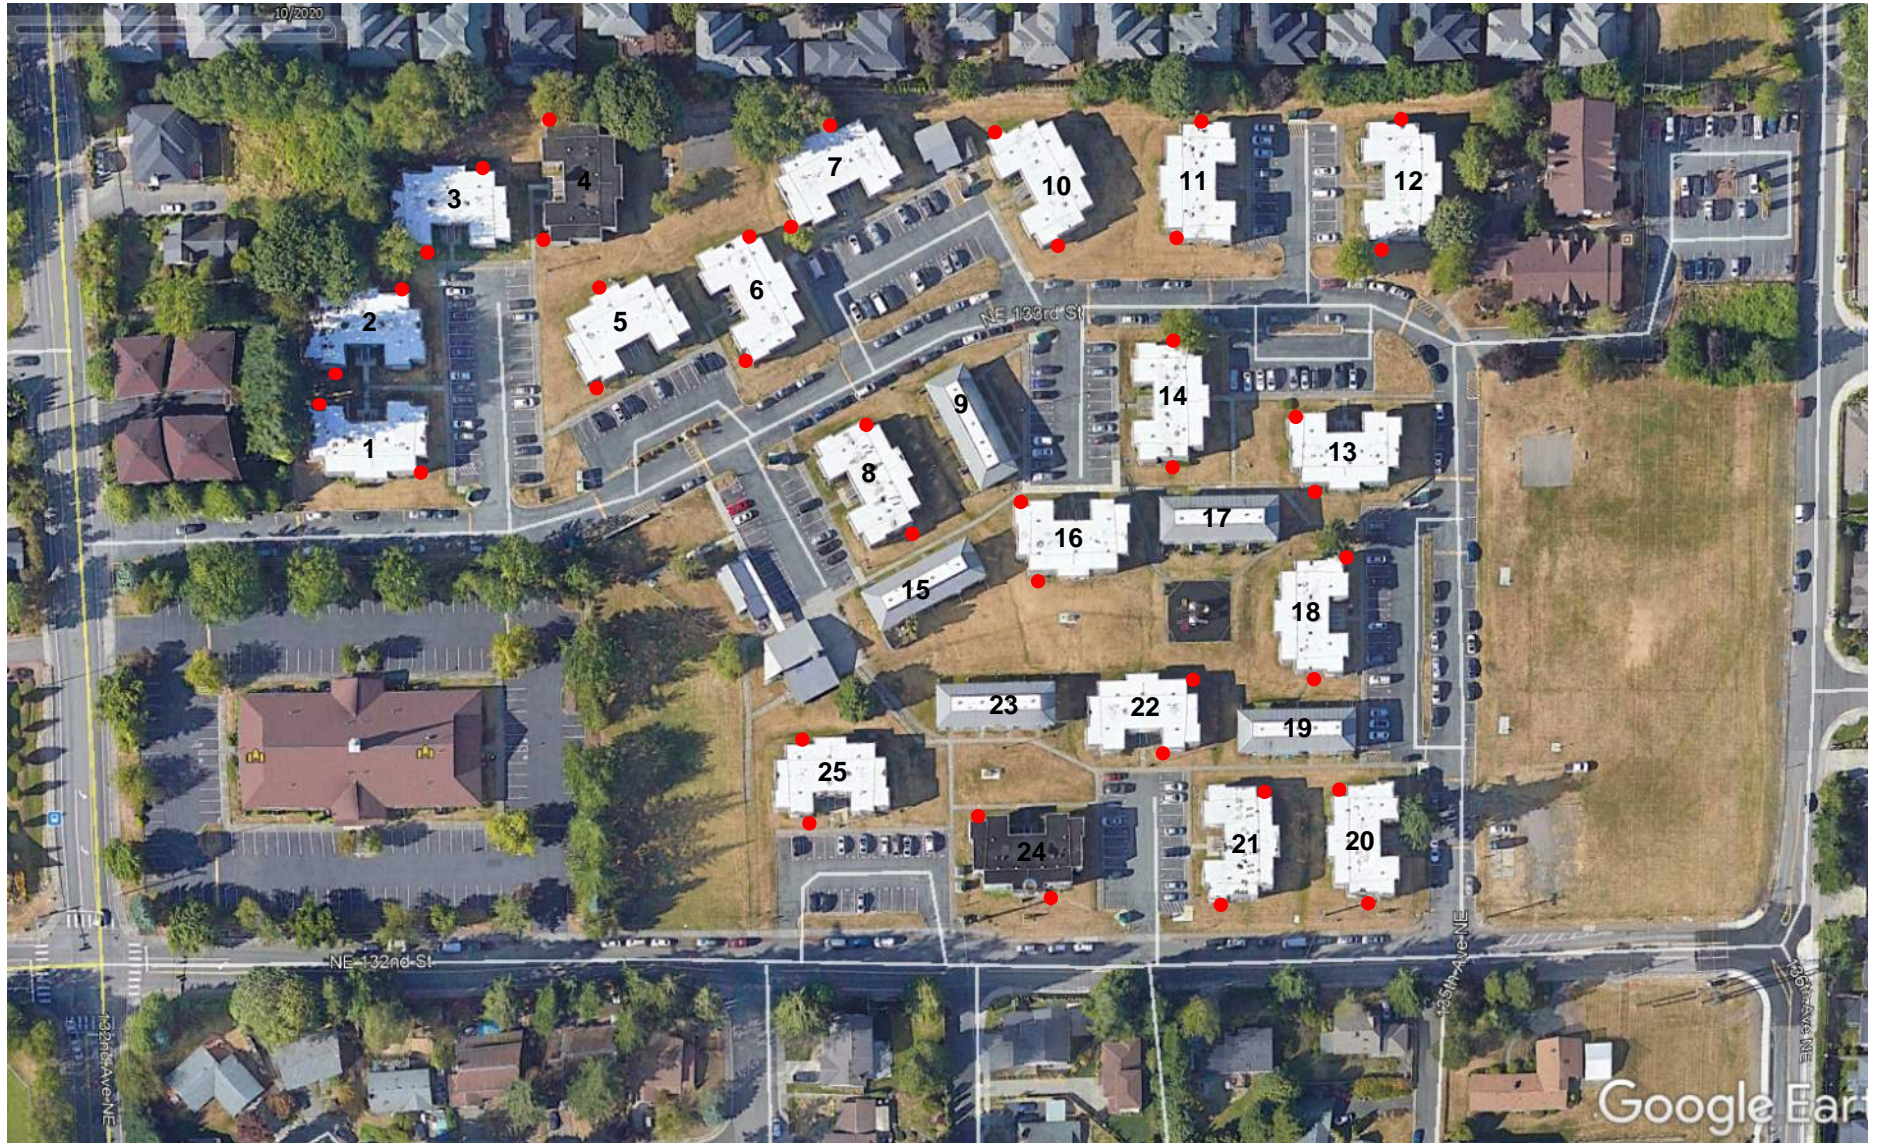
- PROPOSED EXCAVATOR DRILLED BORING
(40 LOCATIONS)

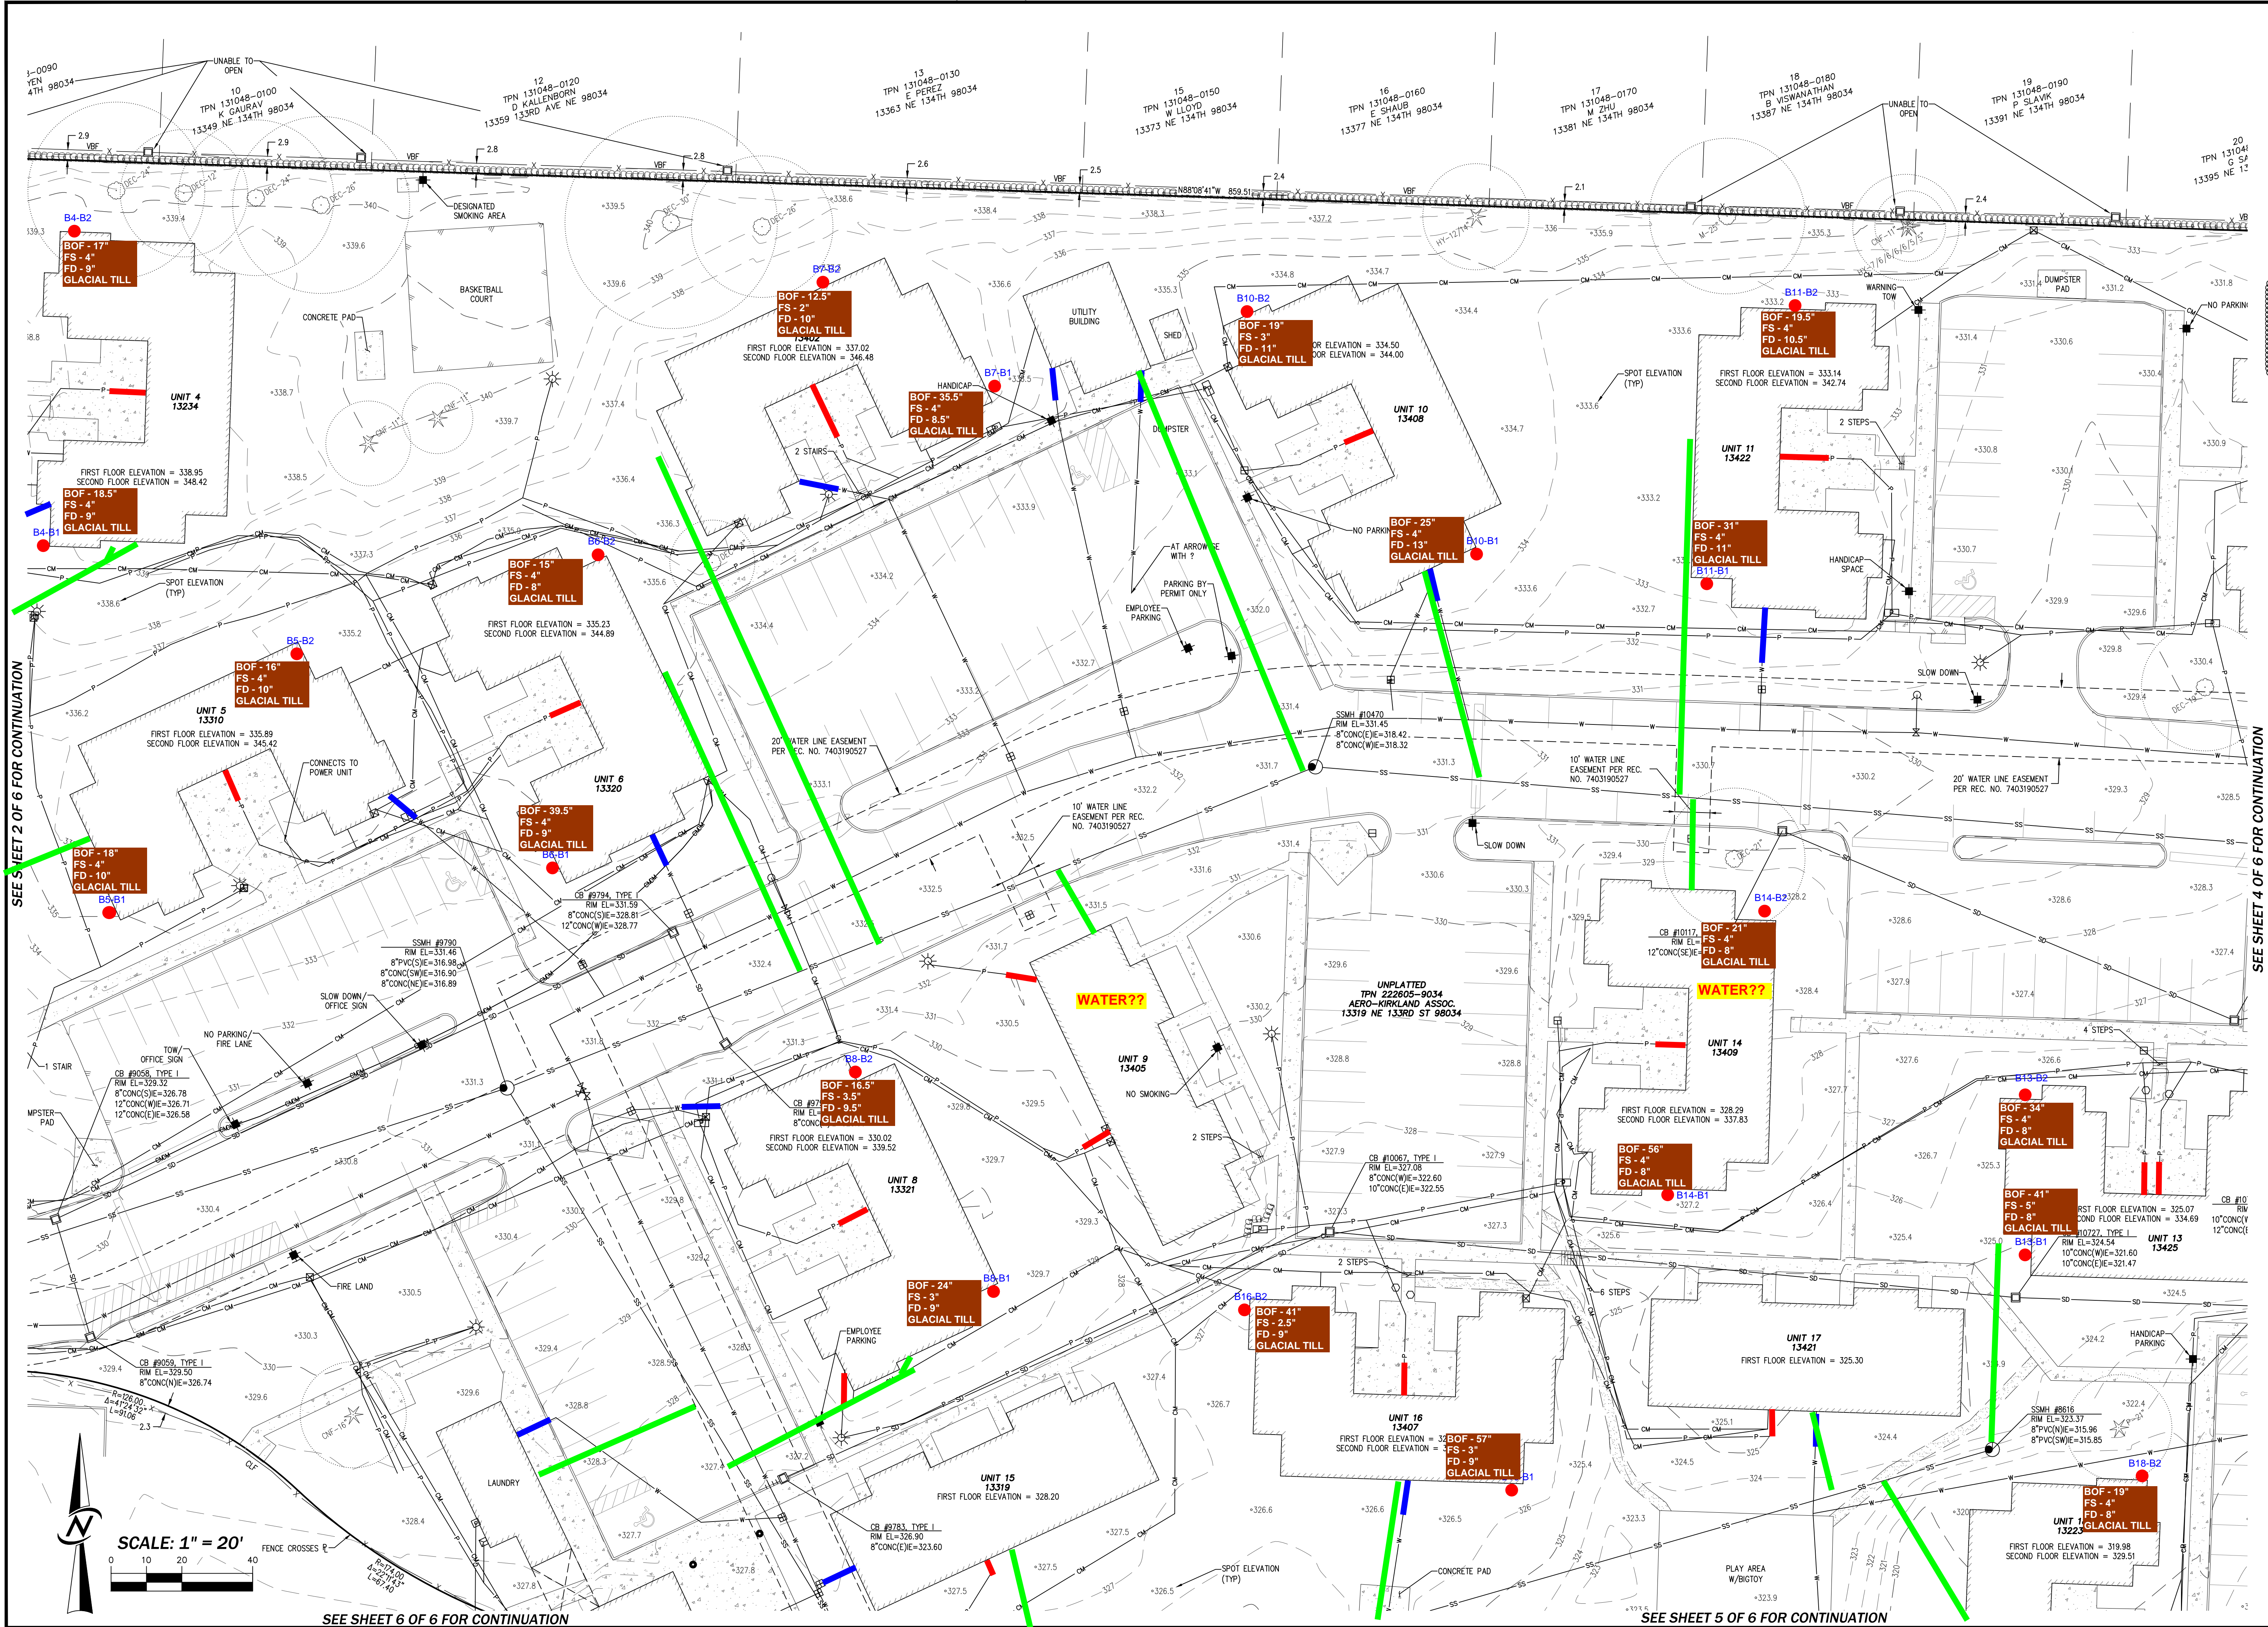
DATE		DESIGNED		DRAWN		APPROVED		PROJECT NUMBER	
MARCH 19, 2021		JEREMY REEF		JEREMY REEF		ROBERT D. WEST, PLS		18221	
SHEET		3		OF		6			
PROJECT NUMBER		18221

BOUNDARY/TOPOGRAPHIC SURVEY
KIRKLAND HEIGHTS APARTMENTS
KING COUNTY HOUSING AUTHORITY
600 ANDOVER PARK W
SEATTLE, WA 98118
