SKYWAY RESOURCE CENTER

PROJECT MANUAL – VOLUME 2 ENVIRONMENTAL REPORTS – PART 1

Hazardous Materials Survey Report

Phase I Environmental Site Assessment

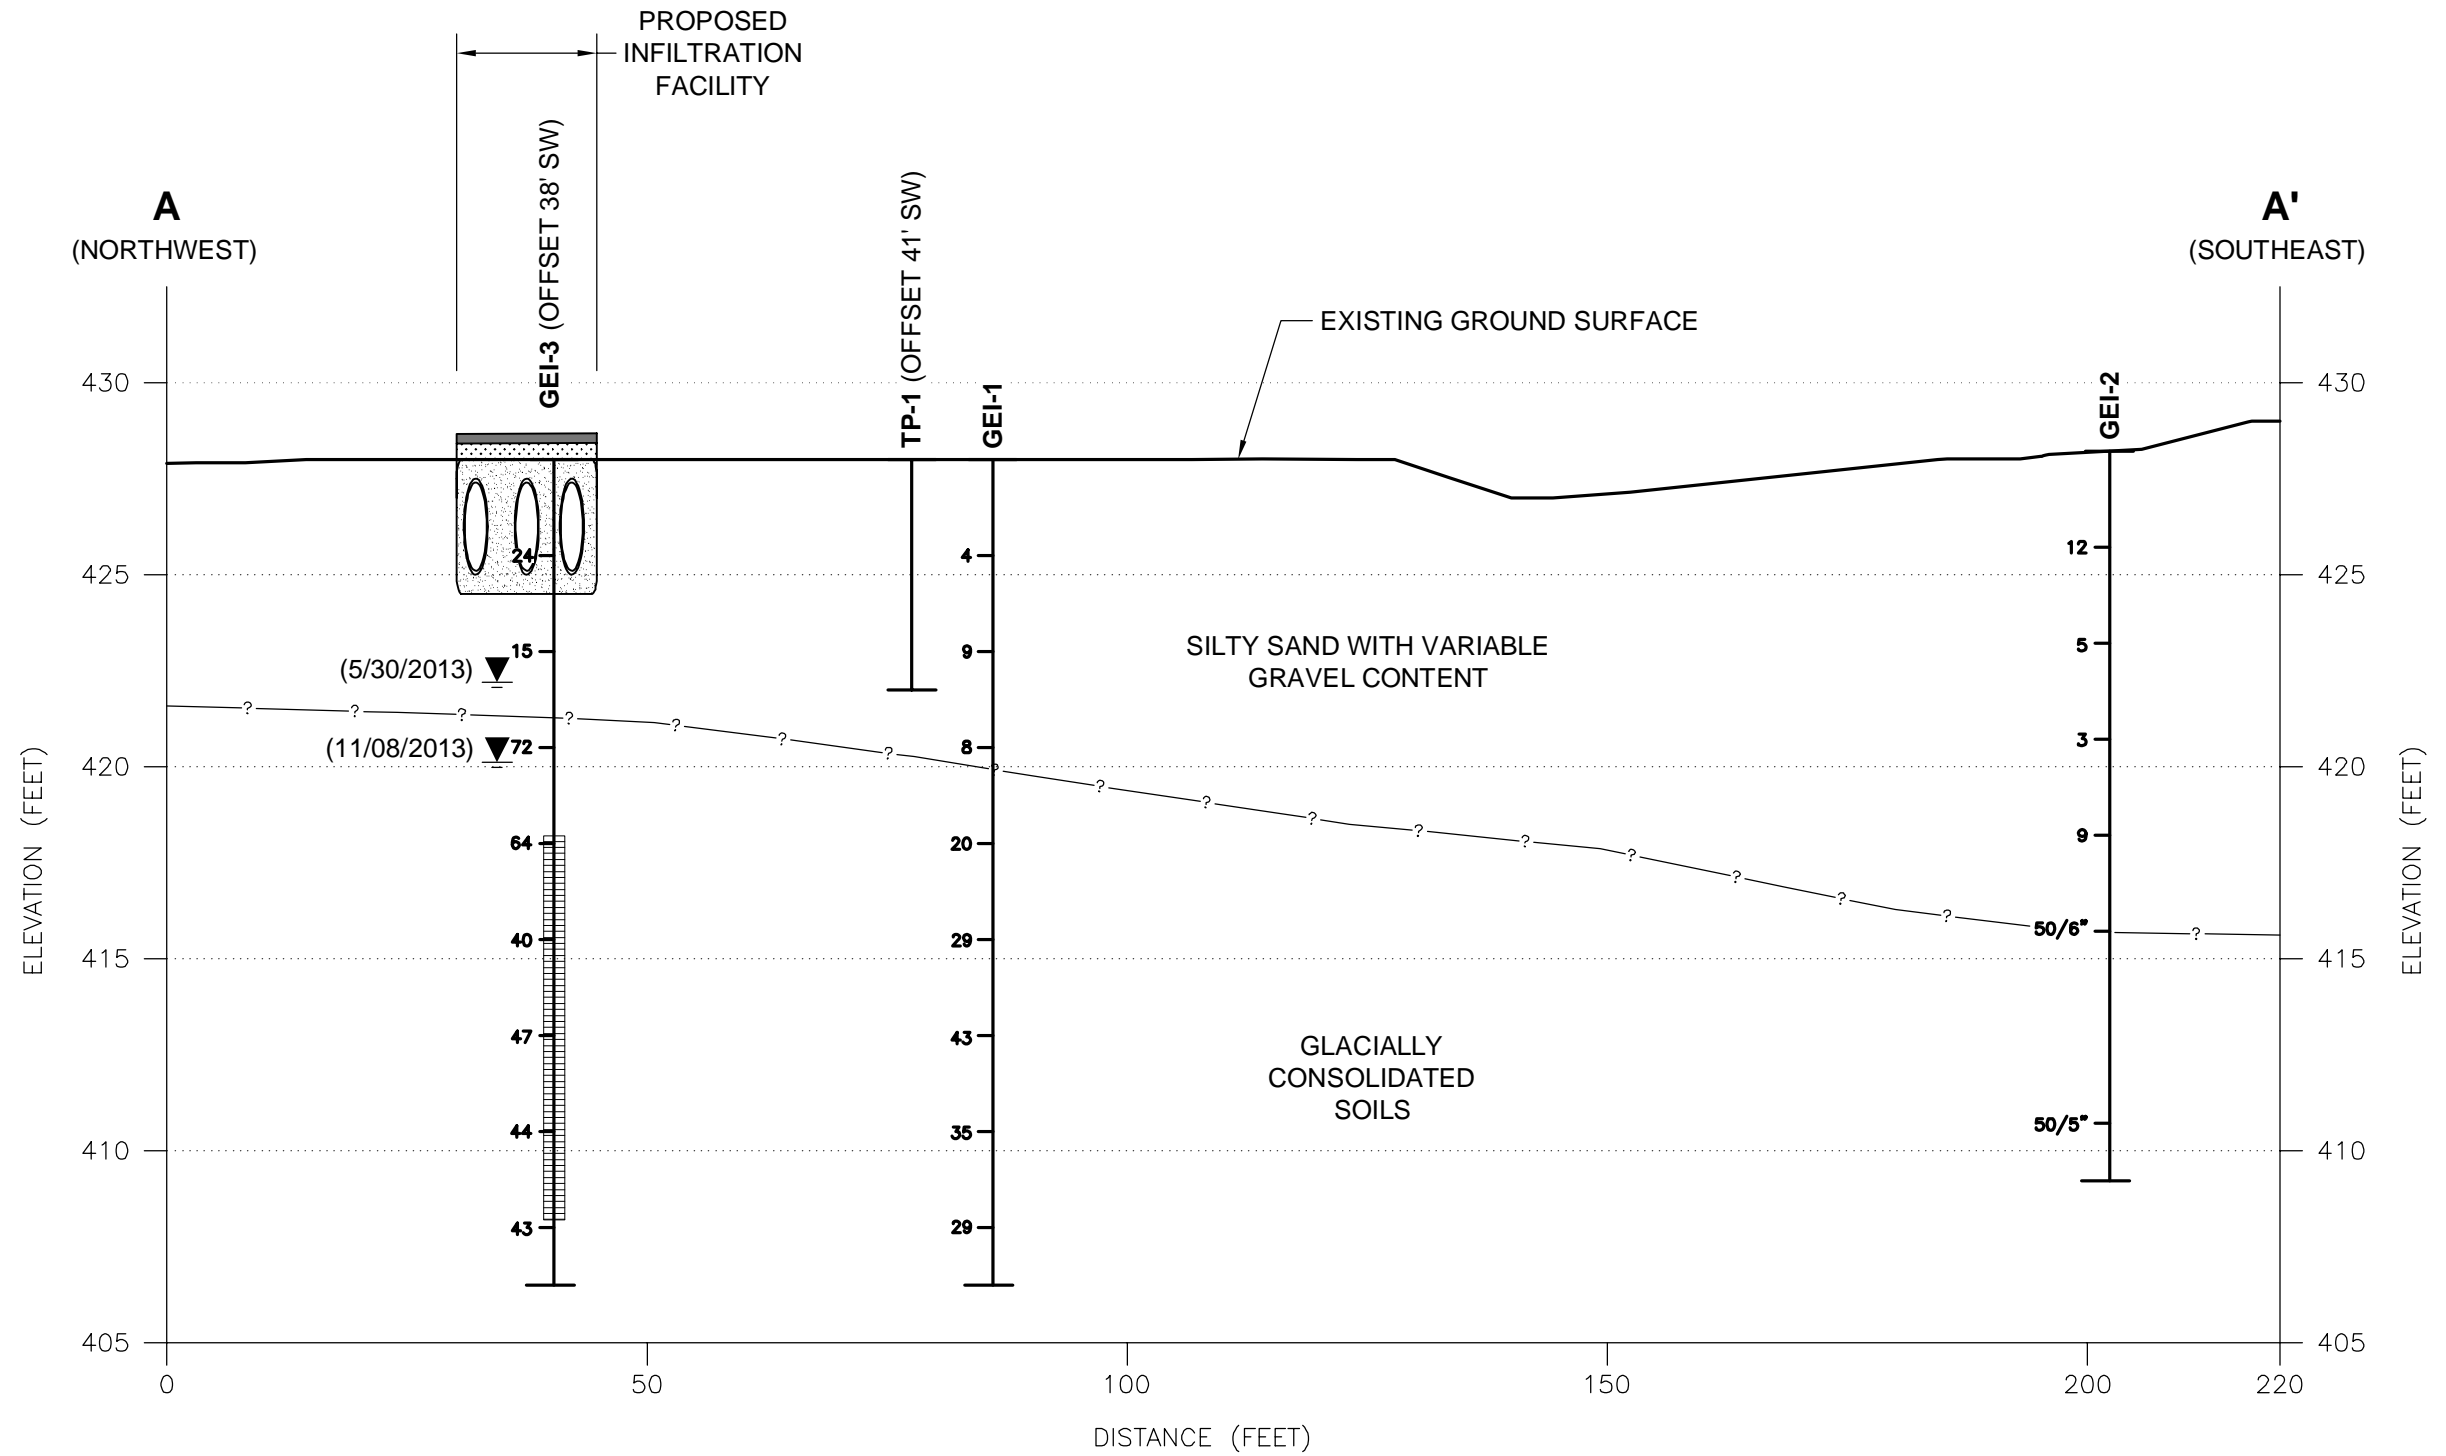
1. The subsurface conditions shown are based on interpolation between widely spaced explorations and should be considered approximate; actual subsurface conditions may vary from those shown.
2. This figure is for informational purposes only. It is intended to assist in the identification of features discussed in a related document. Data were compiled from sources as listed in this figure. The data sources do not guarantee these data are accurate or complete. There may have been updates to the data since the publication of this figure. This figure is a copy of a master document. The hard copy is stored by GeoEngineers, Inc. and will serve as the official document of record.
3. Datum: NAVD 88, unless otherwise noted.

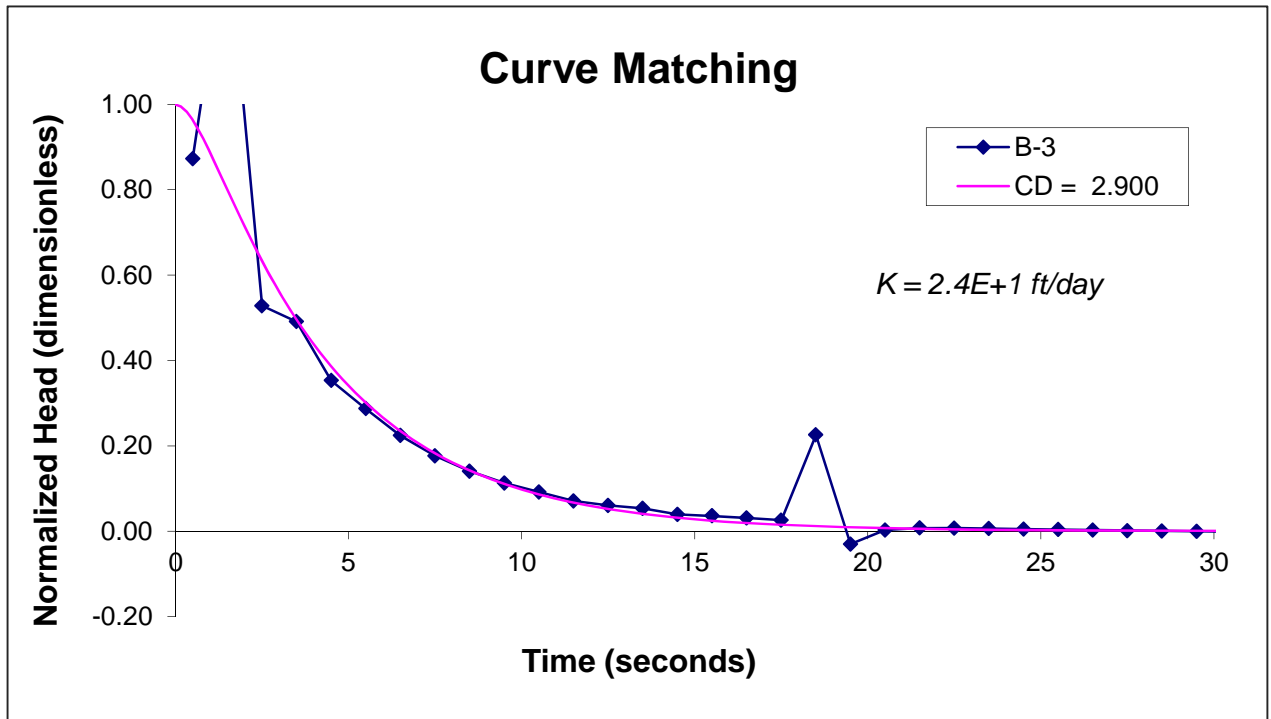
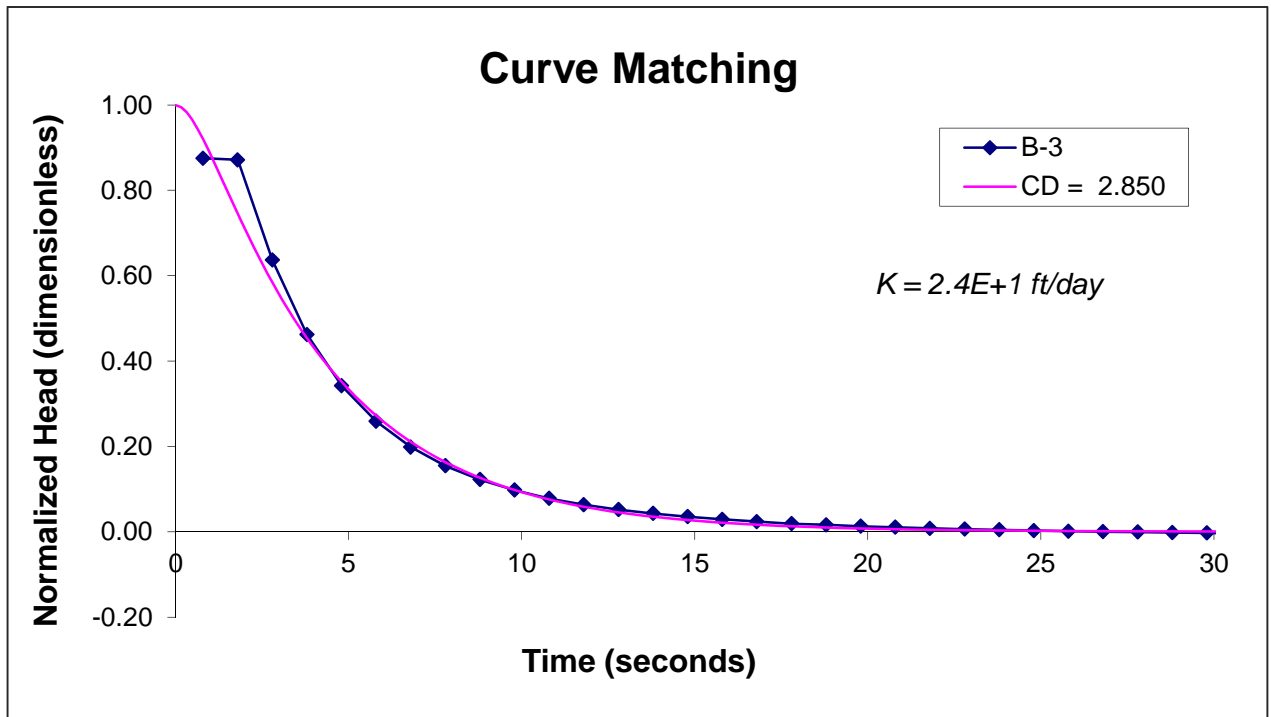
1. Slug Test conducted in Monitoring Well B-3 on 4/4/2013.
2. Underdamped slug test response analyzed using Butler & Garnett (2000) method for High-K.
3. Formation thickness, $B = 13.9$ ft used to calculate hydraulic conductivity, K .

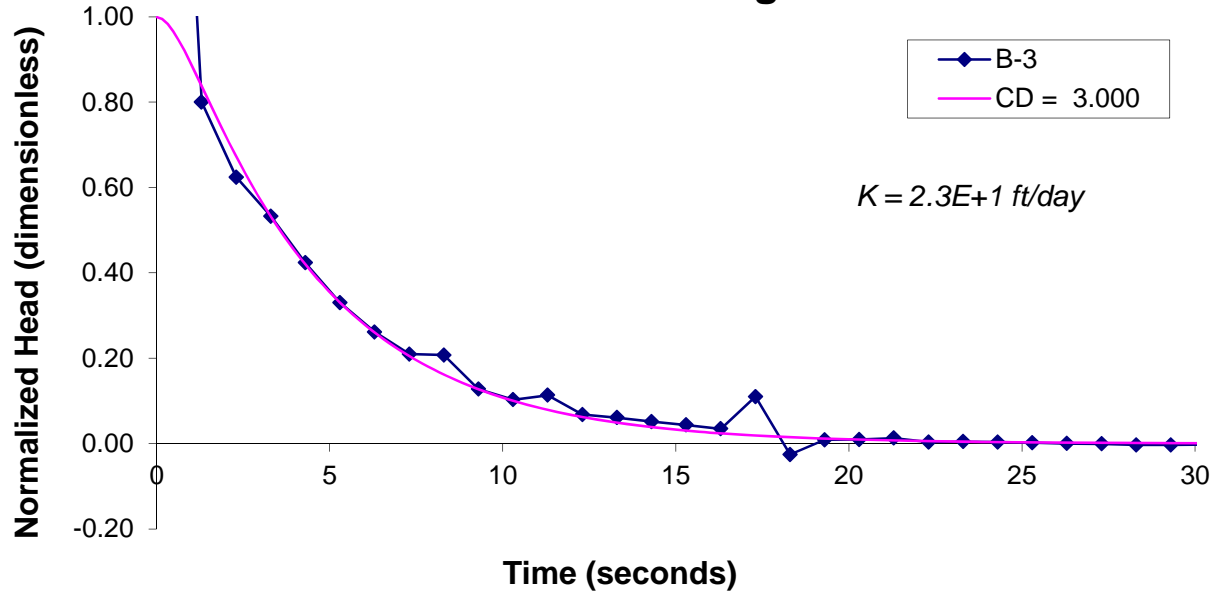
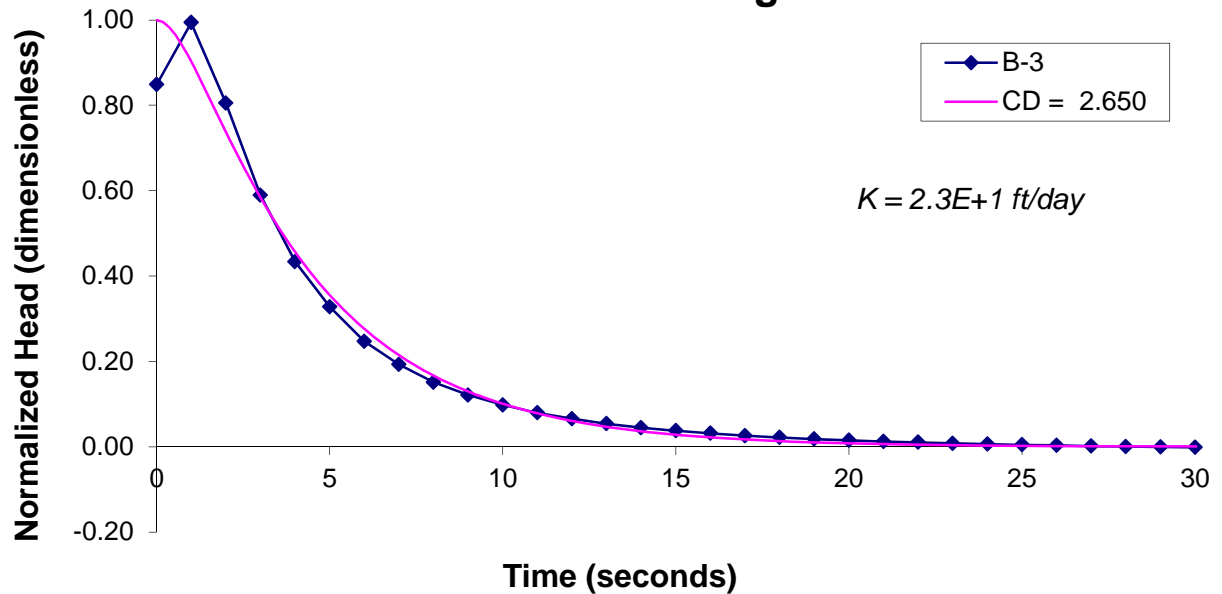
1. Slug Test conducted in Monitoring Well B-3 on 4/4/2013.
2. Underdamped slug test response analyzed using Butler & Garnett (2000) method for High-K.
3. Formation thickness, $B = 13.9 \text{ ft}$ used to calculate hydraulic conductivity, K .

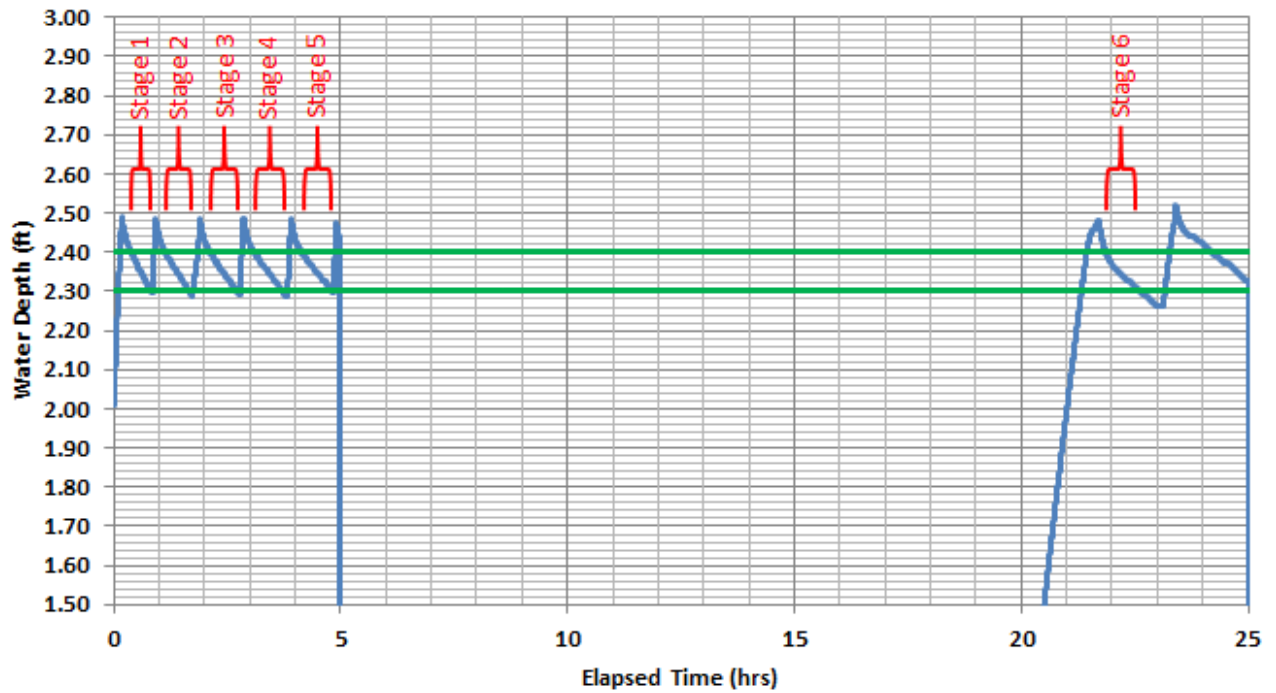
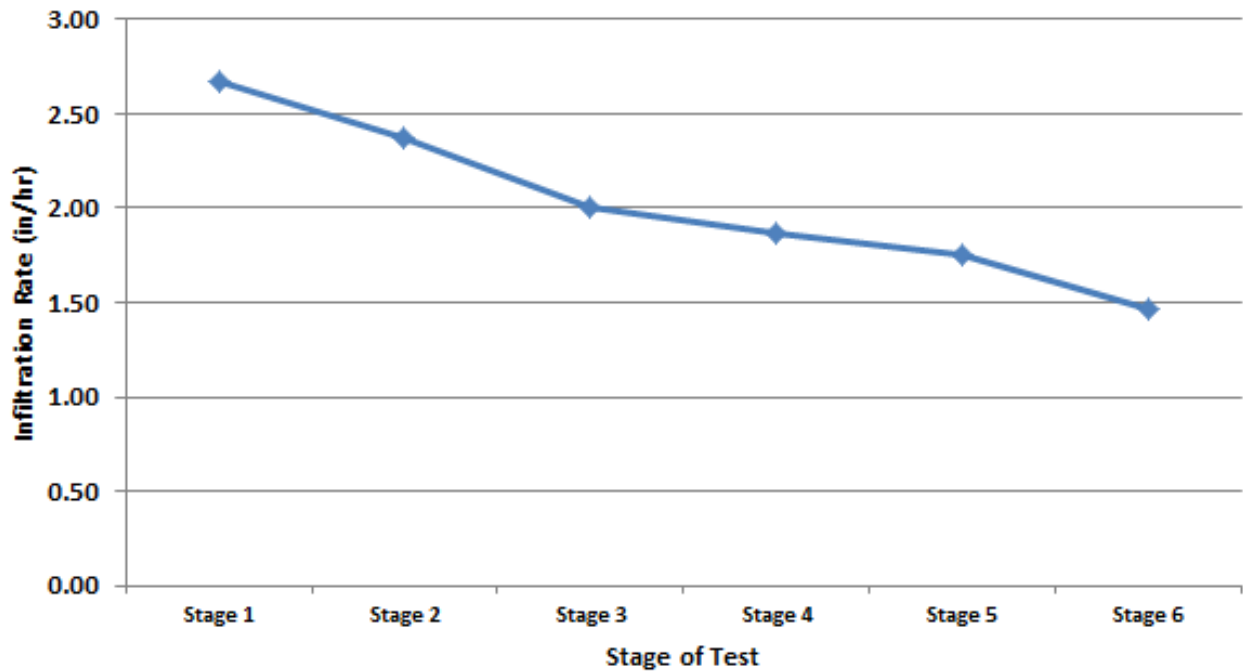
Figure A-9

Water Depth During Infiltration Test

Short-Term Infiltration Rate

Pilot Infiltration Test Results (PIT-1)

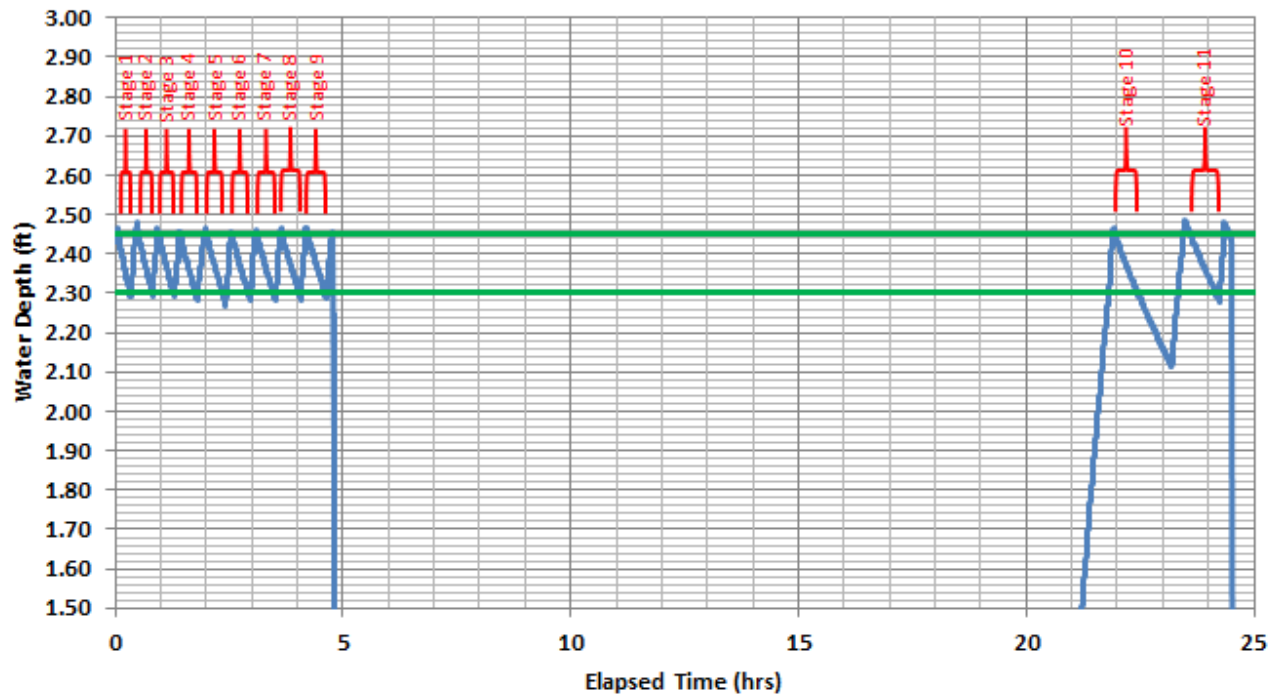
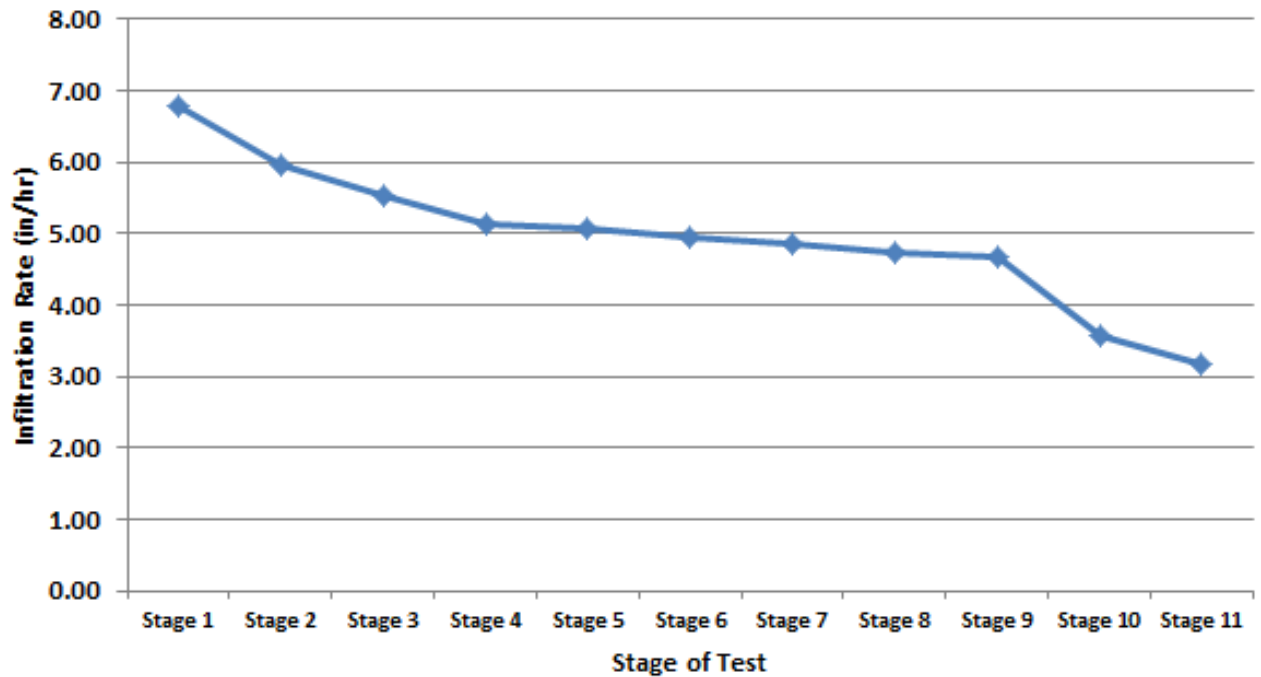
Figure A-10

Water Depth During Infiltration Test

Short-Term Infiltration Rate

Pilot Infiltration Test Results (PIT-2)

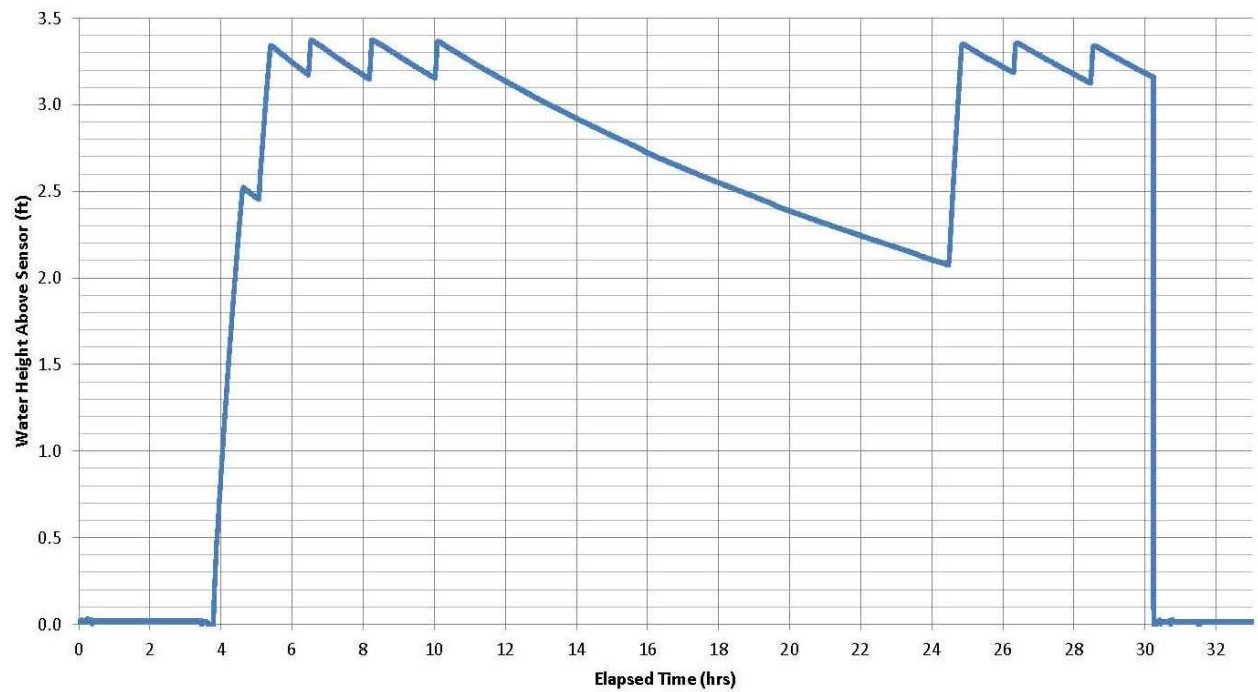
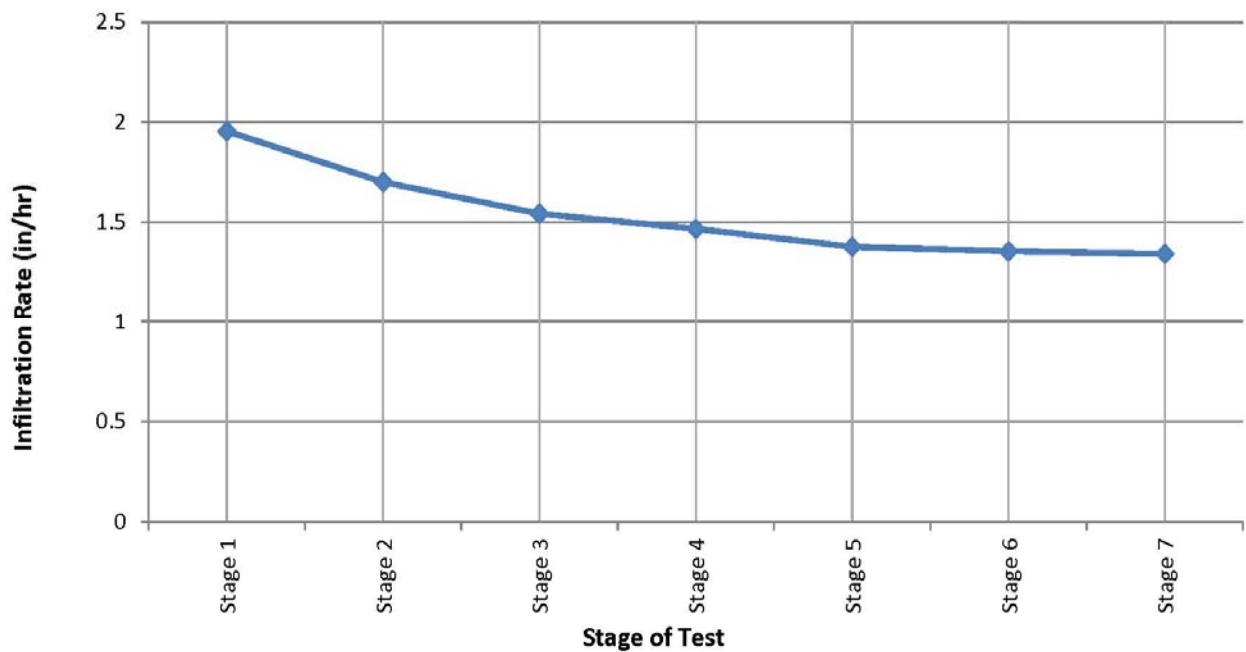
Figure A-11

Water Depth During Infiltration Test

Short-Term Infiltration Rate

Pilot Infiltration Test Results (PIT-3)

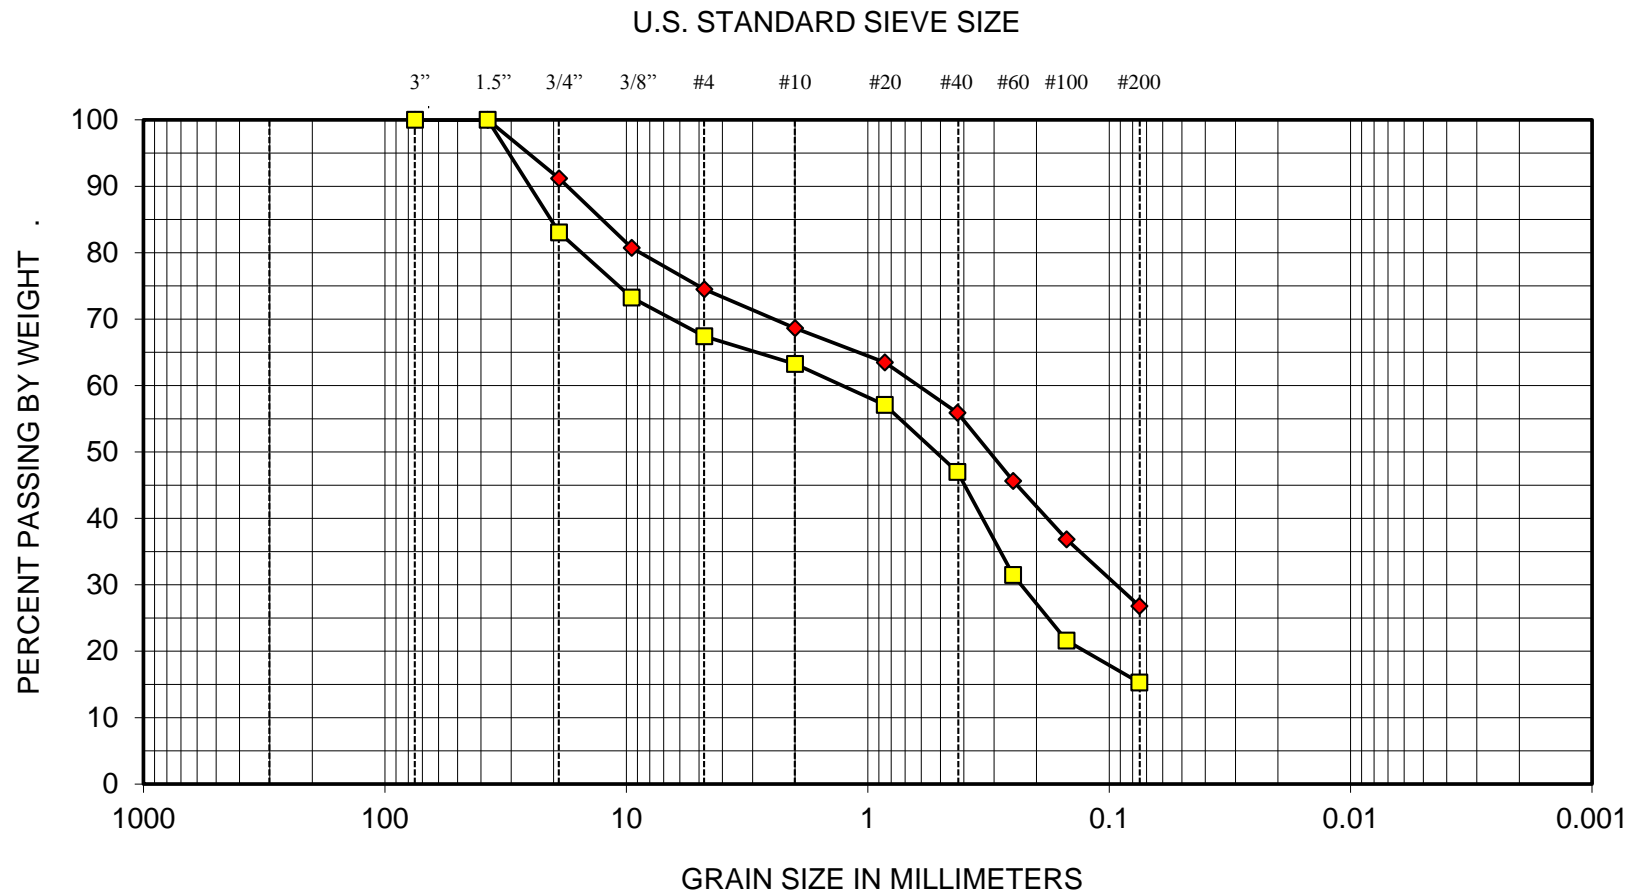
Sieve analyses were performed on selected samples in general accordance with ASTM D 422 to determine the sample grain size distribution. The wet sieve analysis method was used to determine the percentage of soil greater than the U.S. No. 200 mesh sieve. The results of the sieve analyses were plotted, were classified in general accordance with the Unified Soil Classification System (USCS) and are presented in Figure B-1.

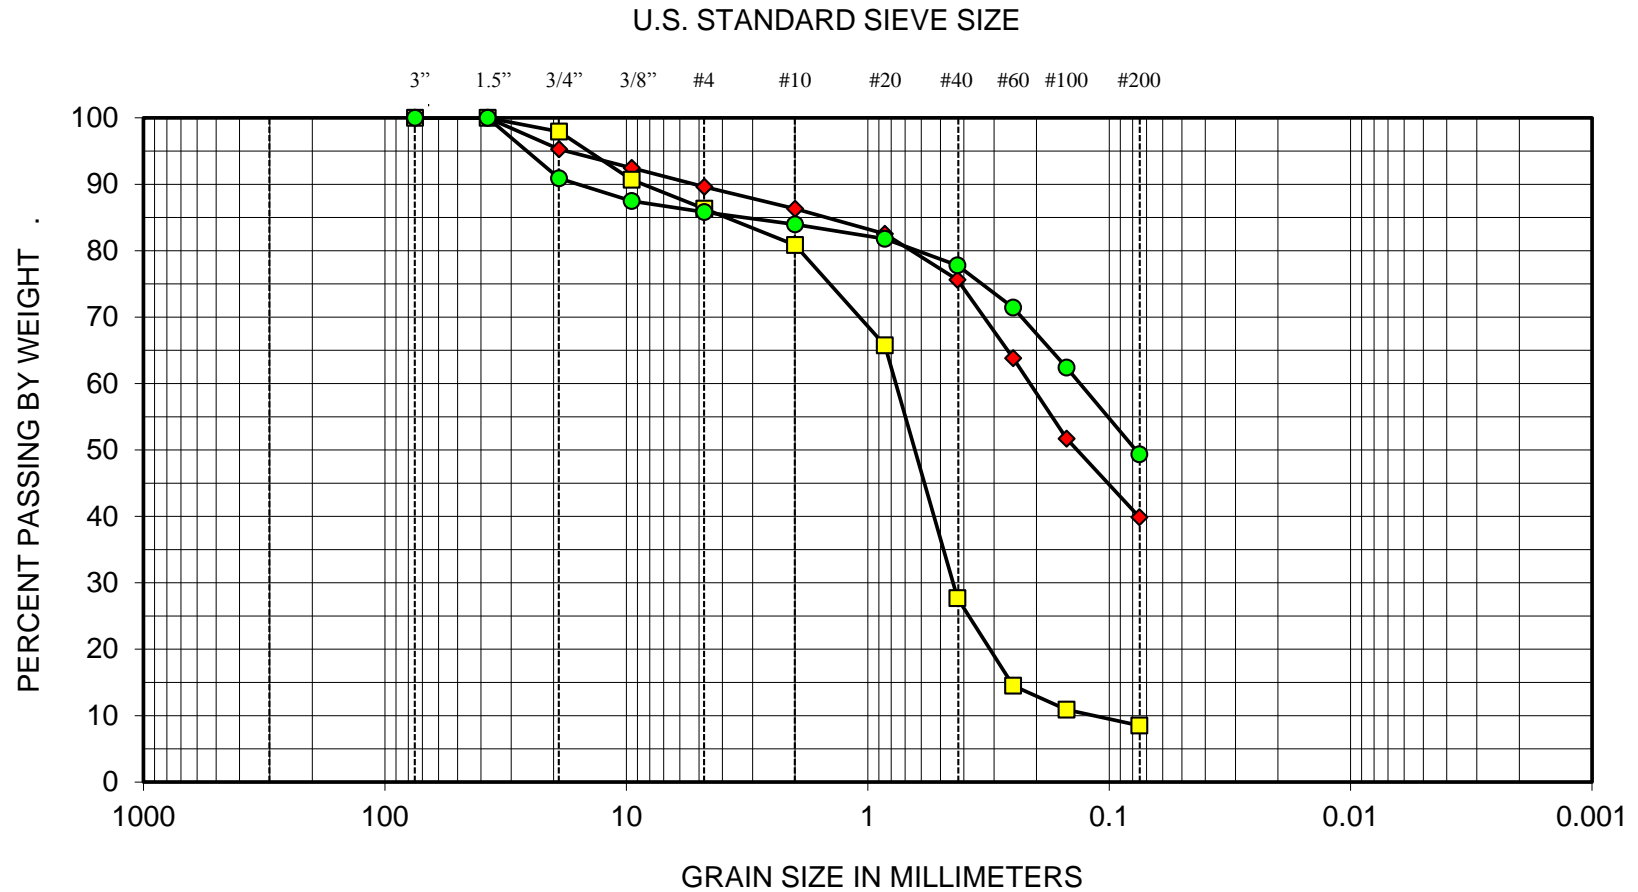
Additional samples were selected for sieve analysis from boring GEI-3 and test pit TP-3 to support the final design of the infiltration facility. The results of these analyses are presented in Figure B-2.

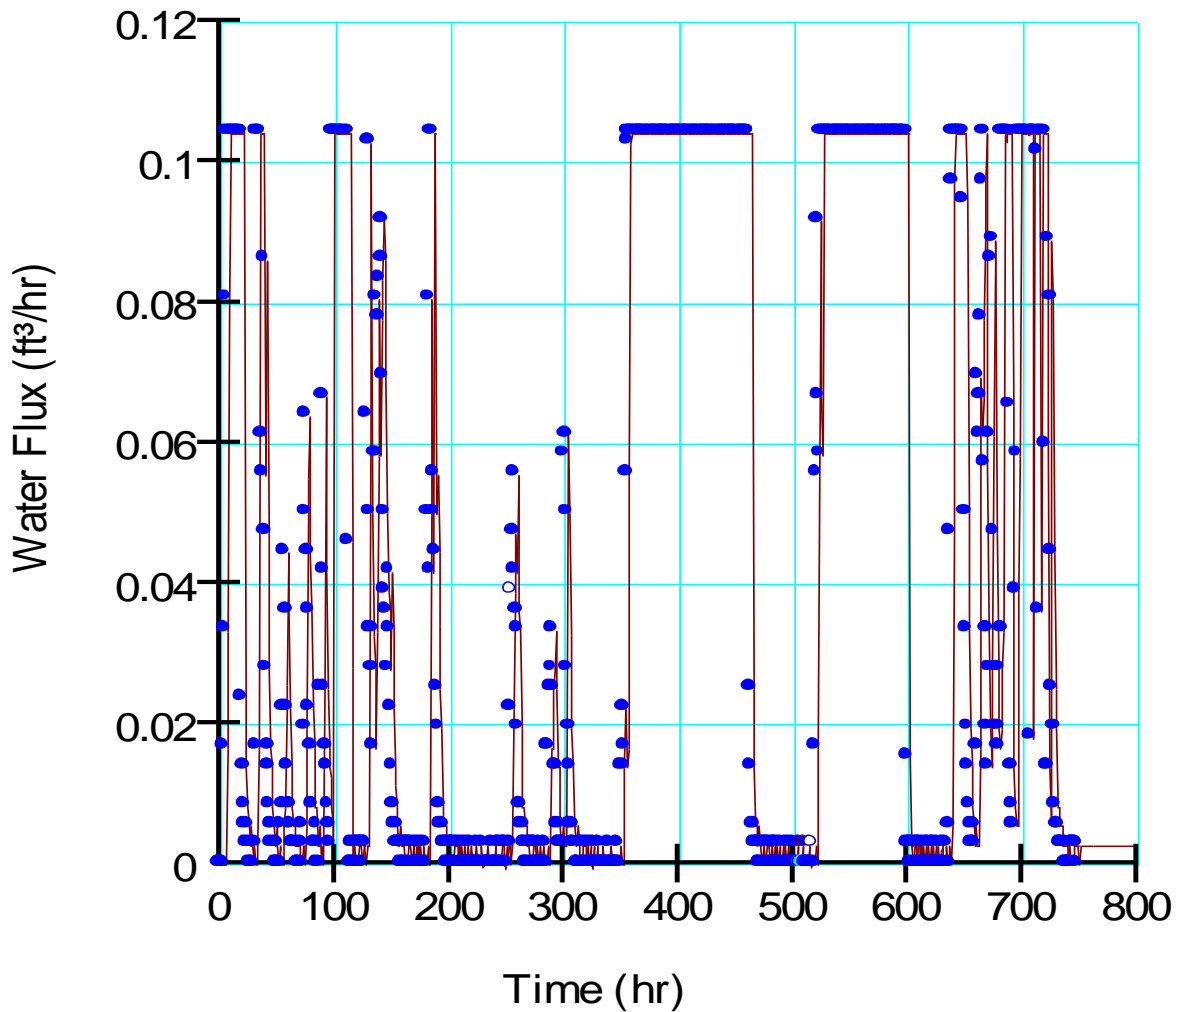
Figure C-1

30-day Pipe Inflow (per 5 ft²)

1. Inflow function for each pipe in SEEP/W model.
2. Revised Inflow Hydrograph provided by Springline Design.
3. Water Flux (ft³/hr) is for each 1-foot length of infiltration tank, assuming uniform application over 5 ft² of infiltration trench bottom area.

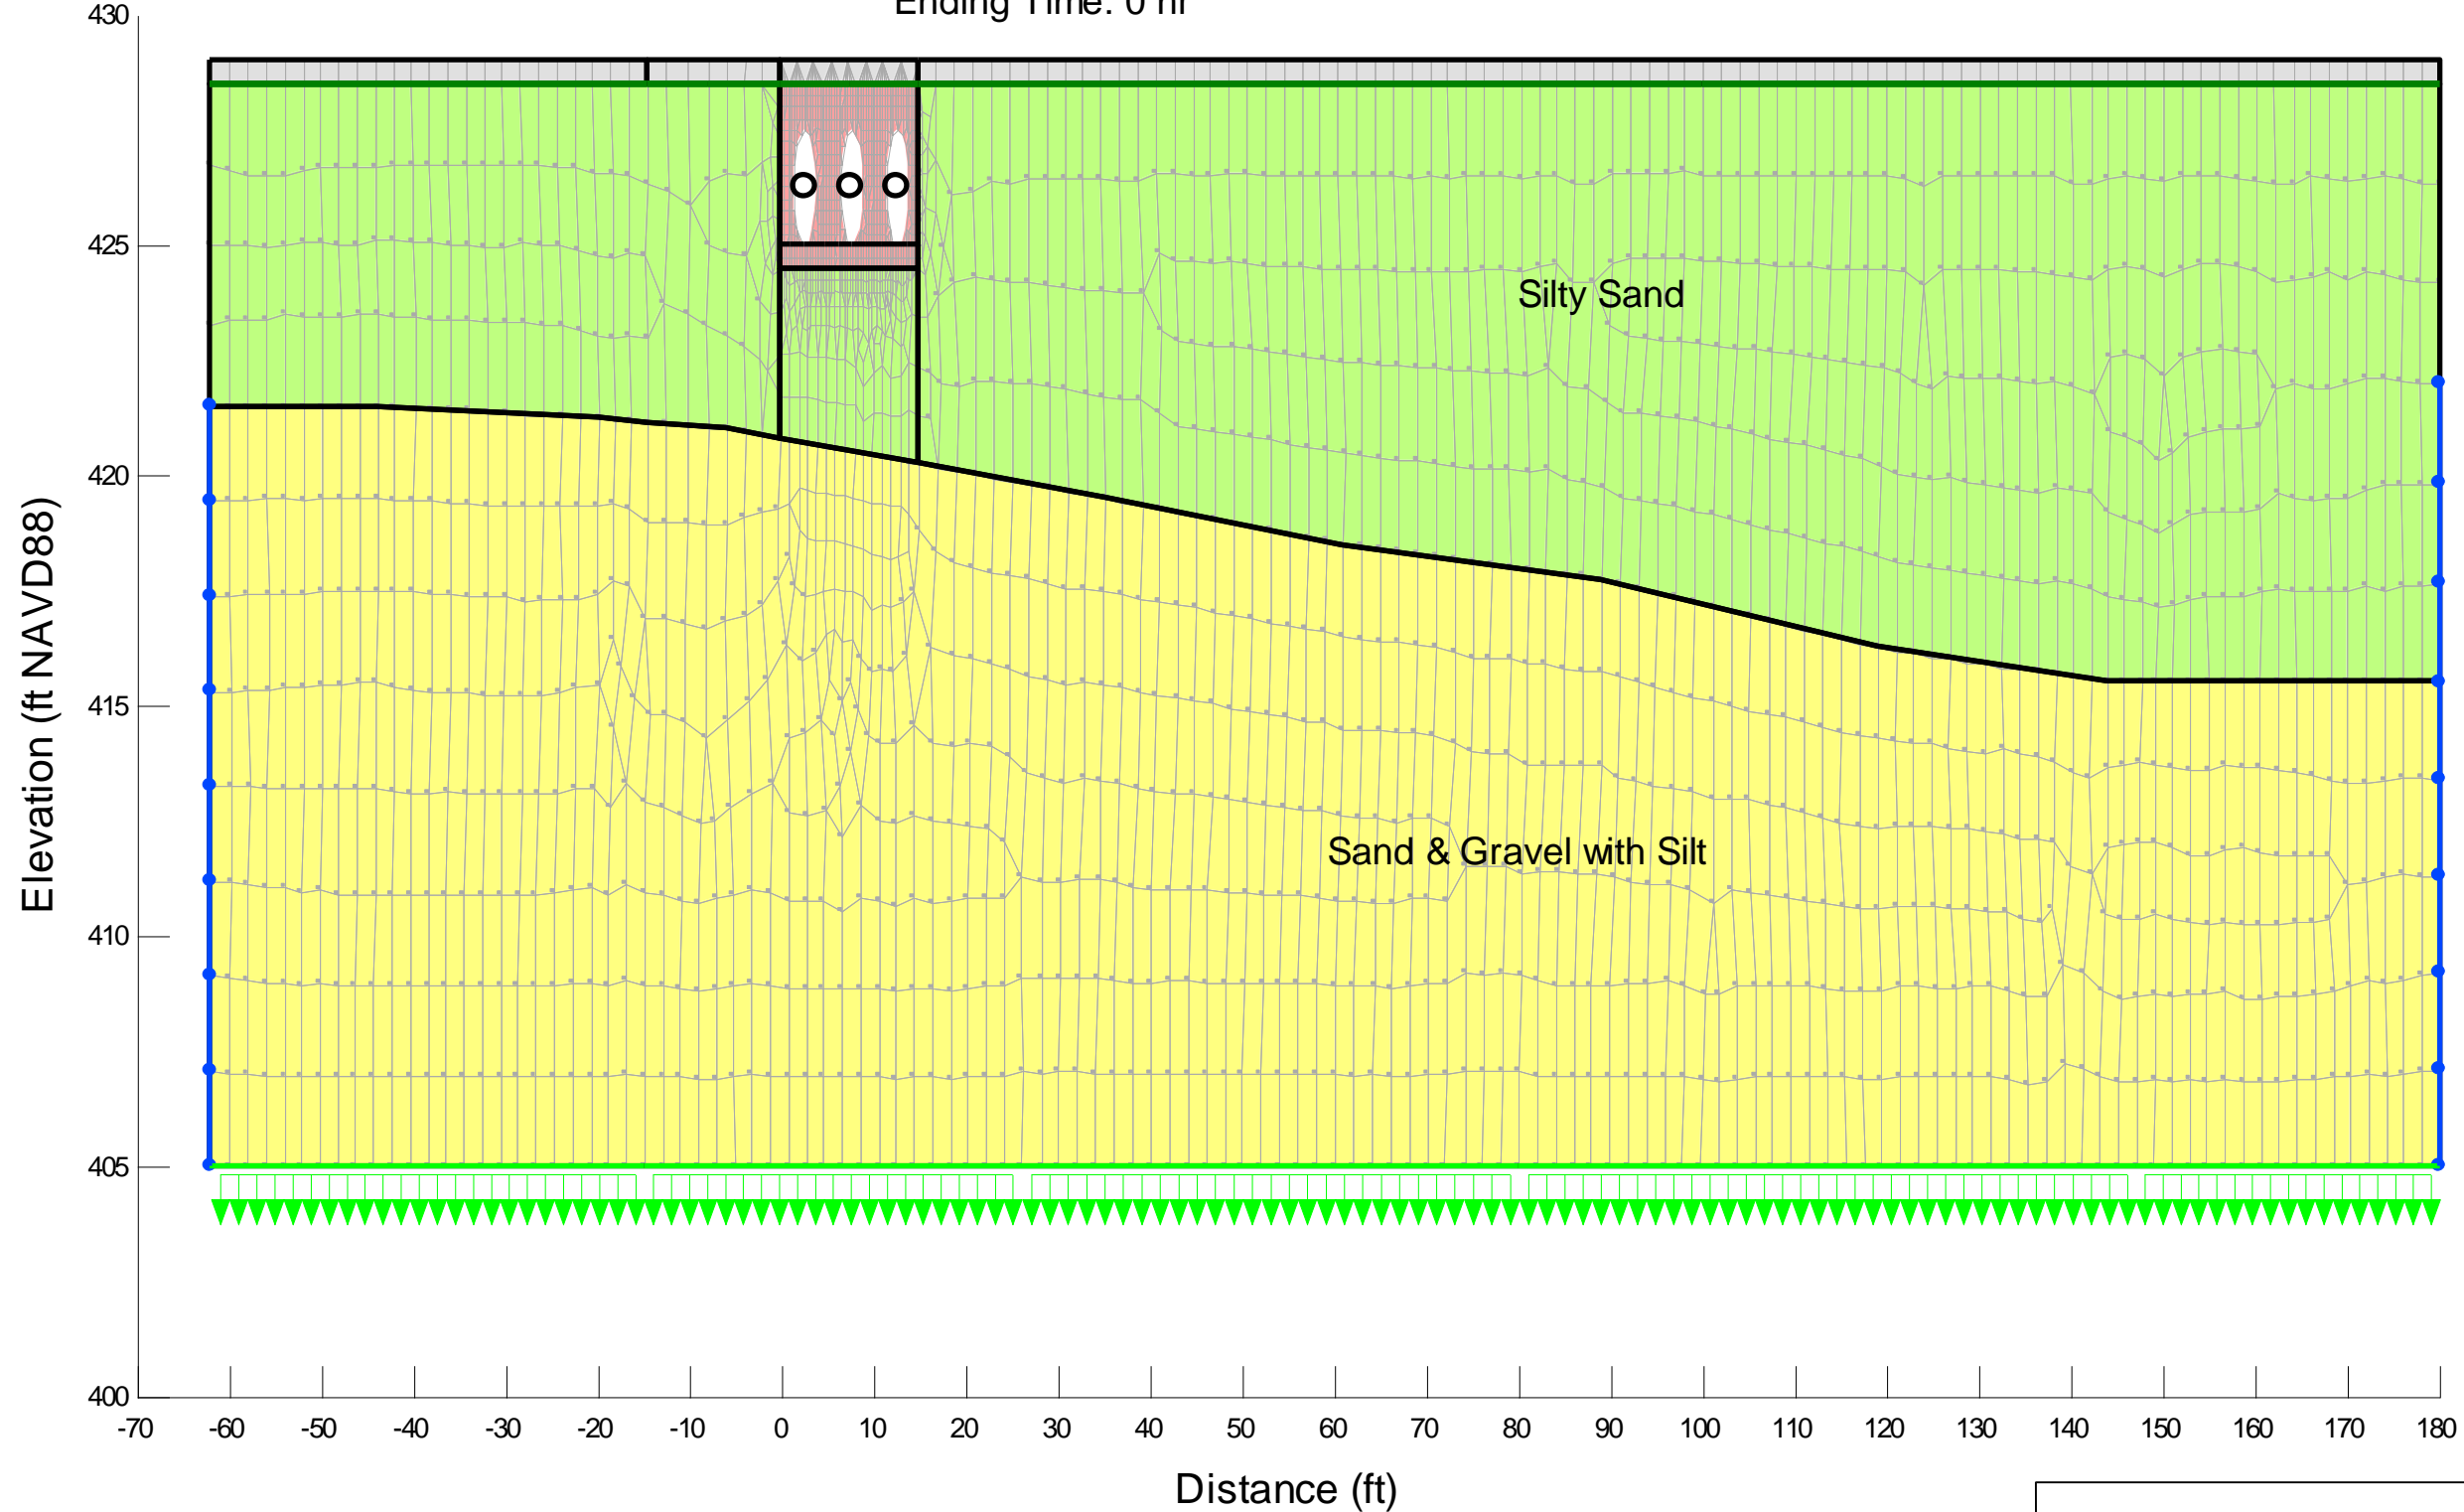
1. Vertical scale is exaggerated 6 times the horizontal scale.
2. Seasonal high groundwater level defined by constant head boundary (Blue line and circles) at Elevation 422 feet along the sides of the model domain.
3. Limited downward seepage into underlying glacial till applied at bottom of Model Domain (green line and arrows) at a nominal 10 inches per year.

SEEP/W Model Domain	
Skyway Library Seattle, Washington	
GEOENGINEERS	Figure C-2
