SKYWAY RESOURCE CENTER

PROJECT MANUAL – VOLUME 2 ENVIRONMENTAL REPORTS – PART 1

Hazardous Materials Survey Report

Phase I Environmental Site Assessment

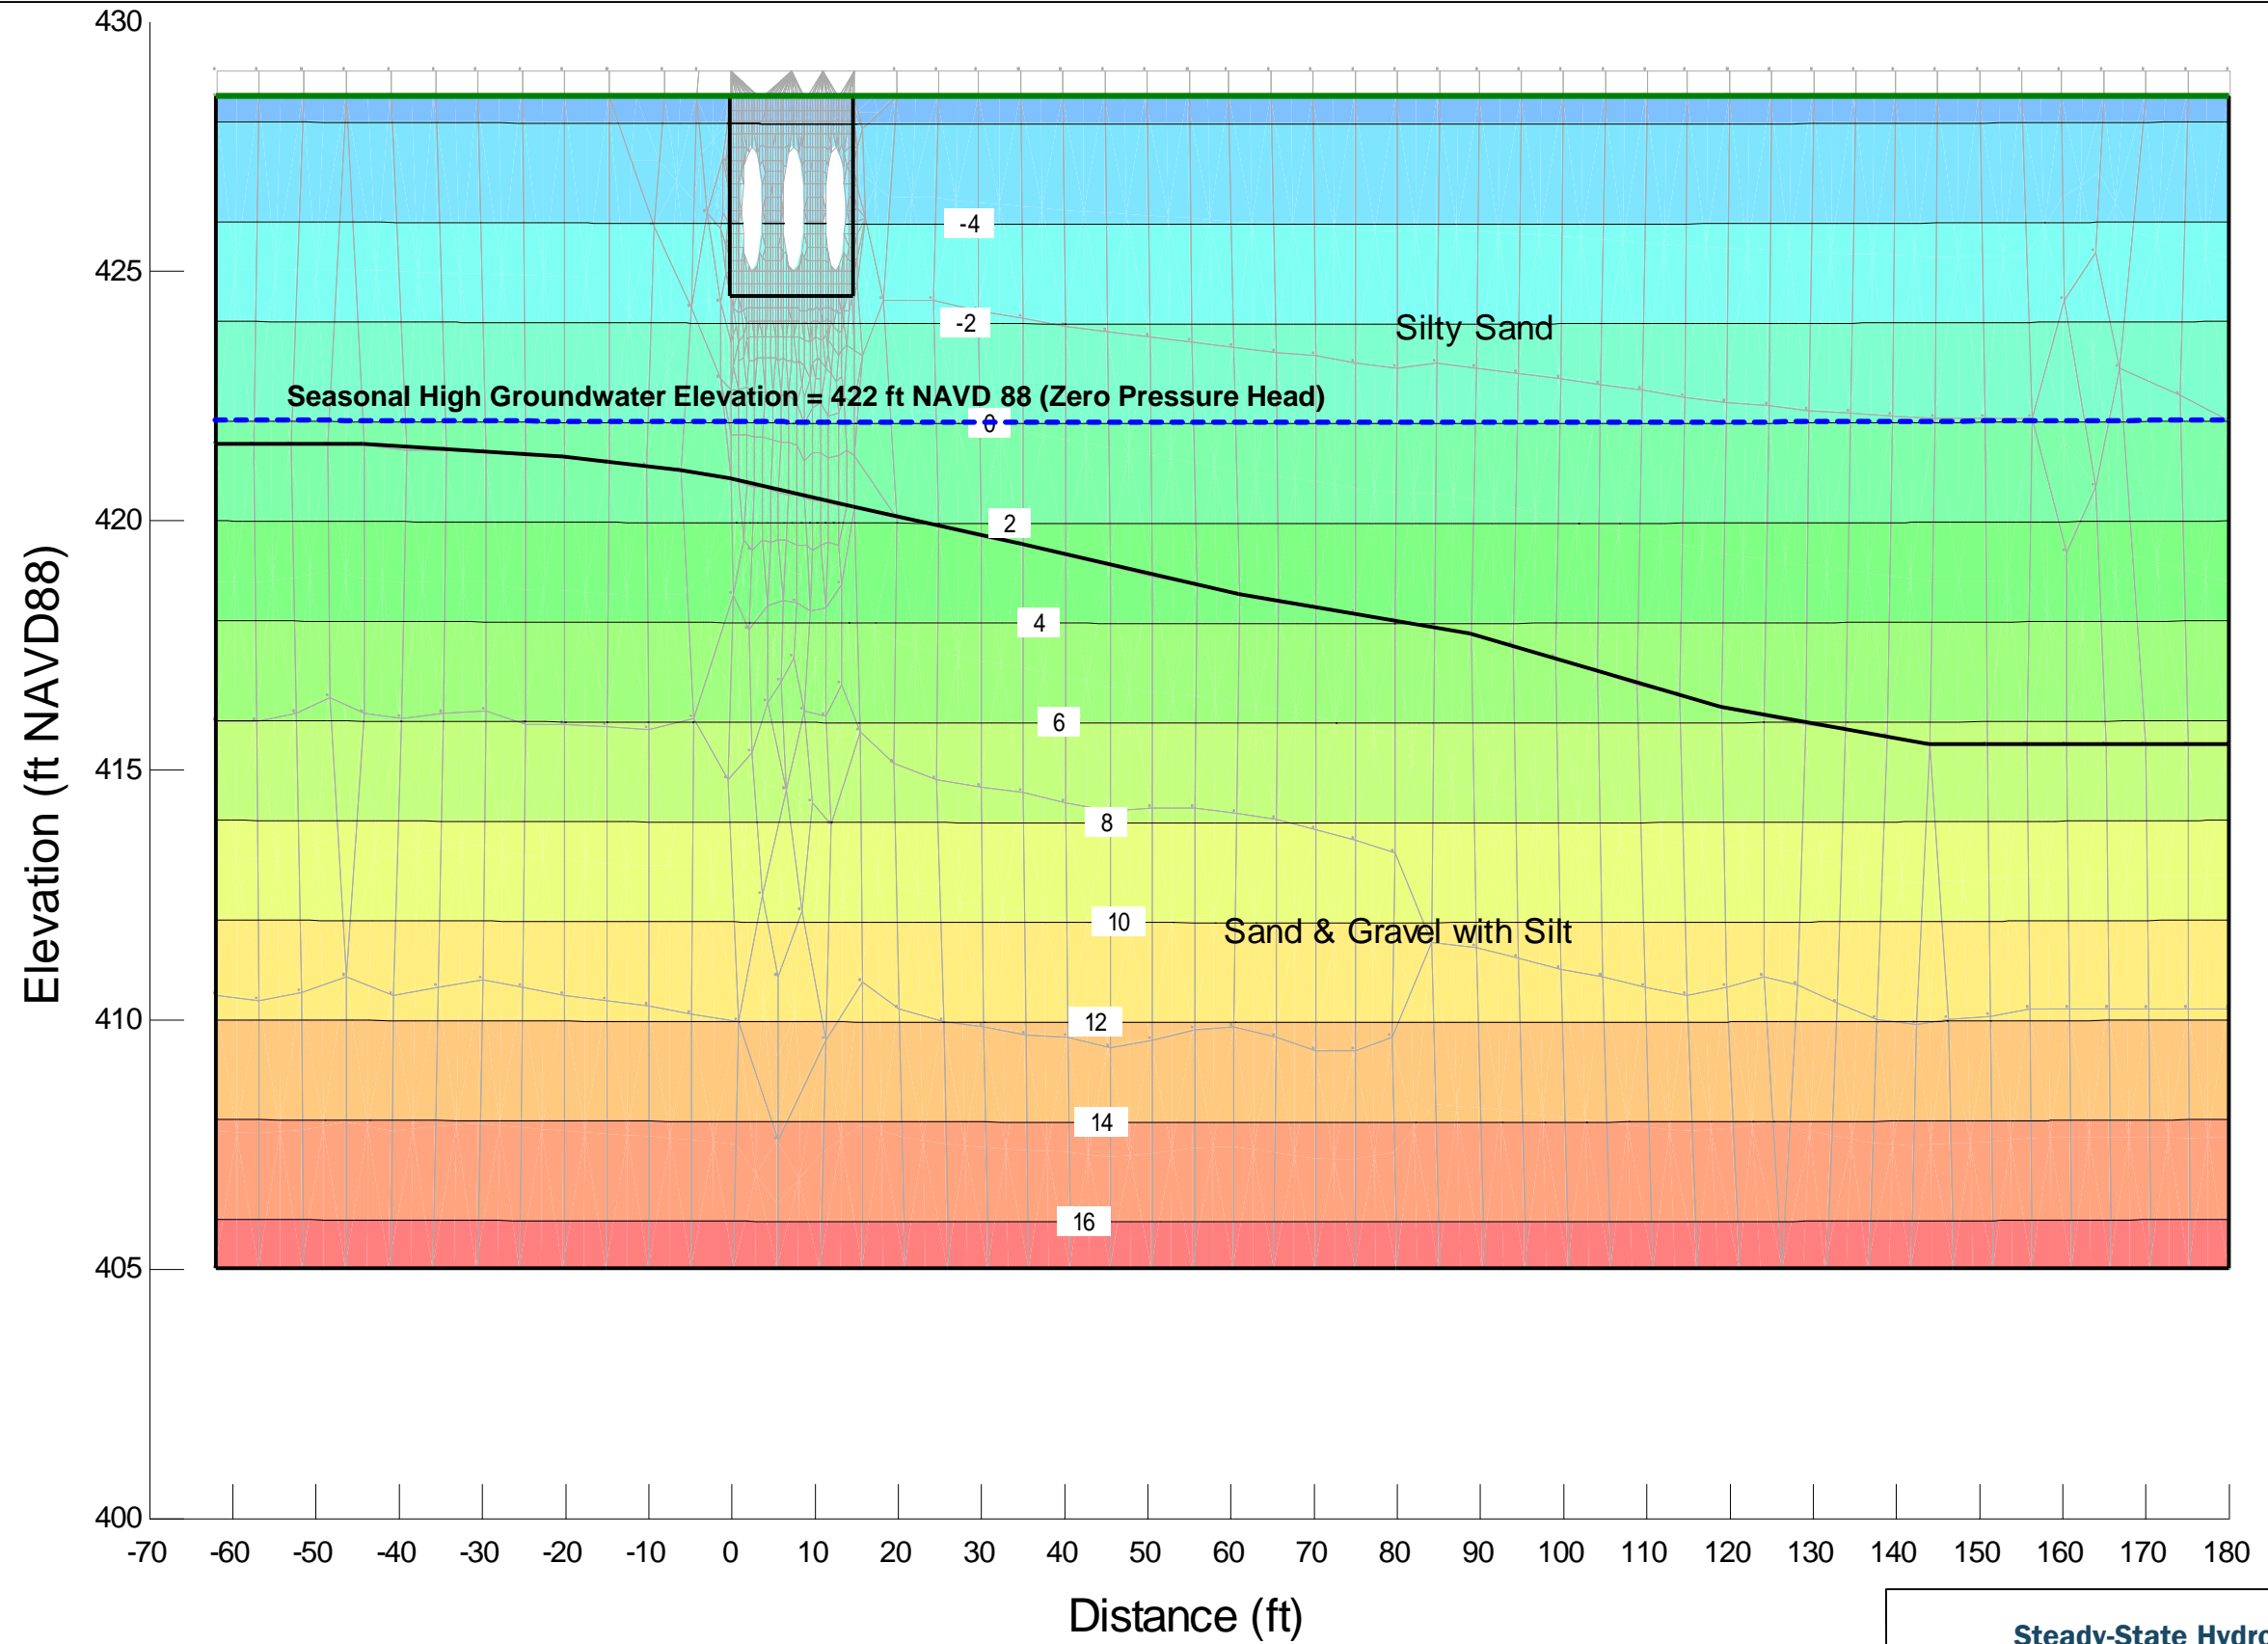
1. Vertical scale is exaggerated 6 times the horizontal scale.
2. Contours are of pressure head in feet of water, Zero pressure head represents the static water table.

Steady-State Hydrostatic Profile	
Skyway Library Seattle, Washington	
GEOENGINEERS	Figure C-3

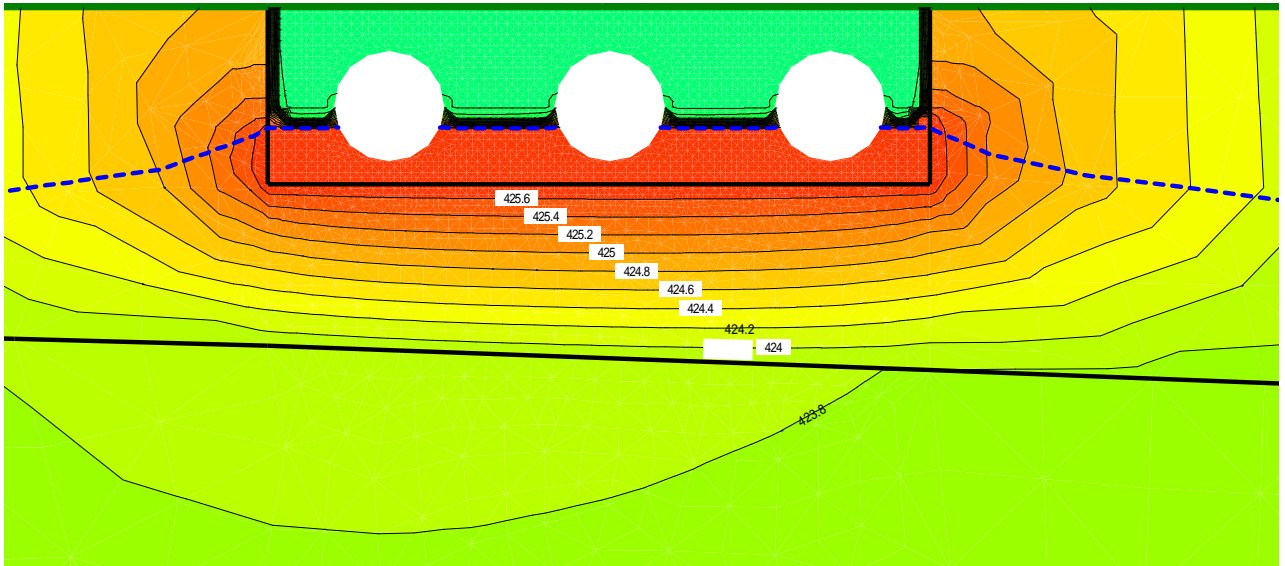
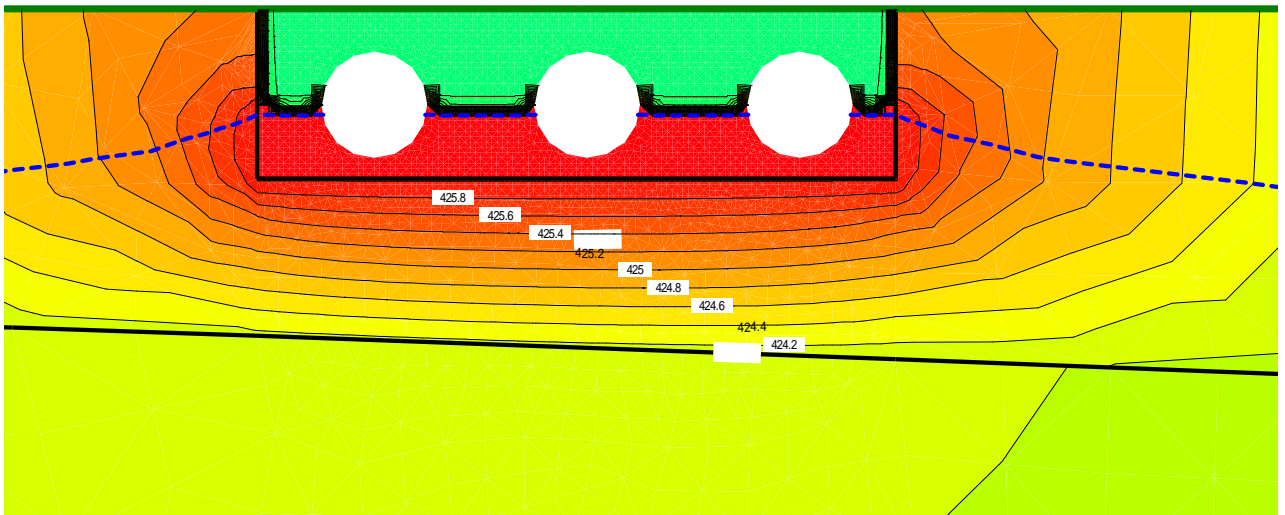
Figure C-6

(a) Mounding after 460 hours

(b) Mounding after 600 hours

1. Contours are total head in feet relative to NAVD 88
2. Total hydraulic head profiles are output from SEEP/W at selected intervals of peak mounding during the 750-hour model simulation representing the 30-day peak runoff volume.

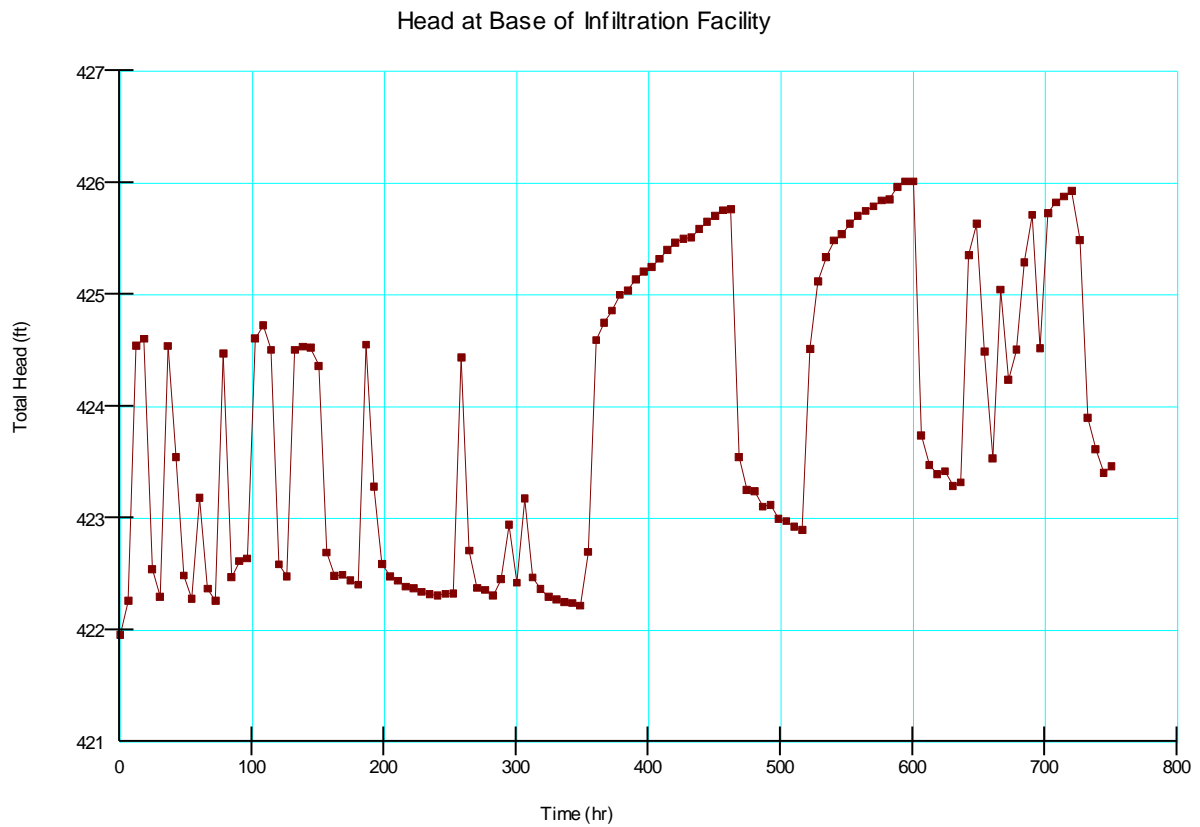
Figure C-7

1. Graph shows total hydraulic head at the base of the infiltration facility.
2. Total hydraulic head is output from SEEP/W model at 6-hour intervals throughout the 750-hour model simulation representing the 30-day peak runoff volume.

The mounding analysis confirms that the stormwater infiltration facility as developed by Springline Design will be feasible at the site, and will function as designed without overflow occurring from the facility.
