THE TRAILHEAD

FLOOR AREA DIAGRAMS
- NORTH BLDG

Pre-construction Arborist Report V2*

Arborist report for King County Housing Authority
Site address: 1550 Newport Way NW., Issaquah, WA. Parcel 292406-9002.
Time of site visit: Tuesday, July 23, 2024. 11 AM.

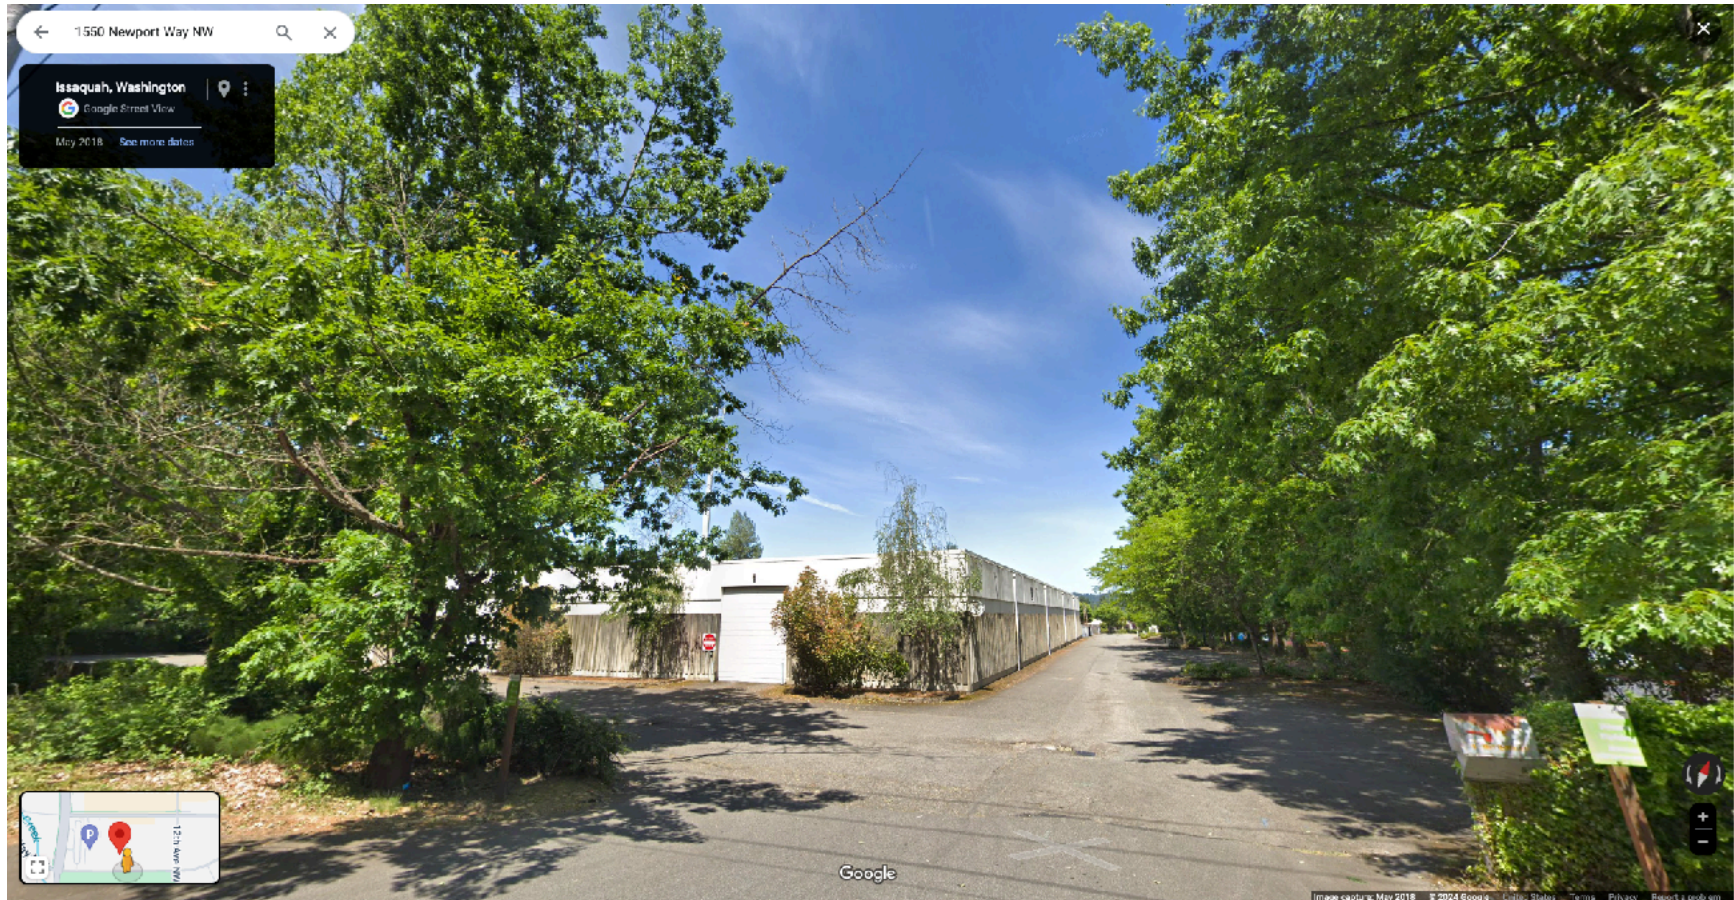
View from SE looking NW. Trees on right side of left image are on the adjoining parcel to the east according to KC parcel map.

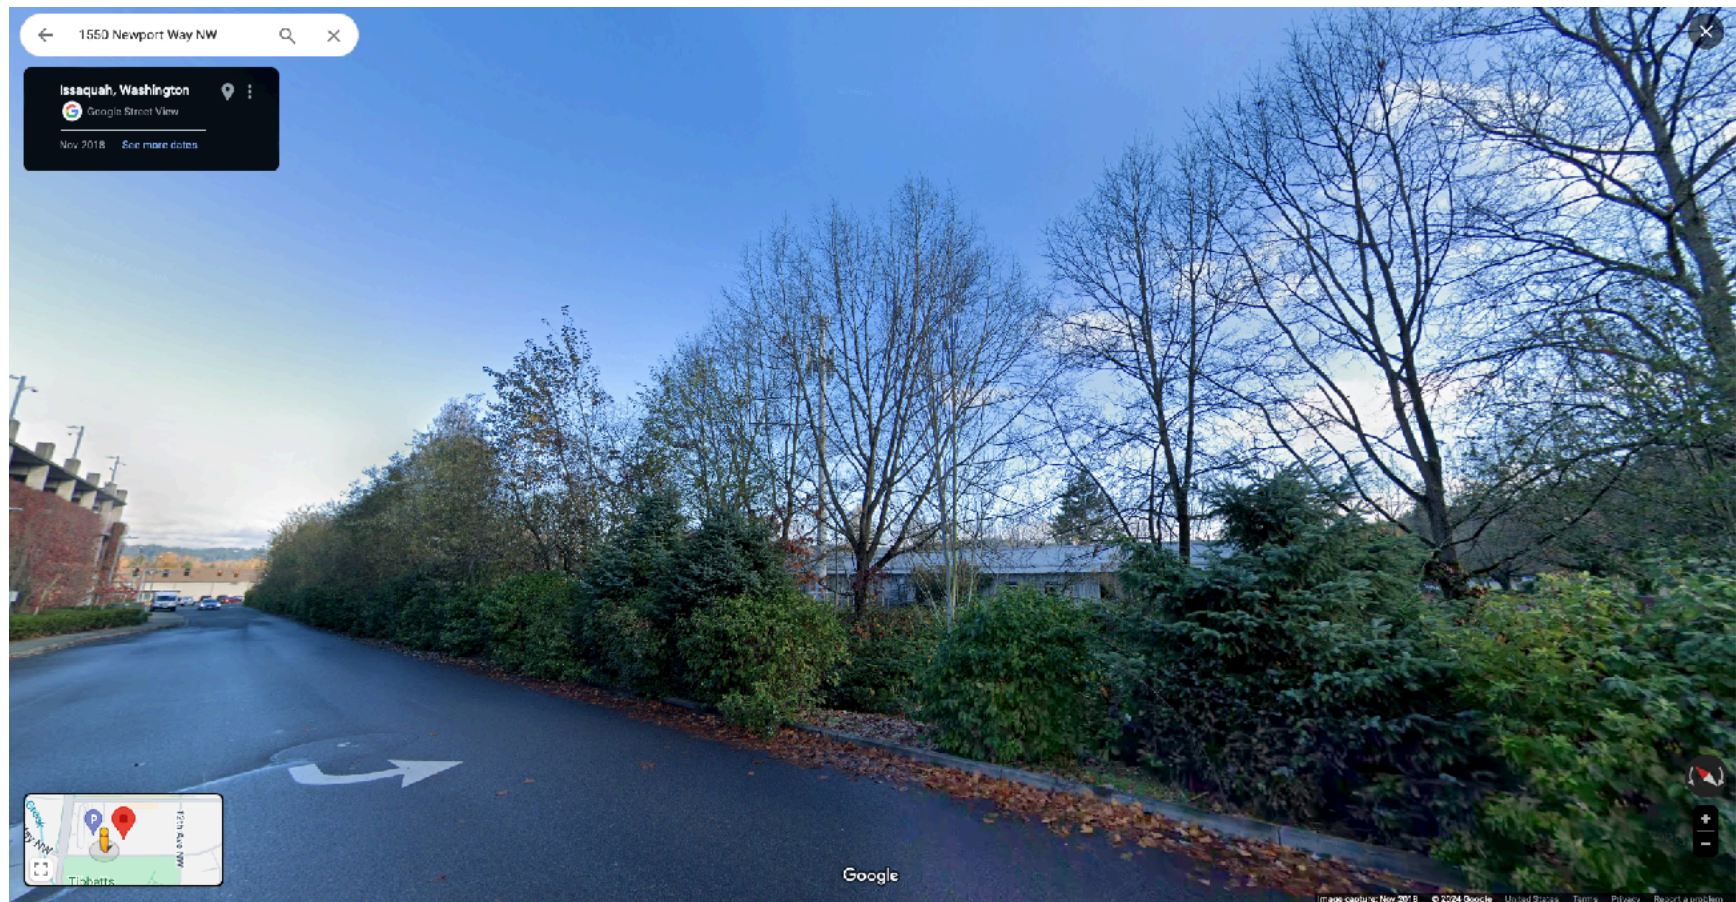
View from SW looking NE (fall/winter photo)

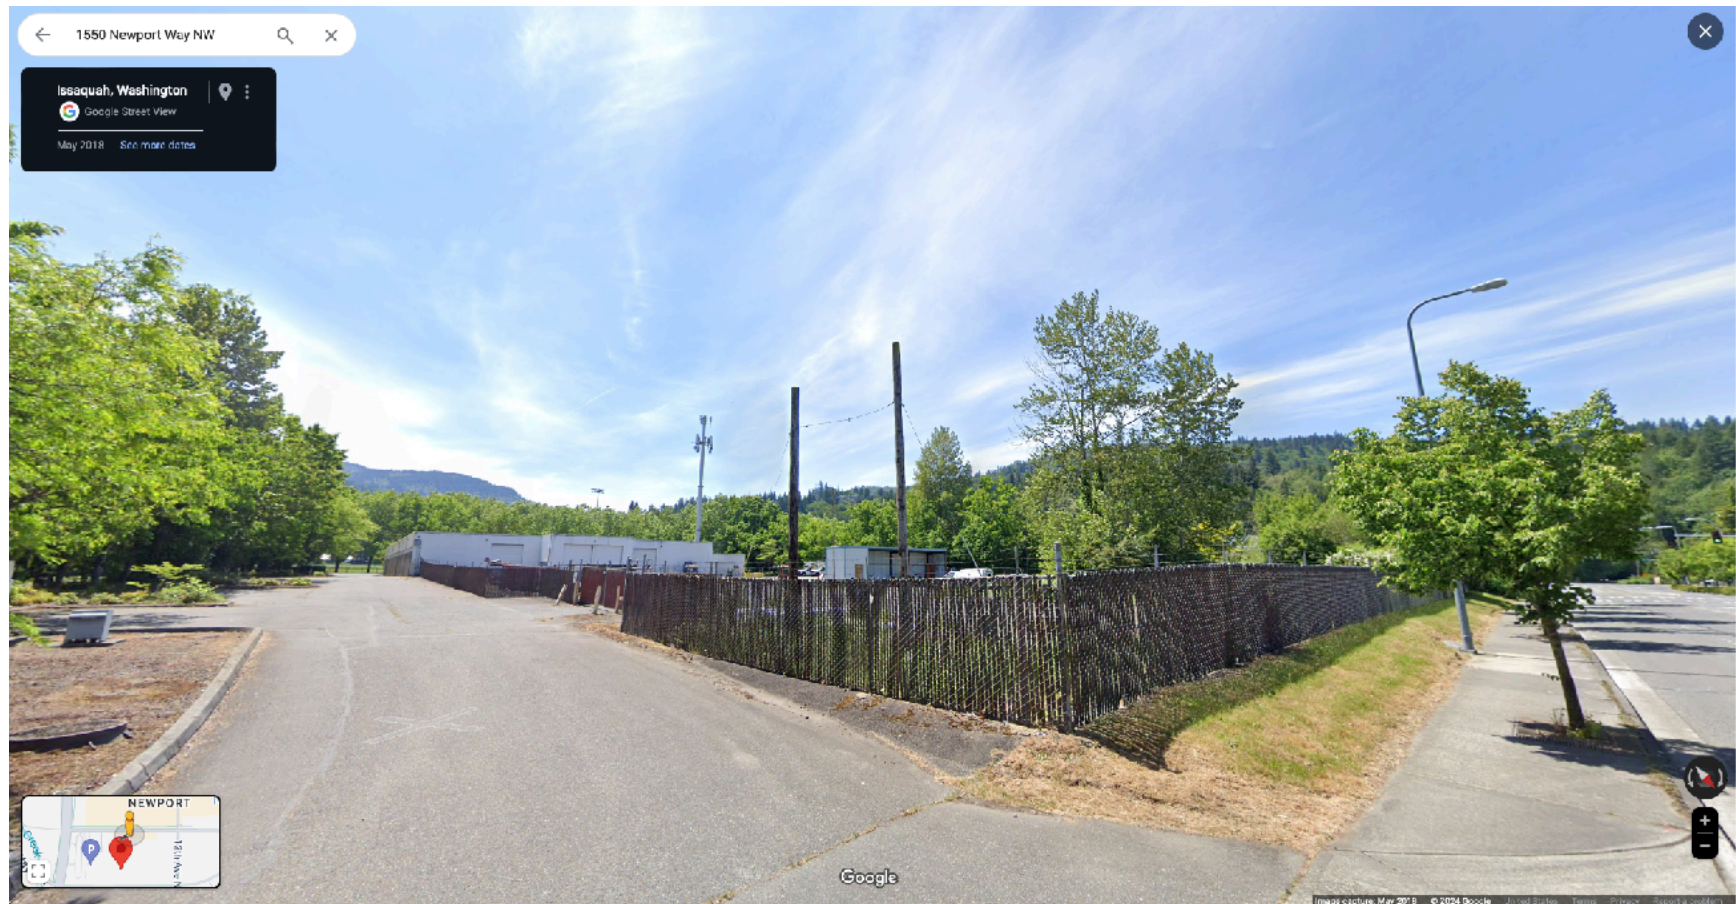
View from NE looking SW. Trees on the far left side of left image are on the adjoining property to the east.

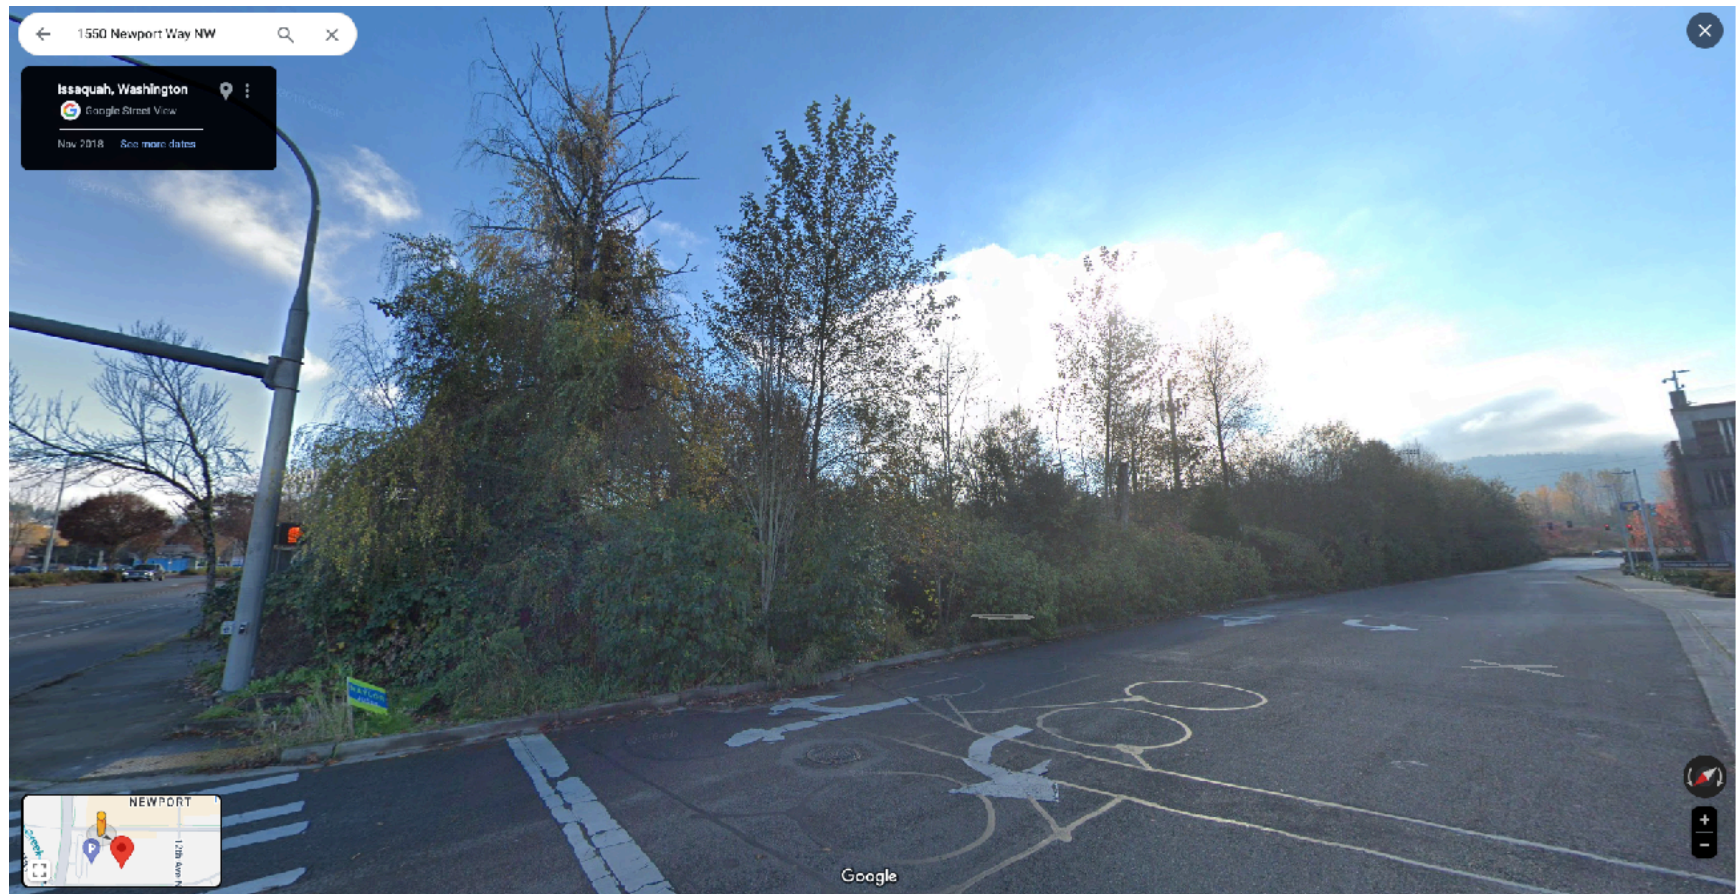
View from NW looking SE (fall/winter photo), with primarily willow along the ditch receding off to the right.

The western side of the ditch area contains small native willows (*Salix* sp.) in generally fair condition. Some trees in this area have failed since the survey map was drawn. Access to this portion of the site was difficult due to the invasive species that have grown in. Himalayan blackberry, English ivy, and horsetail are the prevalent undergrowth in this region.

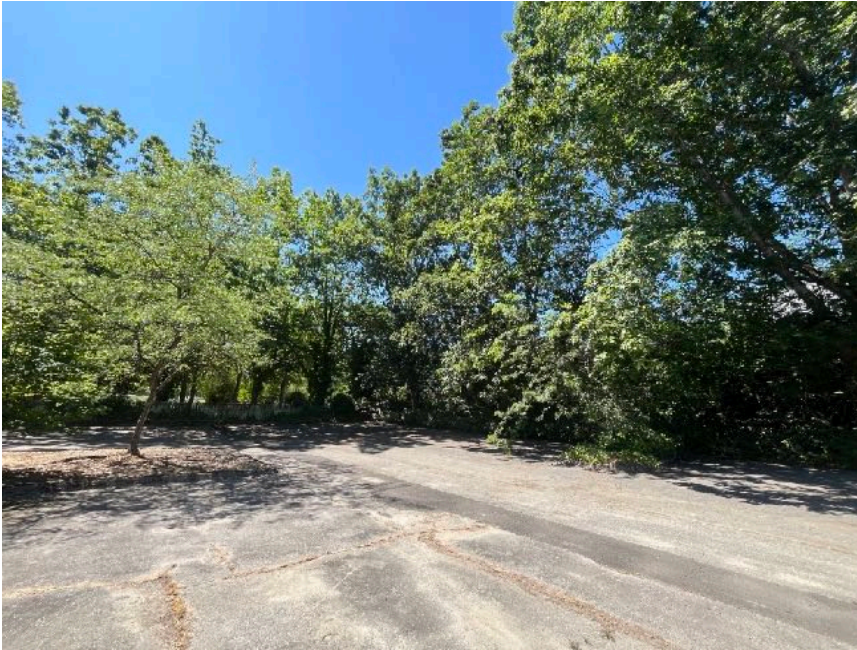
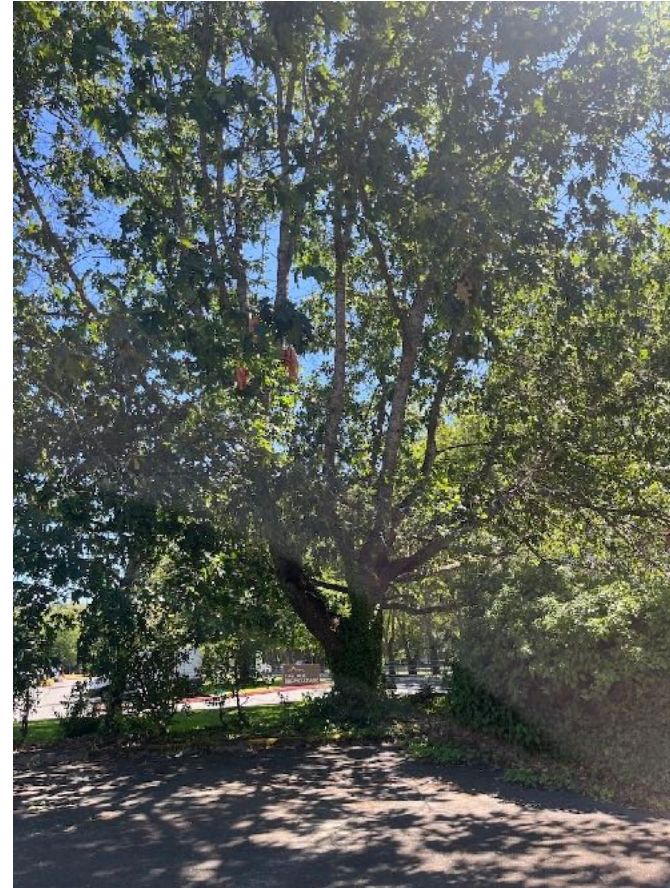
Left photo: Looking south on west side of building, honey locust 3101 is on the left, and red oaks 3001-3003 are on the right.
Right photo: red oak 3080 at SE corner of property

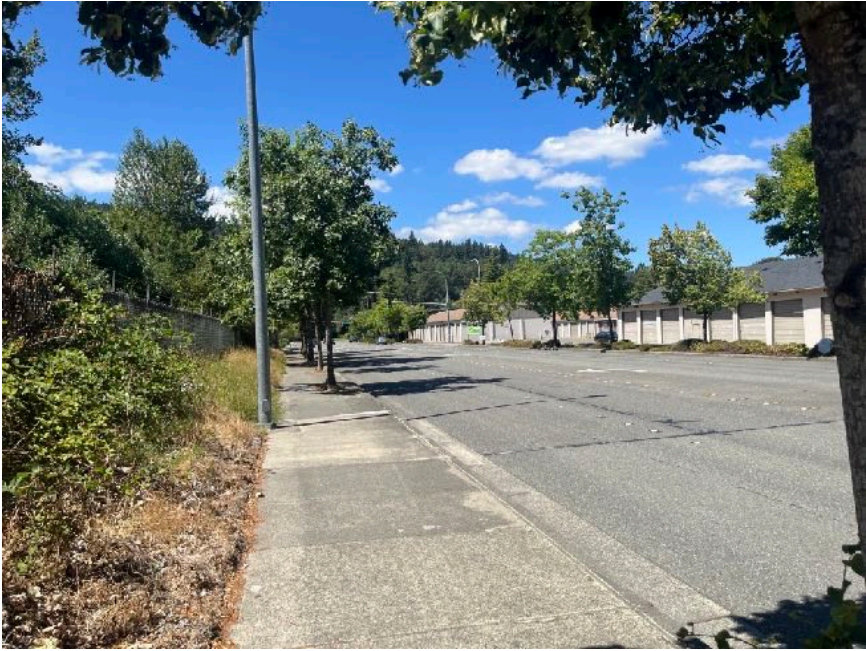
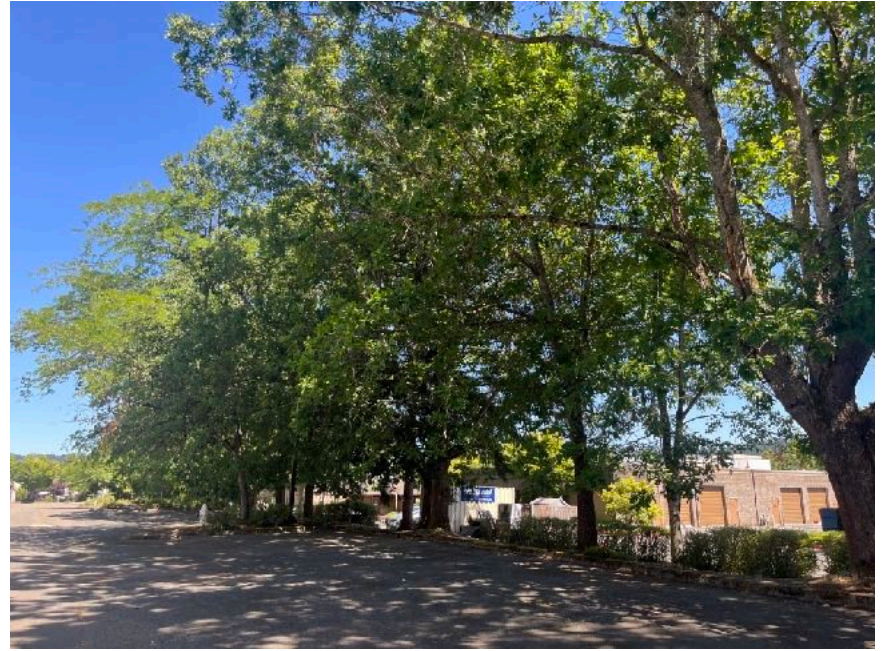
Left photo: looking west along NW Maple St., shows street conditions at the north property boundary, including red oak 3034 just past the street lamp.

Right photo: looking north along the east boundary of the property, on far right is red oak 3078 and various trees northward.

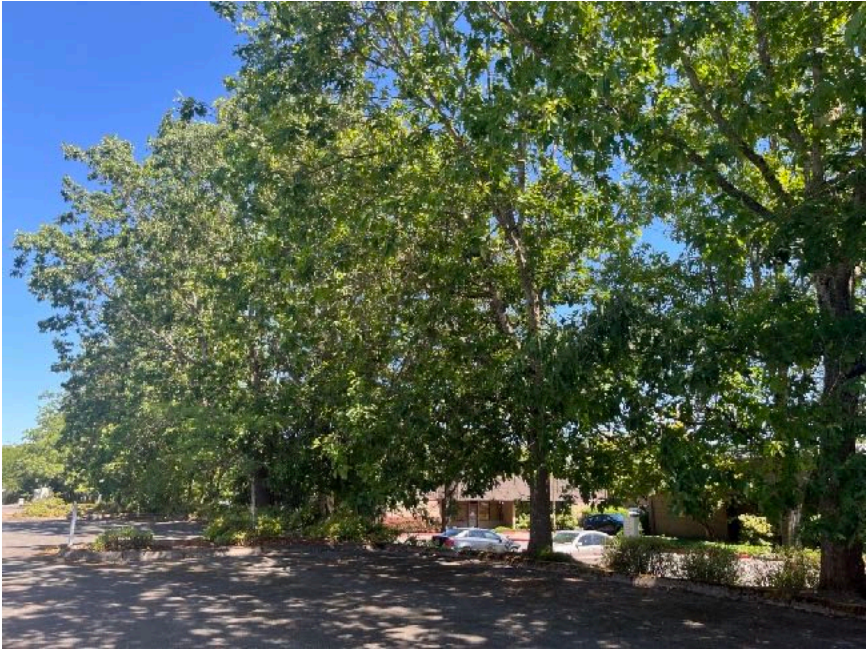
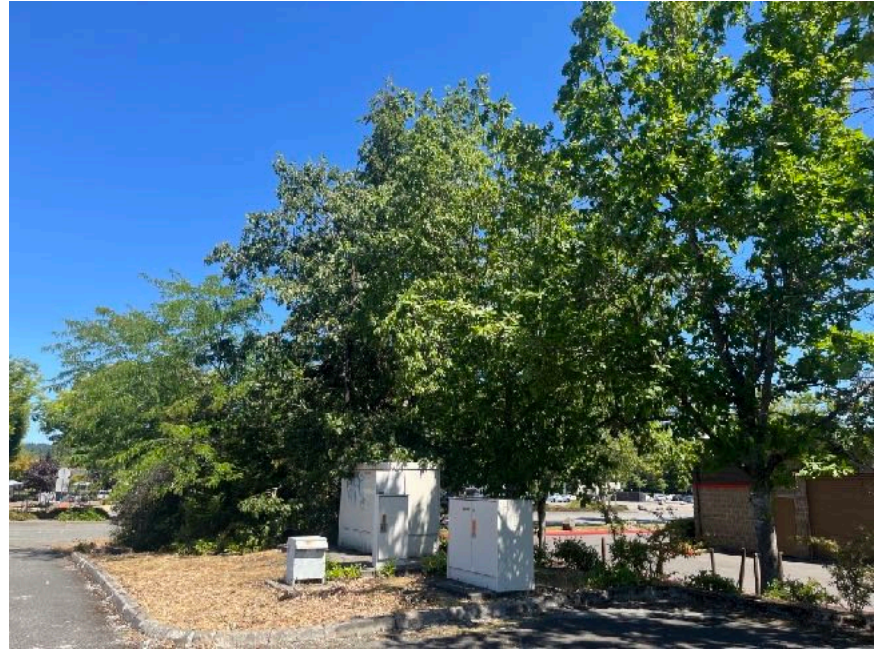
Left photo: Looking north, and moving northward along the eastern edge of the property boundary, red oaks and red maples 3043 to 3046

Right photo: Utilities at the northeast corner of the lot, surrounded by red maples and red oaks, with a honey locust on the far left. Beyond these are two Douglas fir trees.

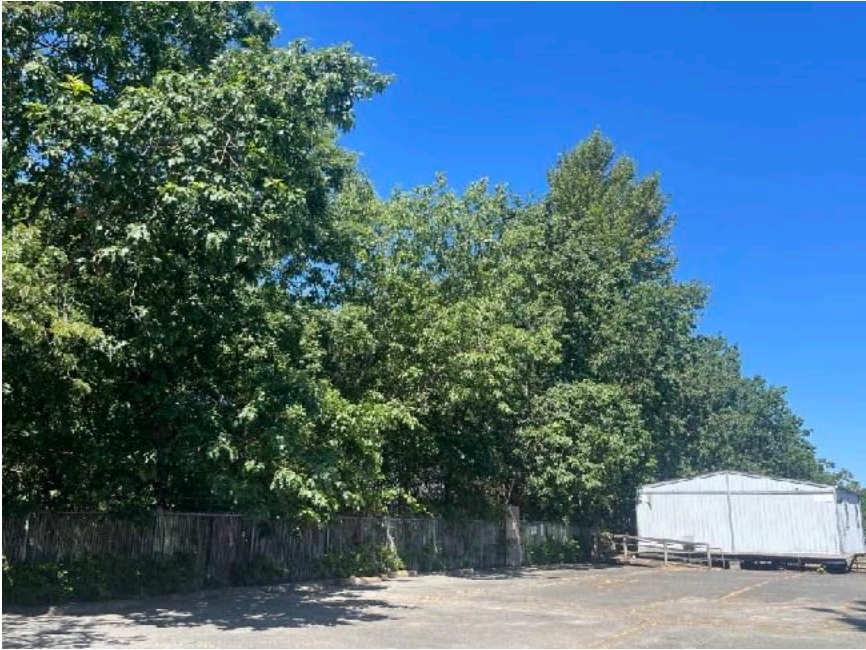
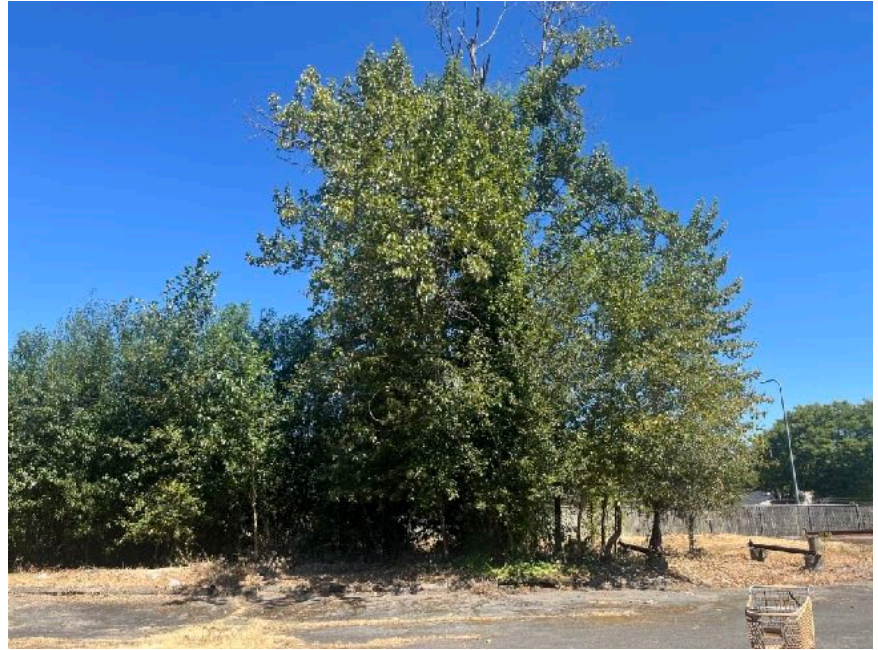
Left photo: From the center of the western edge of the property looking to the northwest, on the right is the doublewide trailer with a ramp. The trees along the western edge showing here are big leaf maple, red oak and red alder, 3010-3015 and beyond. The tall tree on skyline is a black cottonwood 3024.

Right photo: Looking north from within the site, showing the retention pond area at the northern part of the property. Several smaller cottonwoods and one larger one 3095 covered in ivy with a dead crown.

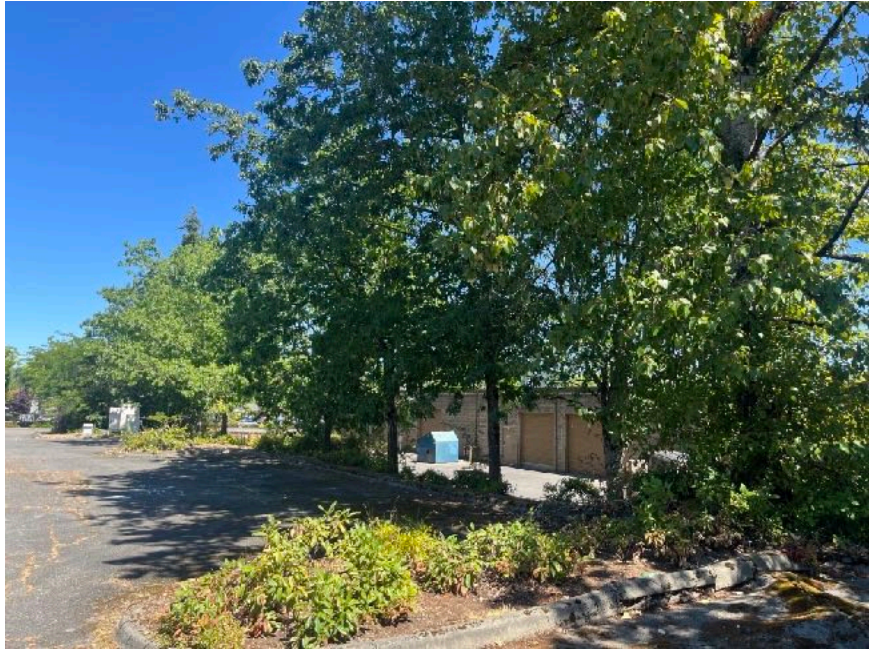
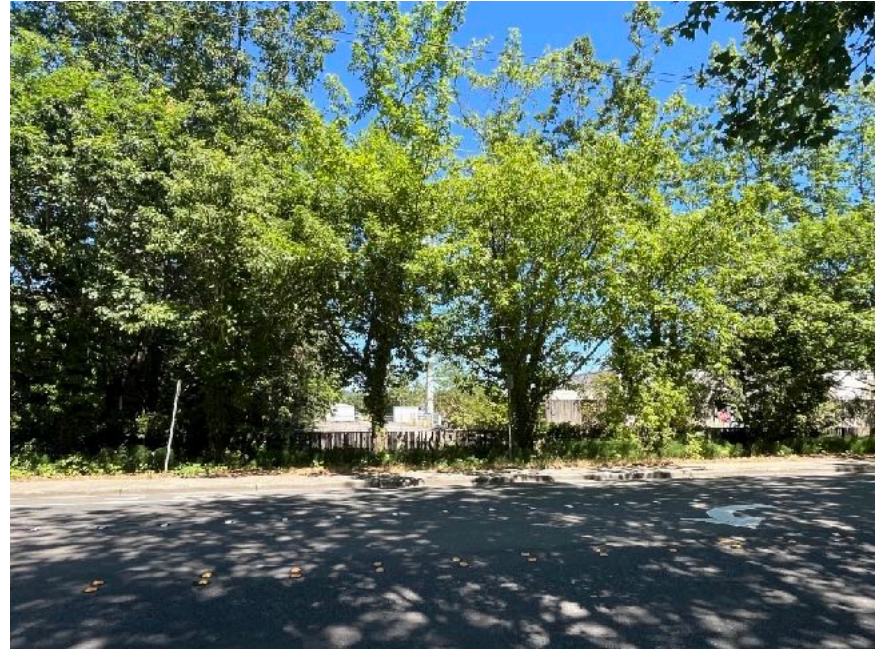
Left photo: near northeast corner, showing smaller red oaks 3034-3036 on eastern edge of property

Right photo: southwest edge of property, looking north across Newport Way NW at red oak street trees, 3090-3093

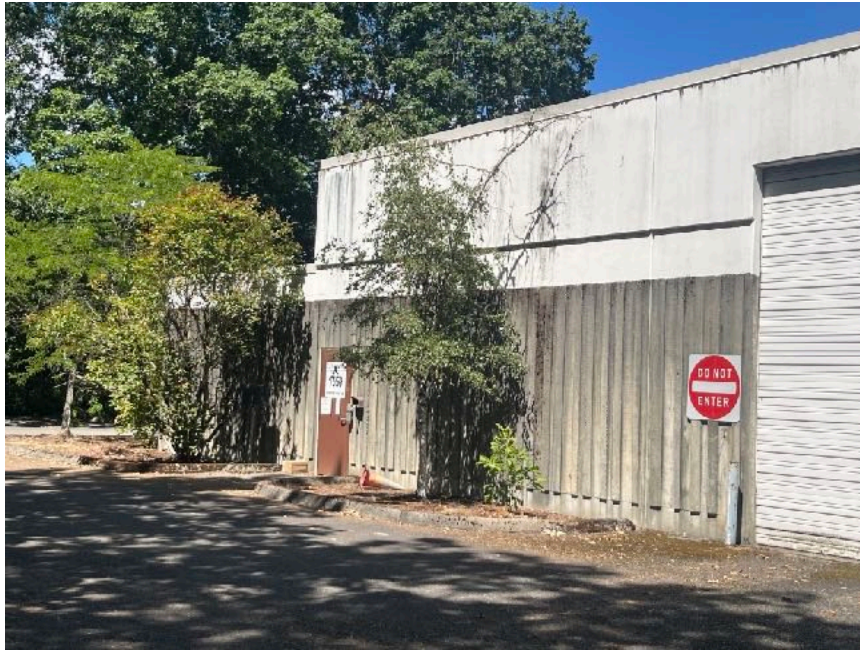
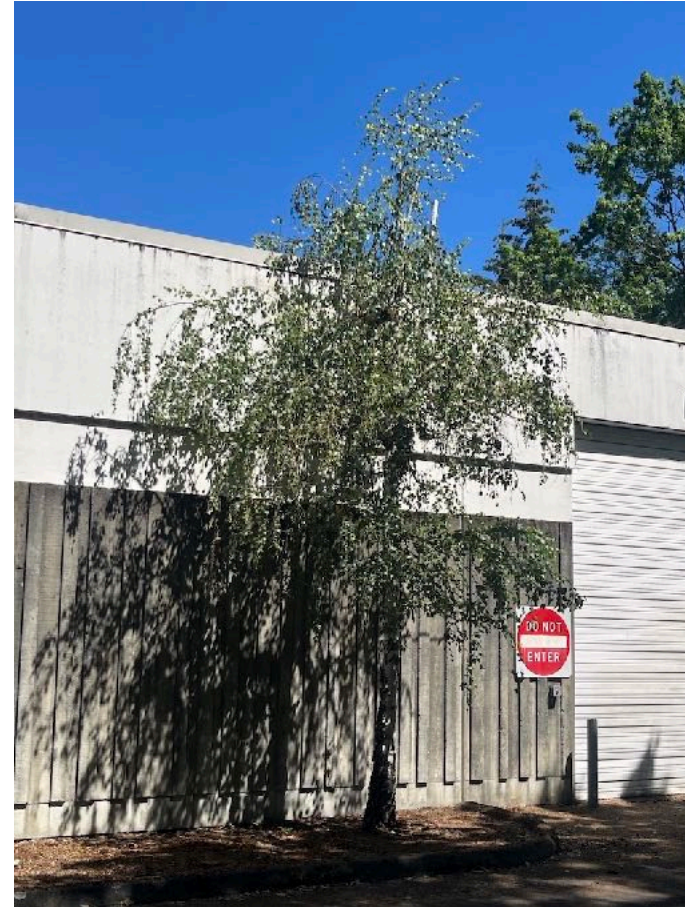
Up against the southern exterior wall of the existing building at this site are several cut-leaf European white birch trees (*Betula pendula* “Dalecarlica”) that are in poor condition. These trees roughly 6 inches of diameter at standard height, have limited access to soil volume, and are being affected by the bronze birch borer. These birch trees are not viable over the long term.

3102, 3103 Cutleaf European white birch along the south edge of the existing building.

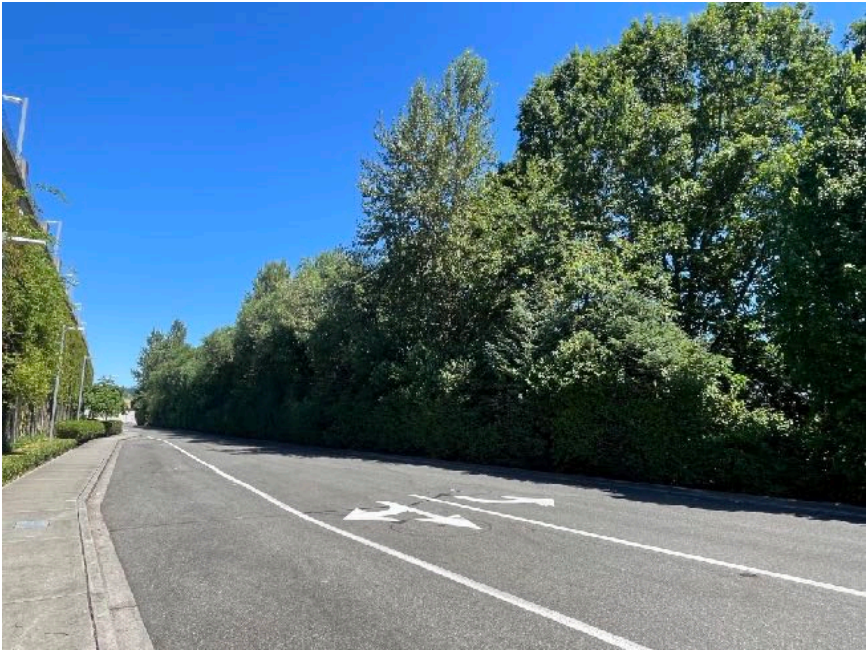
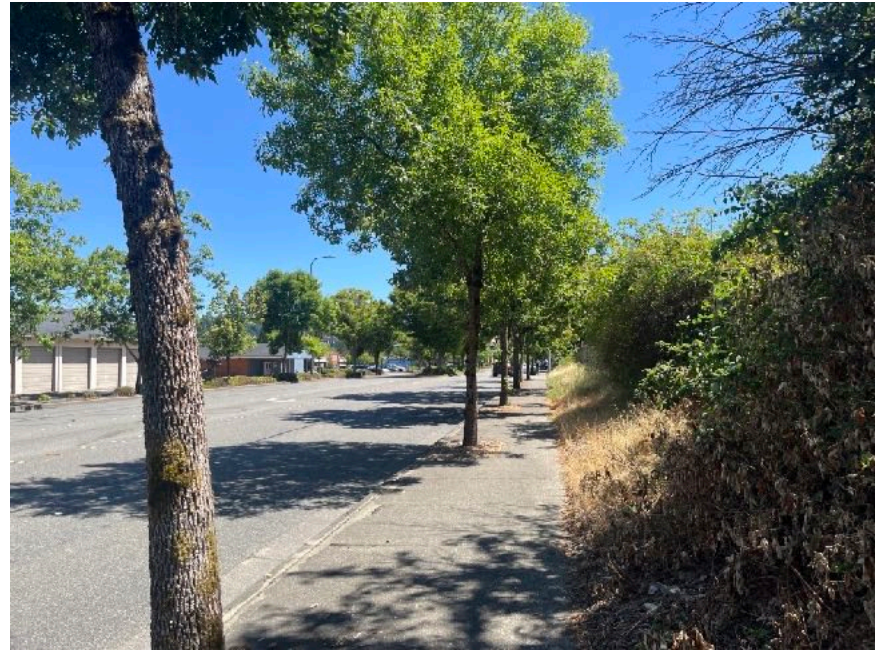
Left photo: Looking north along the west property edge from the street side.
Right photo: Looking east along the north property edge from the sidewalk.

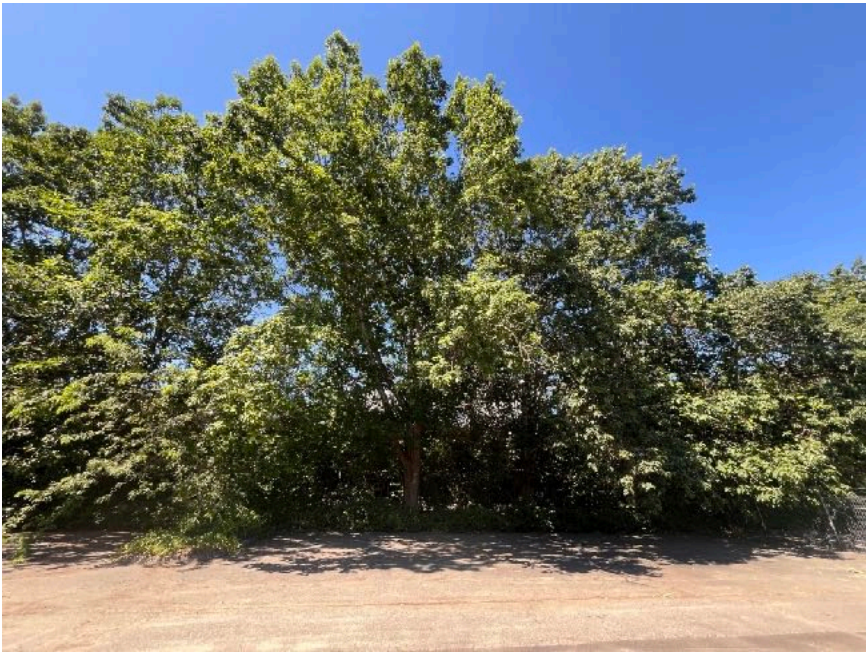
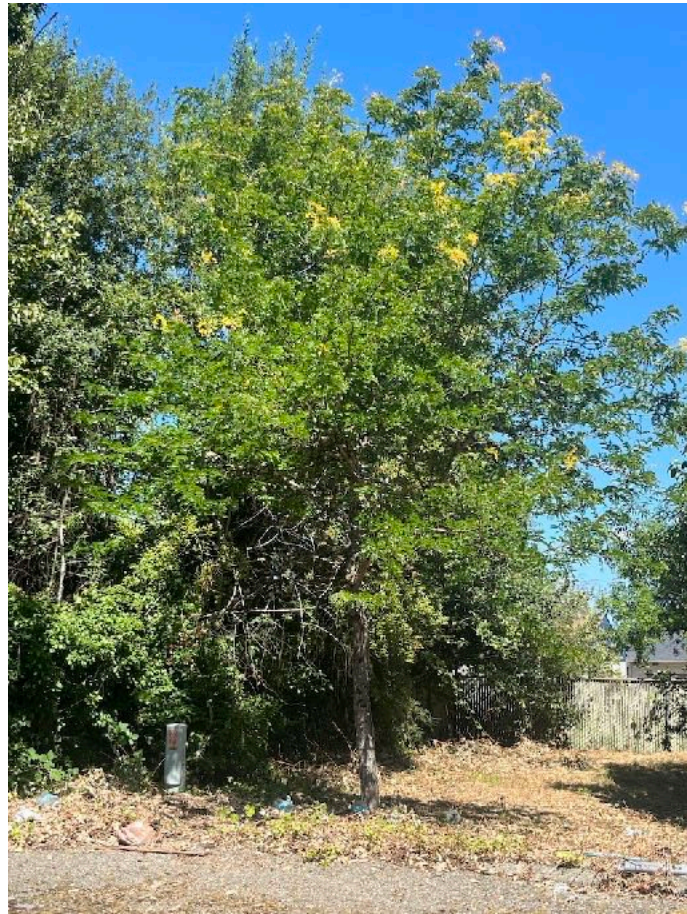
Left photo: View from within the property looking west at the trees on the western property boundary.
Right photo: Typical of the honey locust from this site.

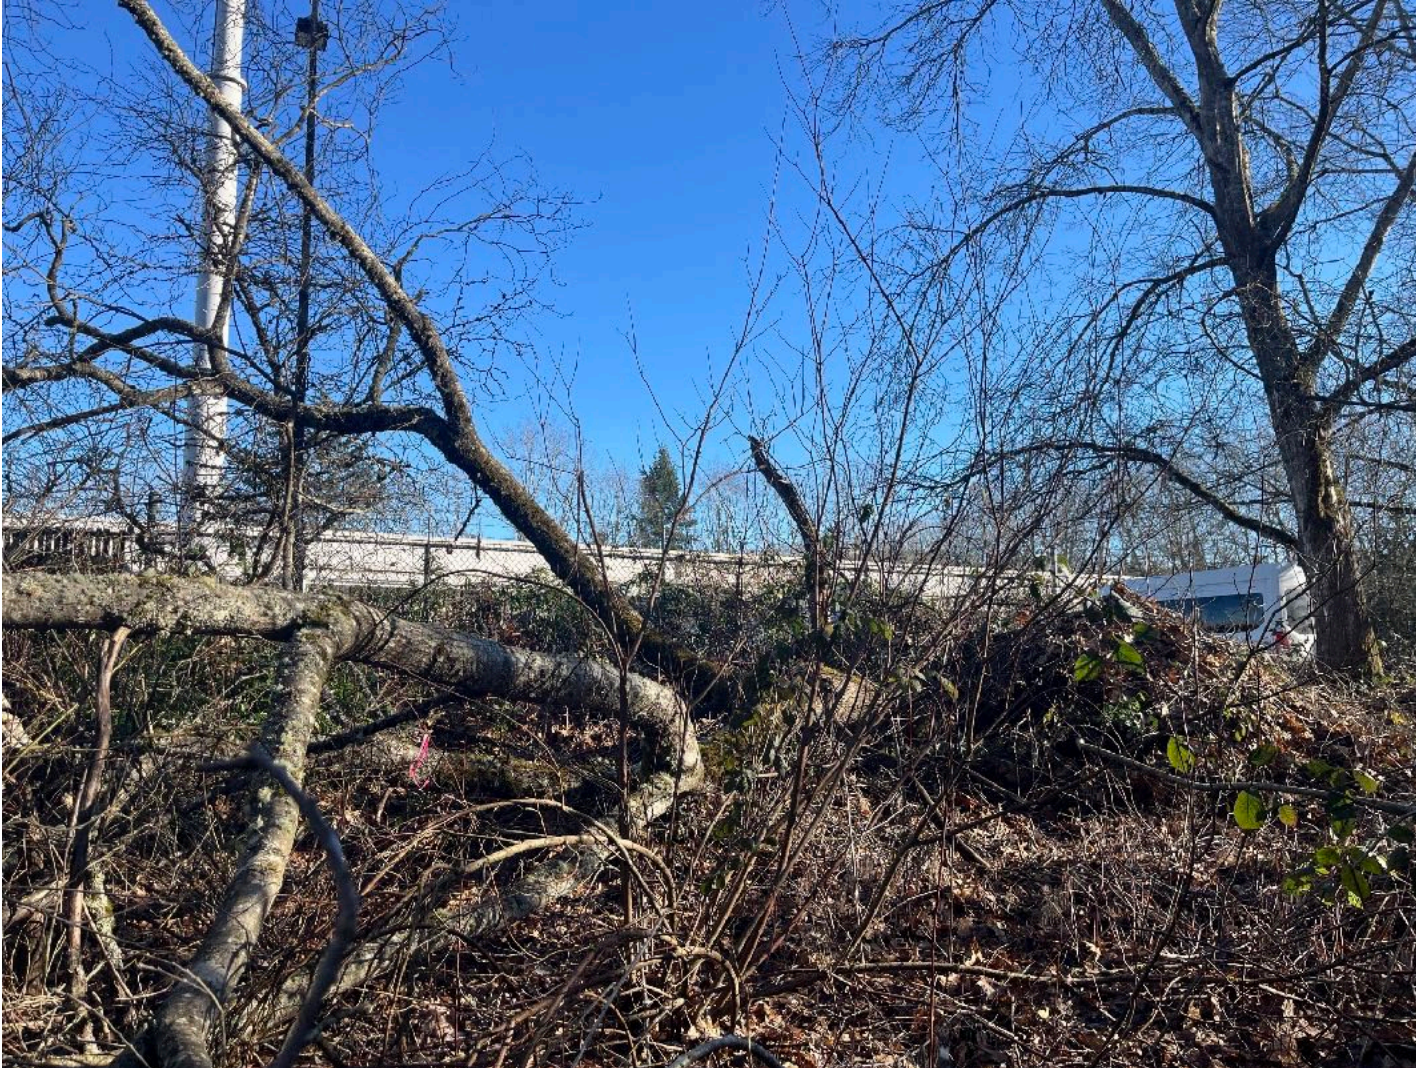
Introduction and assignment: The customer requested an updated report after a recent storm caused some trees on the property to fall. Here is a list of the 7 trees that are no longer viable and which were viable on the 8/7/2024 report: 3007, 3017, 3018, 3019, 3026, 3027, 3028. Trees fell primarily due to soil failure (soil saturation and failure to hold roots against the wind).

3007 Red oak

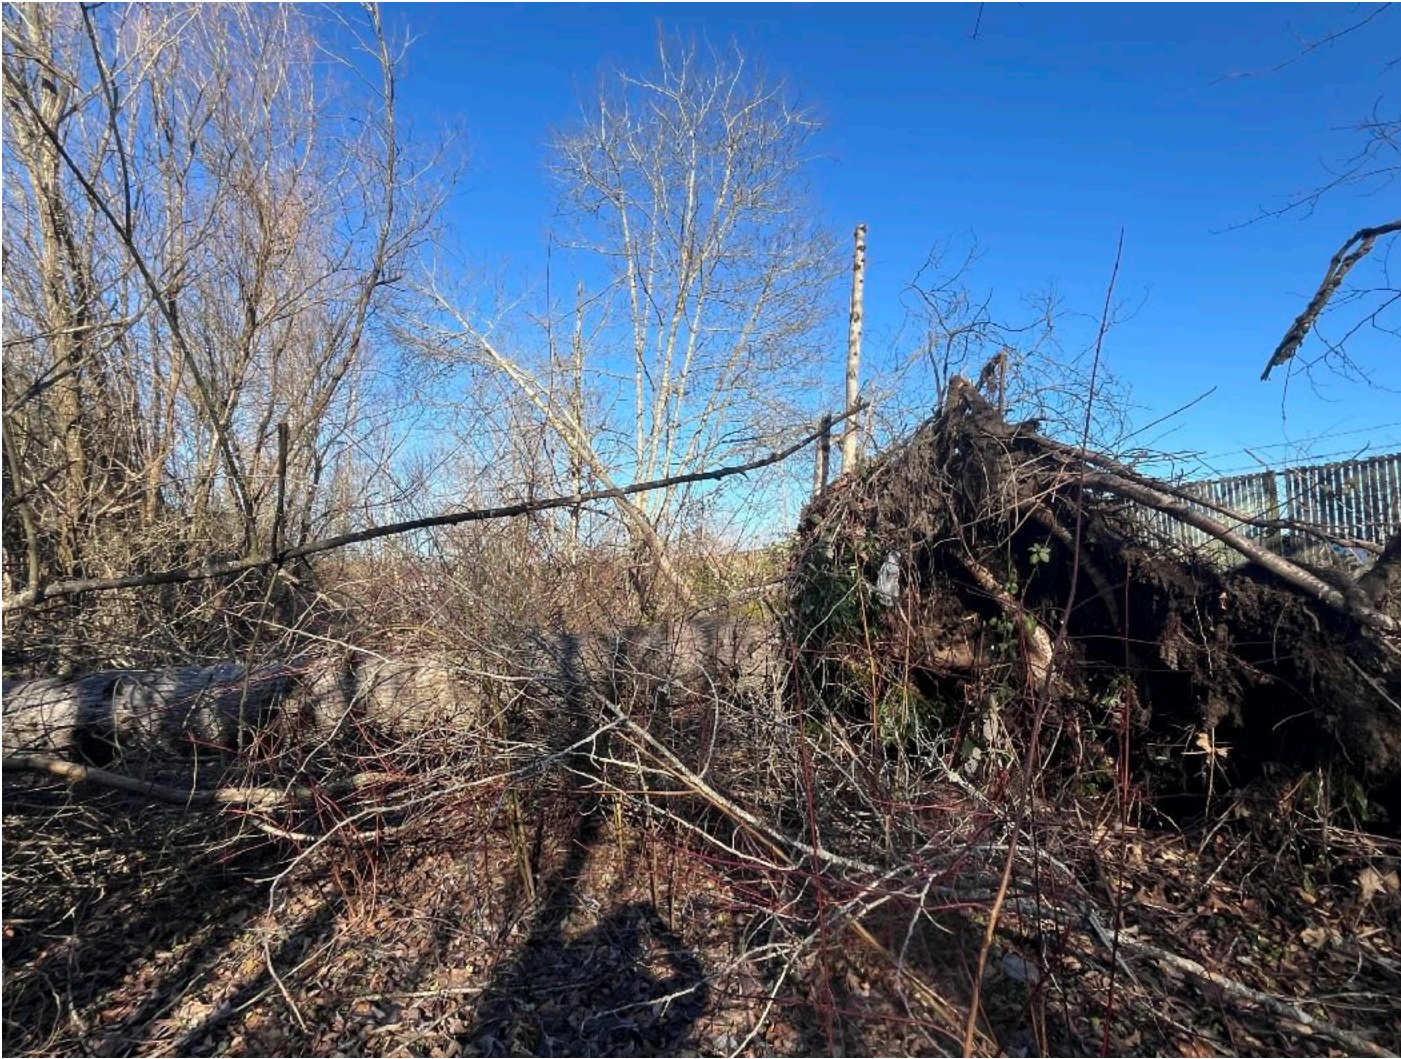
3017 Cottonwood, soil failure.

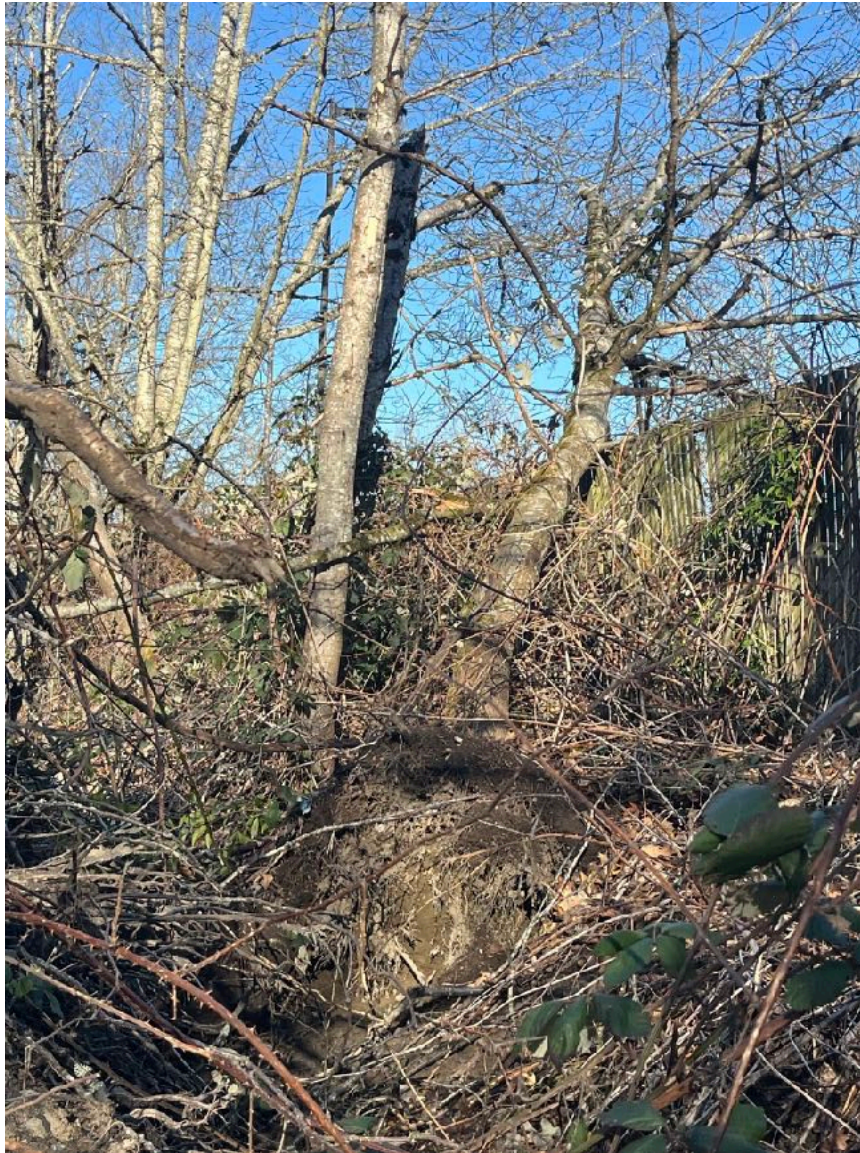
3019 Red oak leaning on fence.

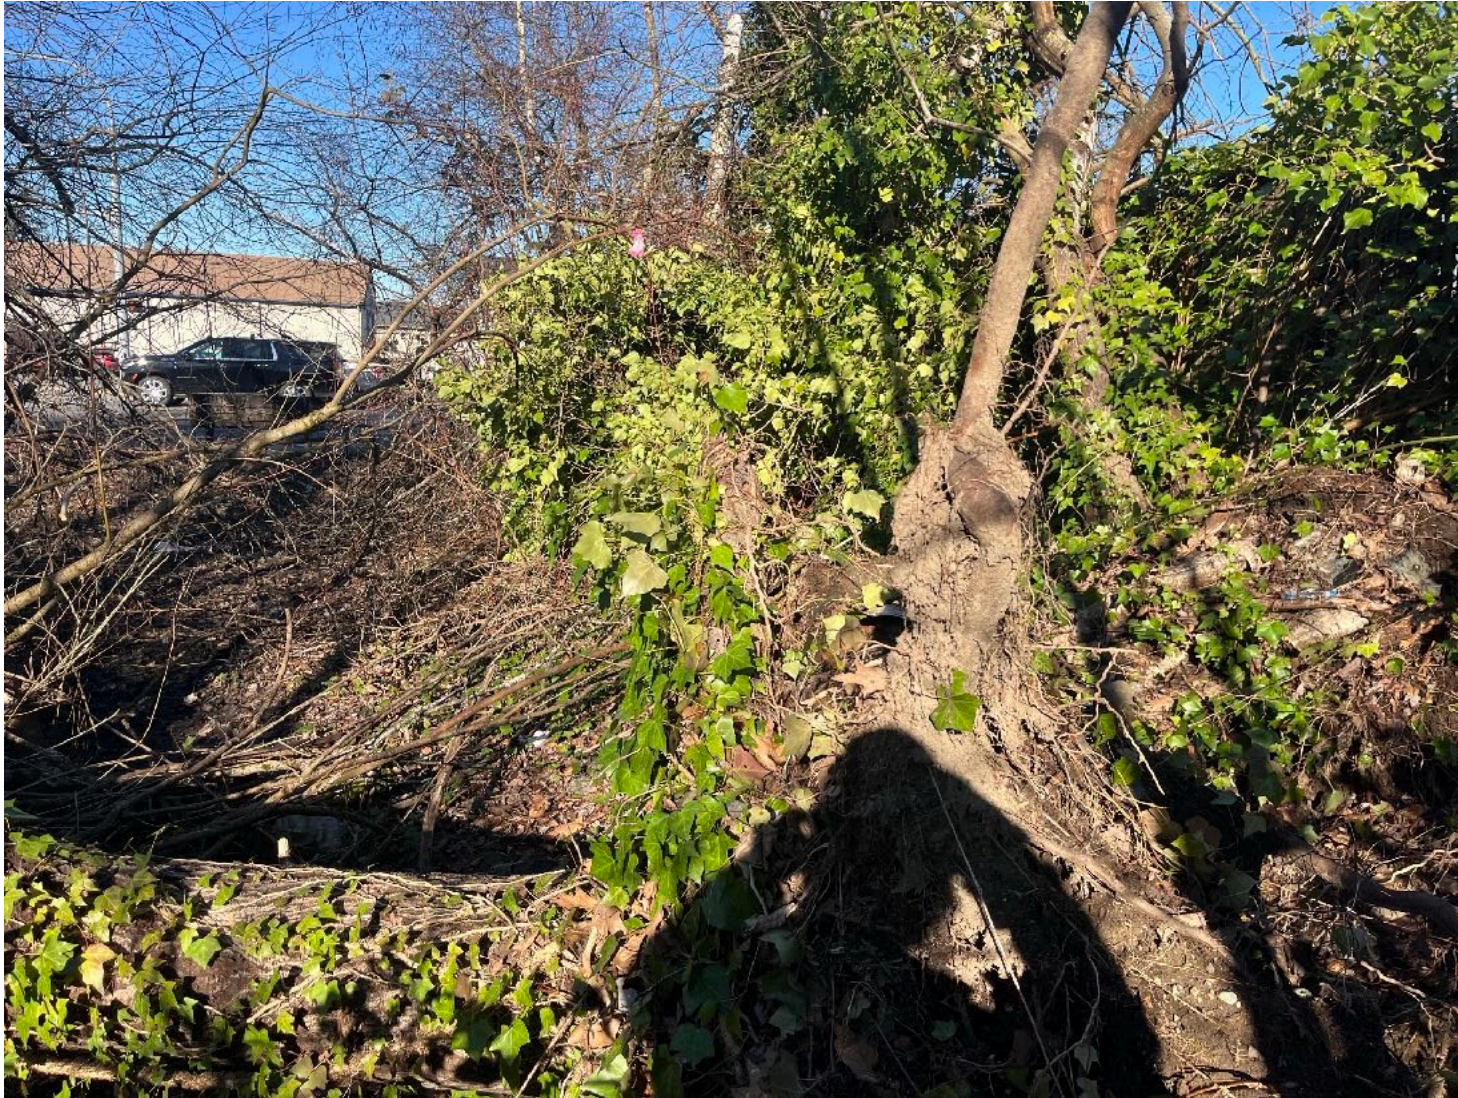
3025	Black cottonwood	<i>Populous trichocarpa</i>		16		1	Failed toward West	Remove	No	NA
3026	Willow	<i>Salix spp.</i>		16	16	4	Bomb cyclone failure	Failed	No	NA
3027	Willow	<i>Salix spp.</i>		8	10	3	Bomb cyclone failure	Failed	No	NA
3028	Red alder	<i>Alnus rubra</i>		14	14	2	Bomb cyclone failure	Failed	No	NA
3029	Willow	<i>Salix spp.</i>		9	15	4		Retain	Yes	20
3030	Willow	<i>Salix spp.</i>		7	12	4		Retain	Yes	17
3031	Linden	<i>Tilia cordata</i>		9	10	4		Retain	Yes	15
3032	Red oak	<i>Quercus rubra</i>		11	12	4		Retain	Yes	17
3033	Oregon ash	<i>Fraxinus latifolia</i>		6	8	3		Remove	No	NA
3034	Red oak	<i>Quercus rubra</i>		6	8	4		Retain	Yes	13

Looking N from seasonal wetland at NW maple St, 3028 red alder in foreground, willows 3026 and 3027 beyond.
