INVITATION TO BID

Fire Restoration

Villages at South Station 3714 South 154th Lane, Tukwila, WA 98188

ADDENDUM NO. 1

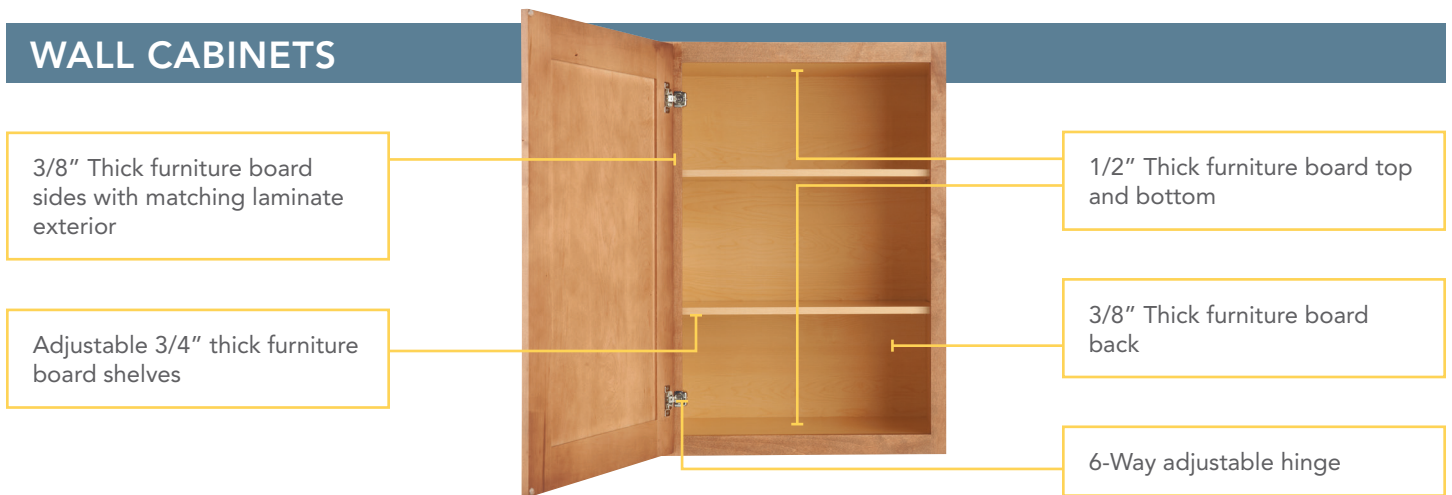
STANDARD CONSTRUCTION

WALL CABINETS

BASE CABINETS

DRAWER FEATURES

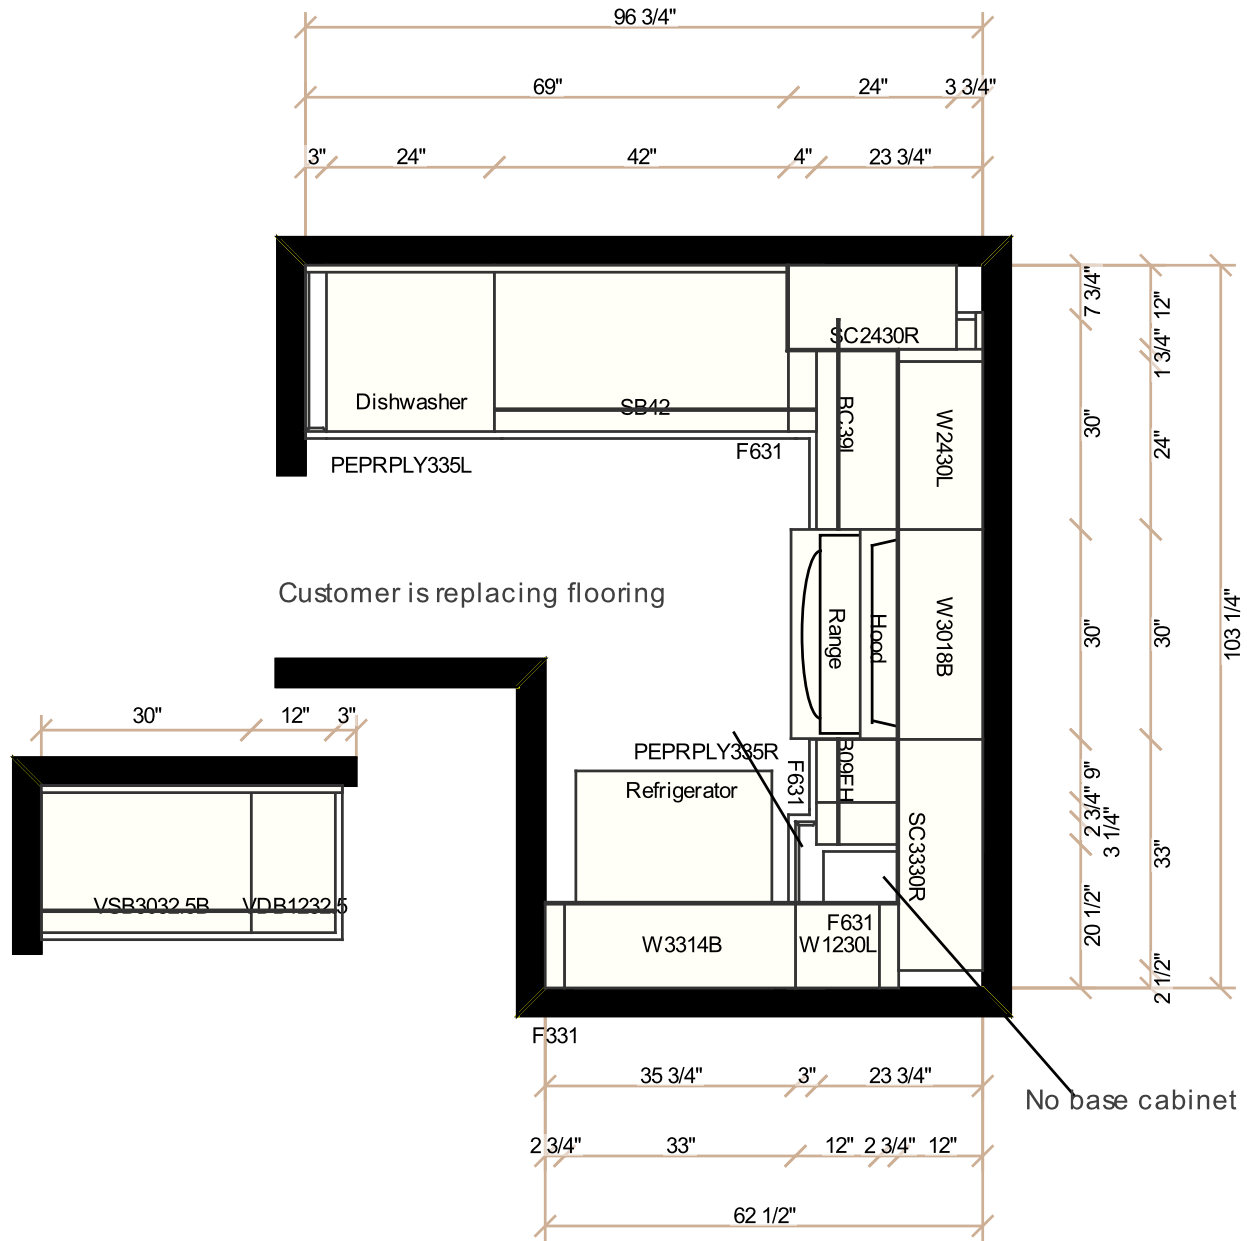
Customer is replacing flooring

No base cabinet in corner

Answer: Cabinet manufacturer is Aristokraft, style is Sinclair from Home Depot. The bar top is to be replaced along with the other countertops so all tops match. Countertop to be Topline Counters “Maui Quartz” solid surface. Provide layout sketch and cabinet submittal prior to ordering for approval by owner. See attached Cabinet Details, Cabinet Finishes and Cabinet Plans for additional information
