# FOR WAYLAND ARMS SLAB REPAIR & SEISMIC UPGRADE RFQ

<b>Project Name:</b>	Wayland Arms Apartments - Settlement Monitoring	<b>Report:</b> 001	
<b>GeoDesign # :</b>	KCHA-13-04	<b>Date:</b> 01/09/2024	
<b>Reports with Unresolved Nonconformance Issues:</b>		<b>Permit:</b>	
<b>Distribution:</b>	Heath MacCoy <HeathM@kcha.org>		
	<b>Weather:</b>	<b>Arrival/Departure:</b>	<b>Prepared By:</b> <i>Ken J. Lamb</i>
<b>Attachments:</b>	<input checked="" type="checkbox"/> Site Plan(s)	<input type="checkbox"/> Density Test Summary	<b>Signature:</b>
	<input type="checkbox"/> Installation Records	<input type="checkbox"/> Other	<b>Reviewed By:</b> <i>Ken J. Lamb</i>

## SUMMARY OF CRACK MONITORING GAGE INSTALLATION:

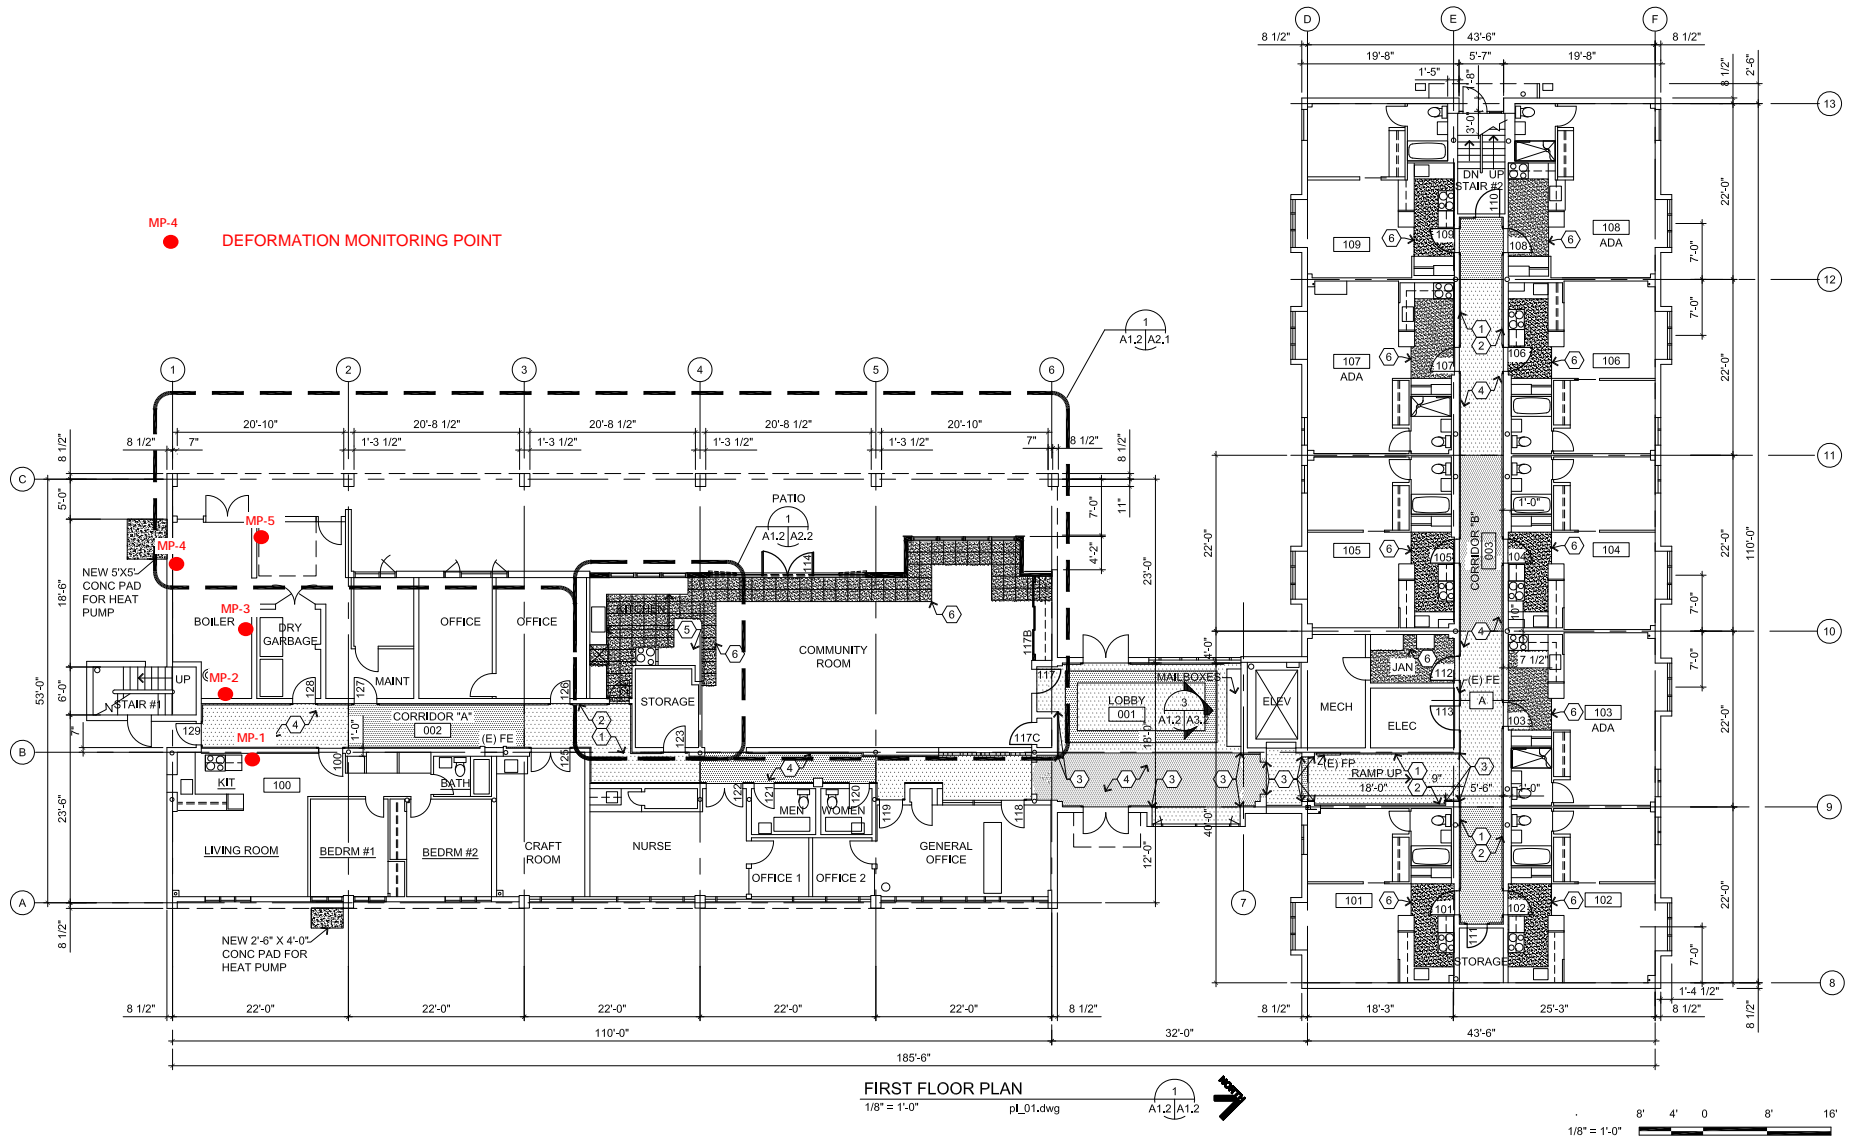
KCHA-13-04

Installed 5 crack monitoring gages at Wayland Arms Apartments in Auburn at the following locations and as shown on Figure 1.

MP-1 - Suite 100 central wall opposite interior hallway between floor and wall stud. Wall studs are hanging from 2nd floor joist and there is an existing gap between the floor slab and base plate.

MP-2 - Mechanical room central wall opposite interior hallway, between floor and cinder block wall.

MP-3 - Mechanical Room north wall behind fire water pipes between floor slab and cinder block wall.

MP-4 - Mechanical Room south wall west of boiler behind 6-inch metal ducting pipe, between floor slab and wall.

MP-5 - Water Tank room, west side of building just north of mechanical room accessed through exterior doors.

We recommend reading them on a 3-month interval for first year and revise monitoring interval based on past readings.
