# PROJECT MANUAL

**Siding & Exterior Trim Replacement  
Carriage House Apartments – Building E**

**Contract Number: AW2601831**

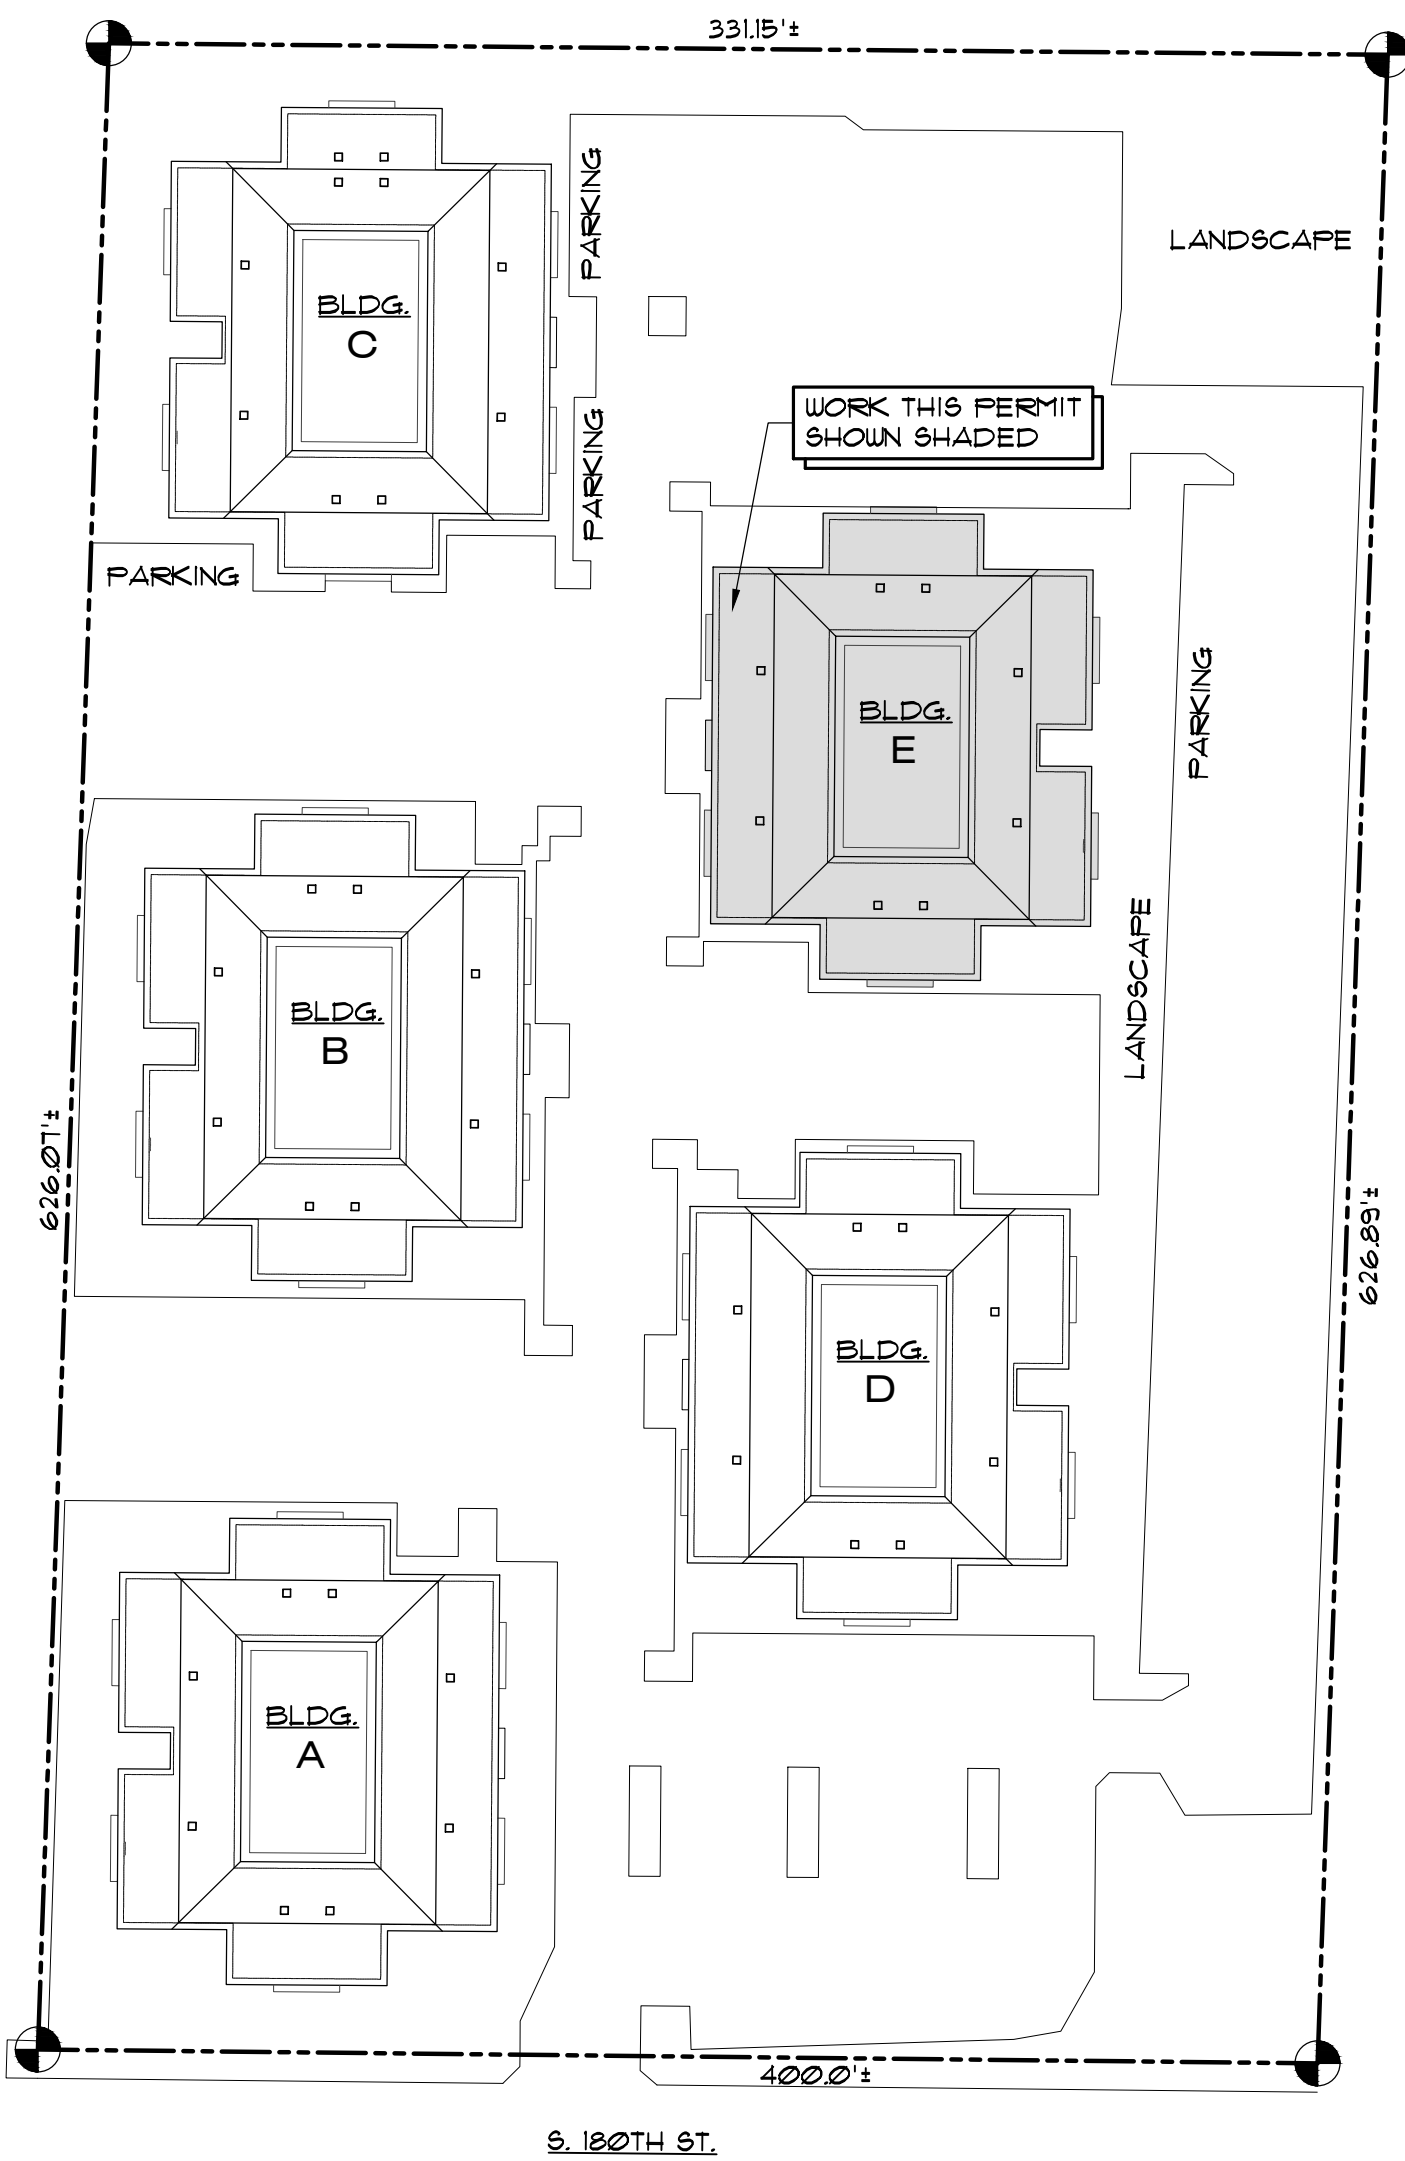
SITE PLAN  
SCALE: 1" = 60'-0"

NOTE:  
THE INFORMATION ON THIS SITE PLAN IS SCHEMATIC AND HAS BEEN DERIVED FROM THE SITE PLAN INFORMATION ON RECORD WITH KING COUNTY, AERIAL PHOTOGRAPHS, AND SITE VISITS.

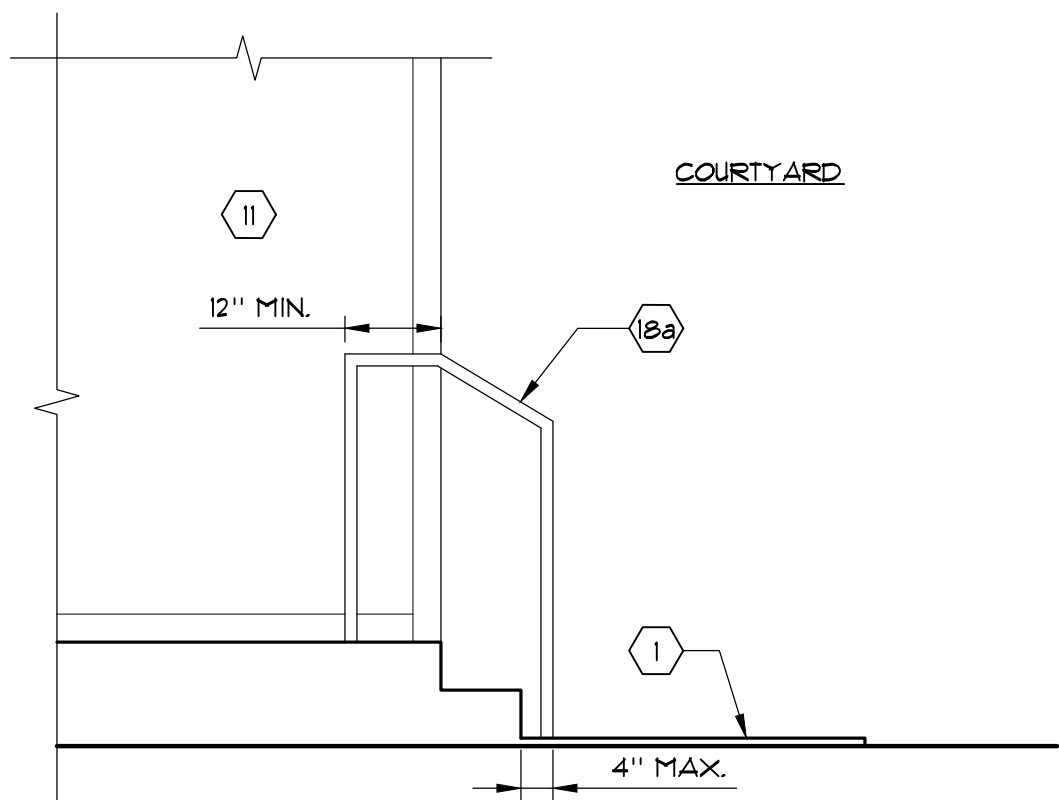
**PARTIAL FIRST FLOOR  
UNIT CORRIDOR PROFILE** 2  
SCALE: 1/2" = 1'-0"

NOTE:  
FOR ADDITIONAL HANDRAIL  
INFORMATION, REF. HANDRAIL  
SPECIFICATIONS ON SHEET 11

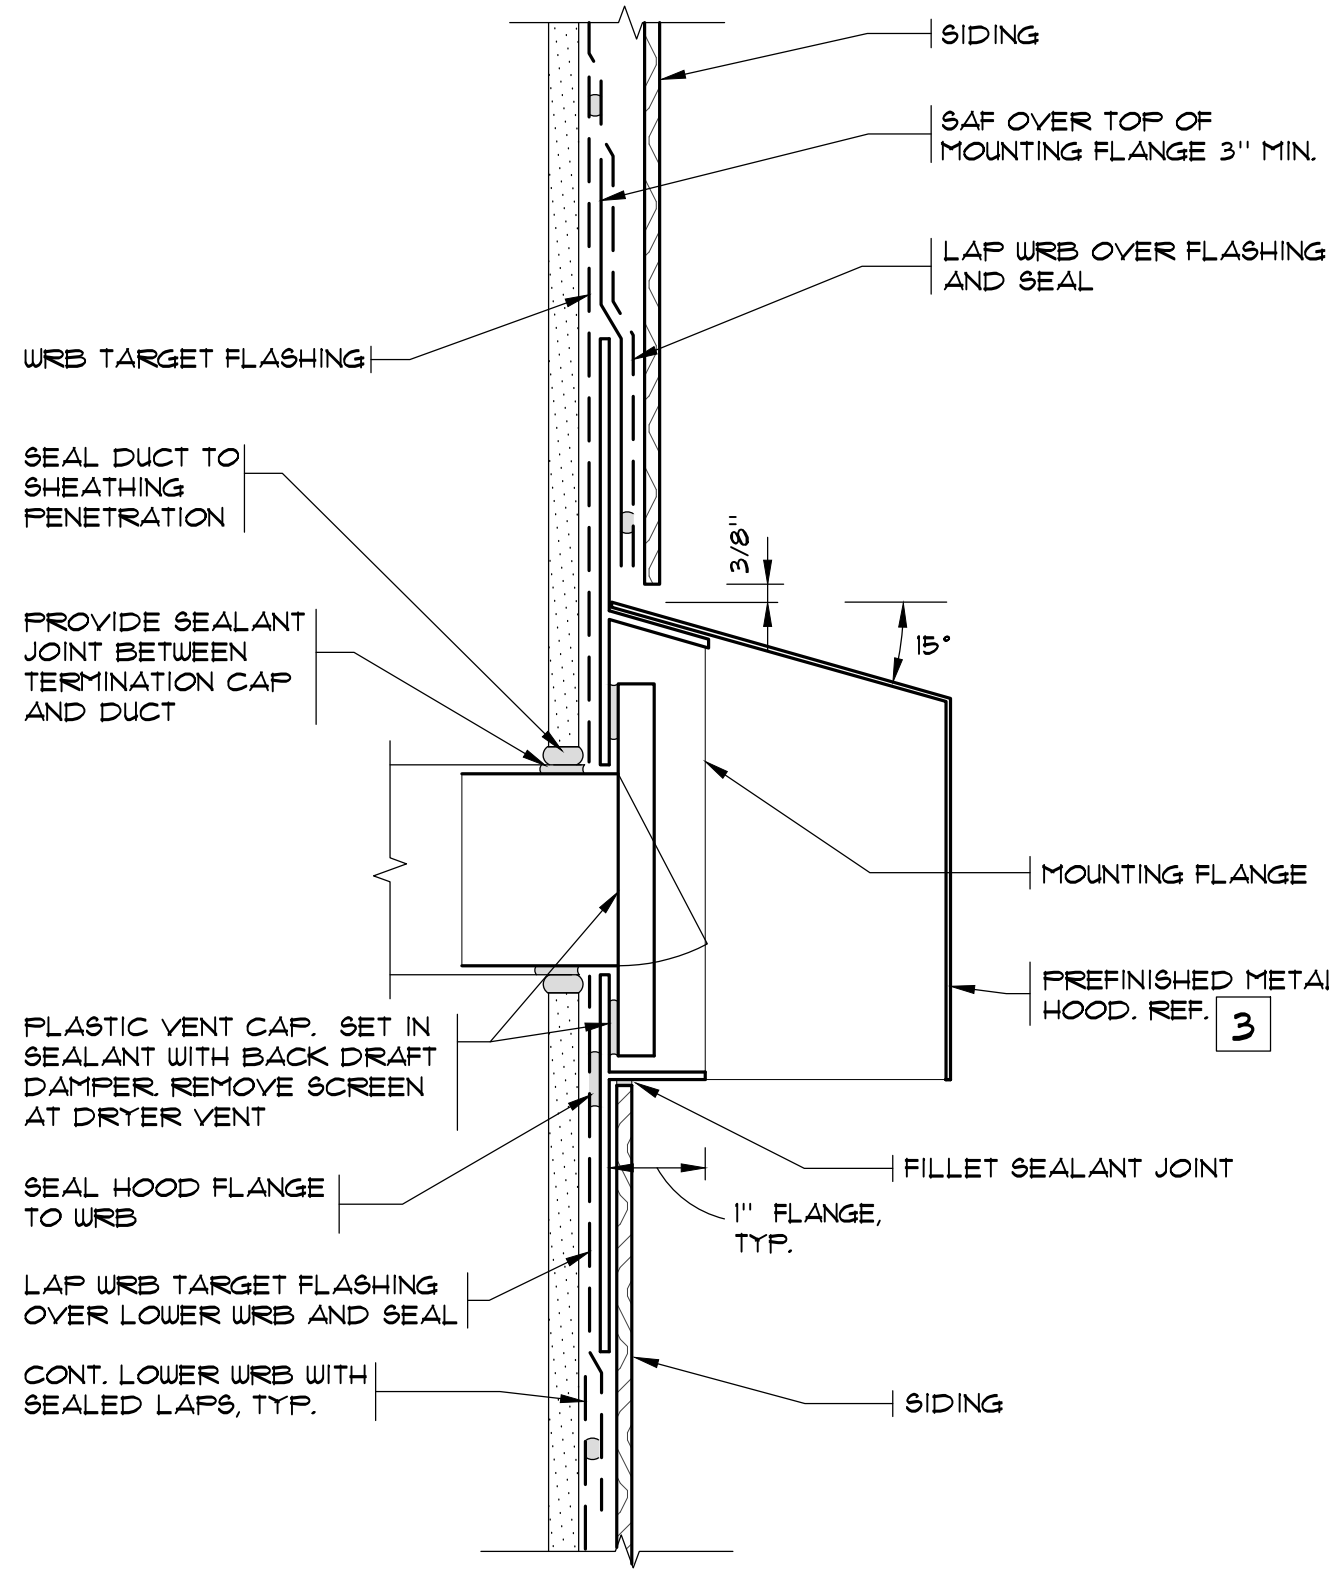
VENT HOOD - SECTION

NOTE:  
FOR ADDITIONAL INFORMATION  
REF. 2 3 4

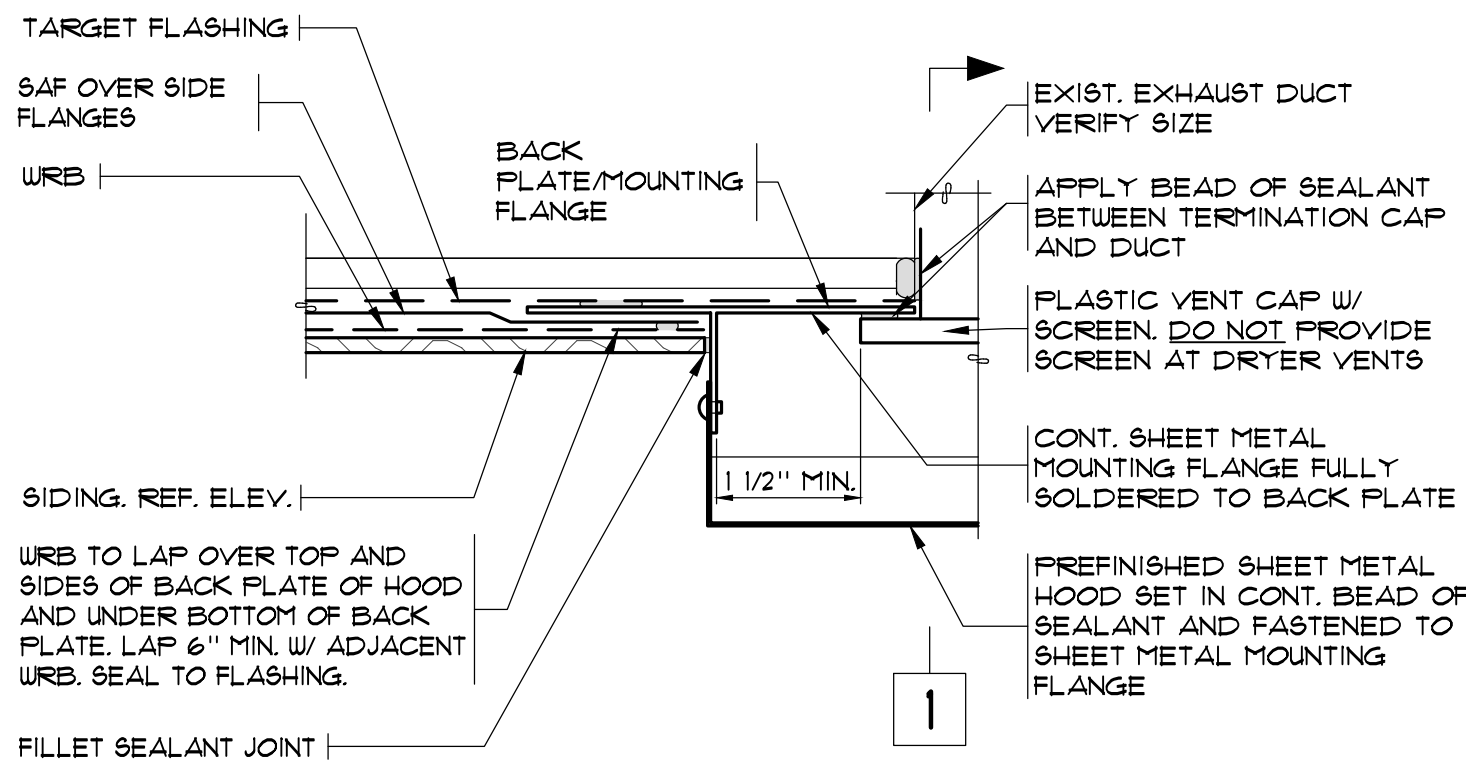
VENT HOOD - PLAN VIEW

NOTE:  
FOR ADDITIONAL INFORMATION  
REF. 1 3 4

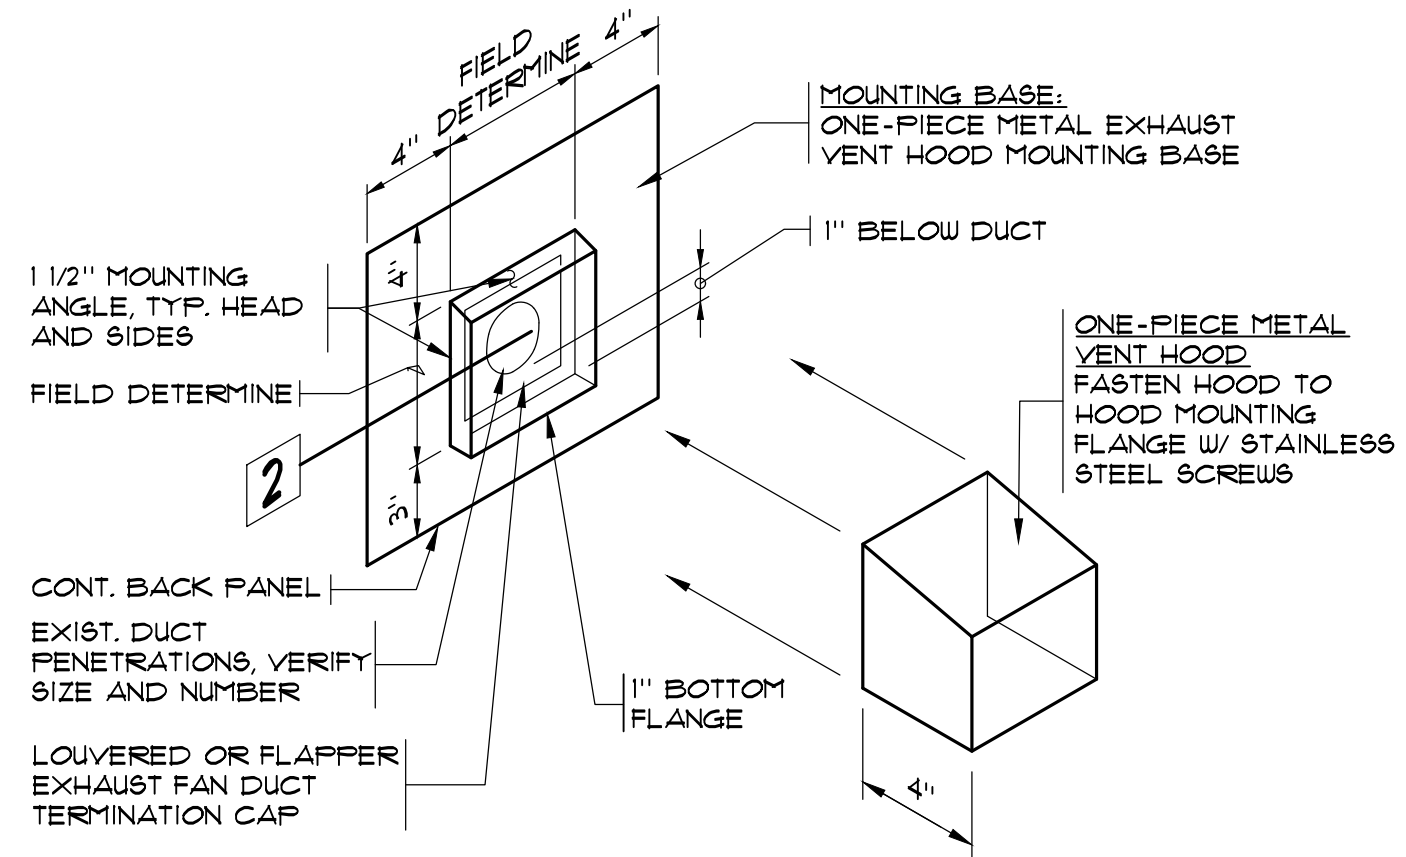
- NOTES:
1. EXTEND VENT HOOD AS REQUIRED FOR MULTIPLE EXHAUST VENTS. PROVIDE VERT. METAL SUPPORT BETWEEN EA. VENT (NOT SHOWN).
  2. FOR ADDITIONAL INFORMATION REF. 1 2 4
  3. AT INSIDE CORNER MODIFY JAMB FLANGES TO EXTEND ONTO ADJACENT WALL SURFACE 4\"/>
  4. SOLDER ALL SEAMS

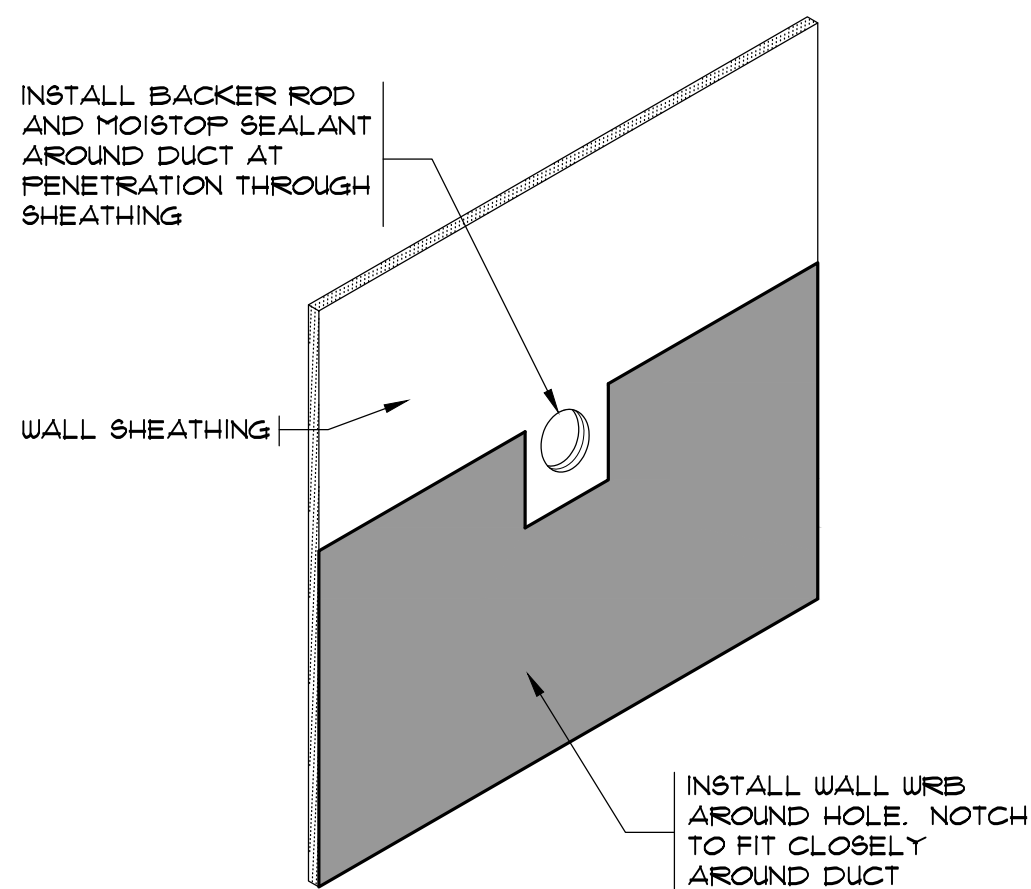
STEP #1

INSTALL URB TARGET FLASHING PIECE OVER HOLE. EXTEND 3\"/>

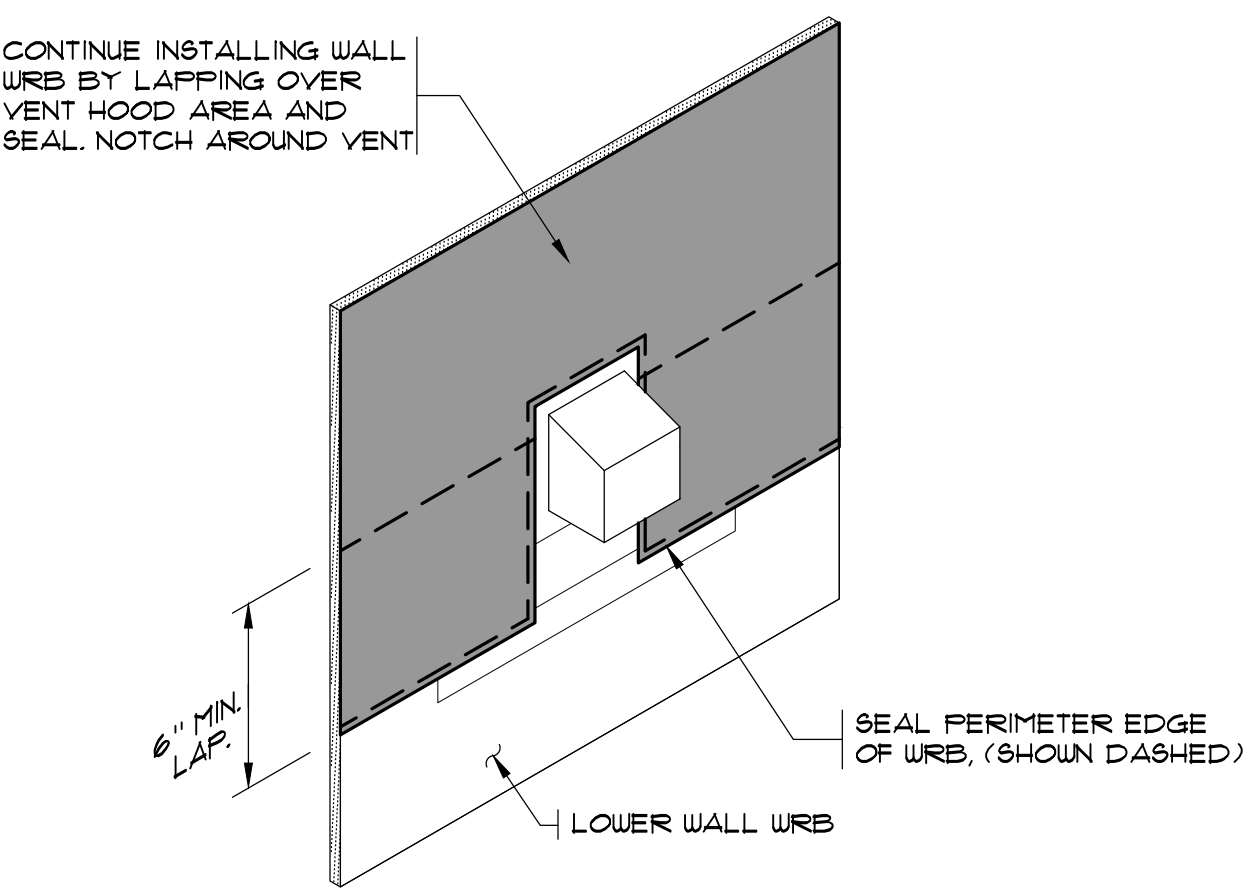
STEP #5

METAL VENT HOOD

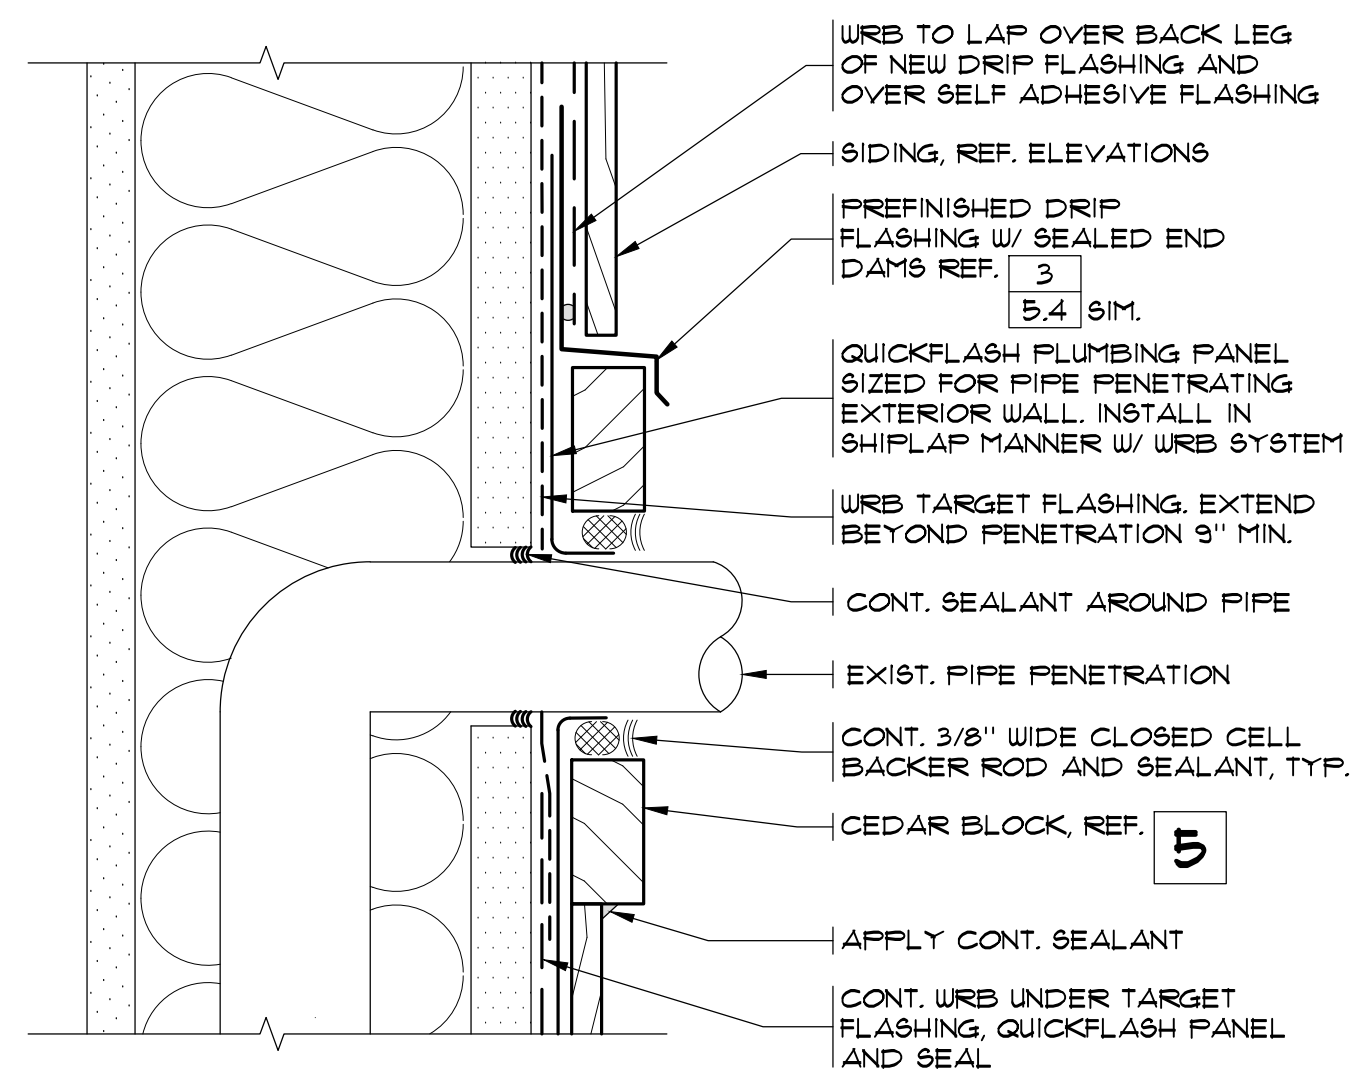
**HOSE BIBB PENETRATION** 3  
SCALE: 6" = 1'-0"

NOTES:  
1. ALTERNATE TO QUICKFLASH FLASHING IS LIQUID APPLIED FLASHING (LAF). LAF SHALL EXTEND 6" IN ALL DIRECTION AROUND PIPE PENETRATION AND 1/2" ONTO PIPE.  
2. FOR ADDITIONAL INFORMATION, REF. 1

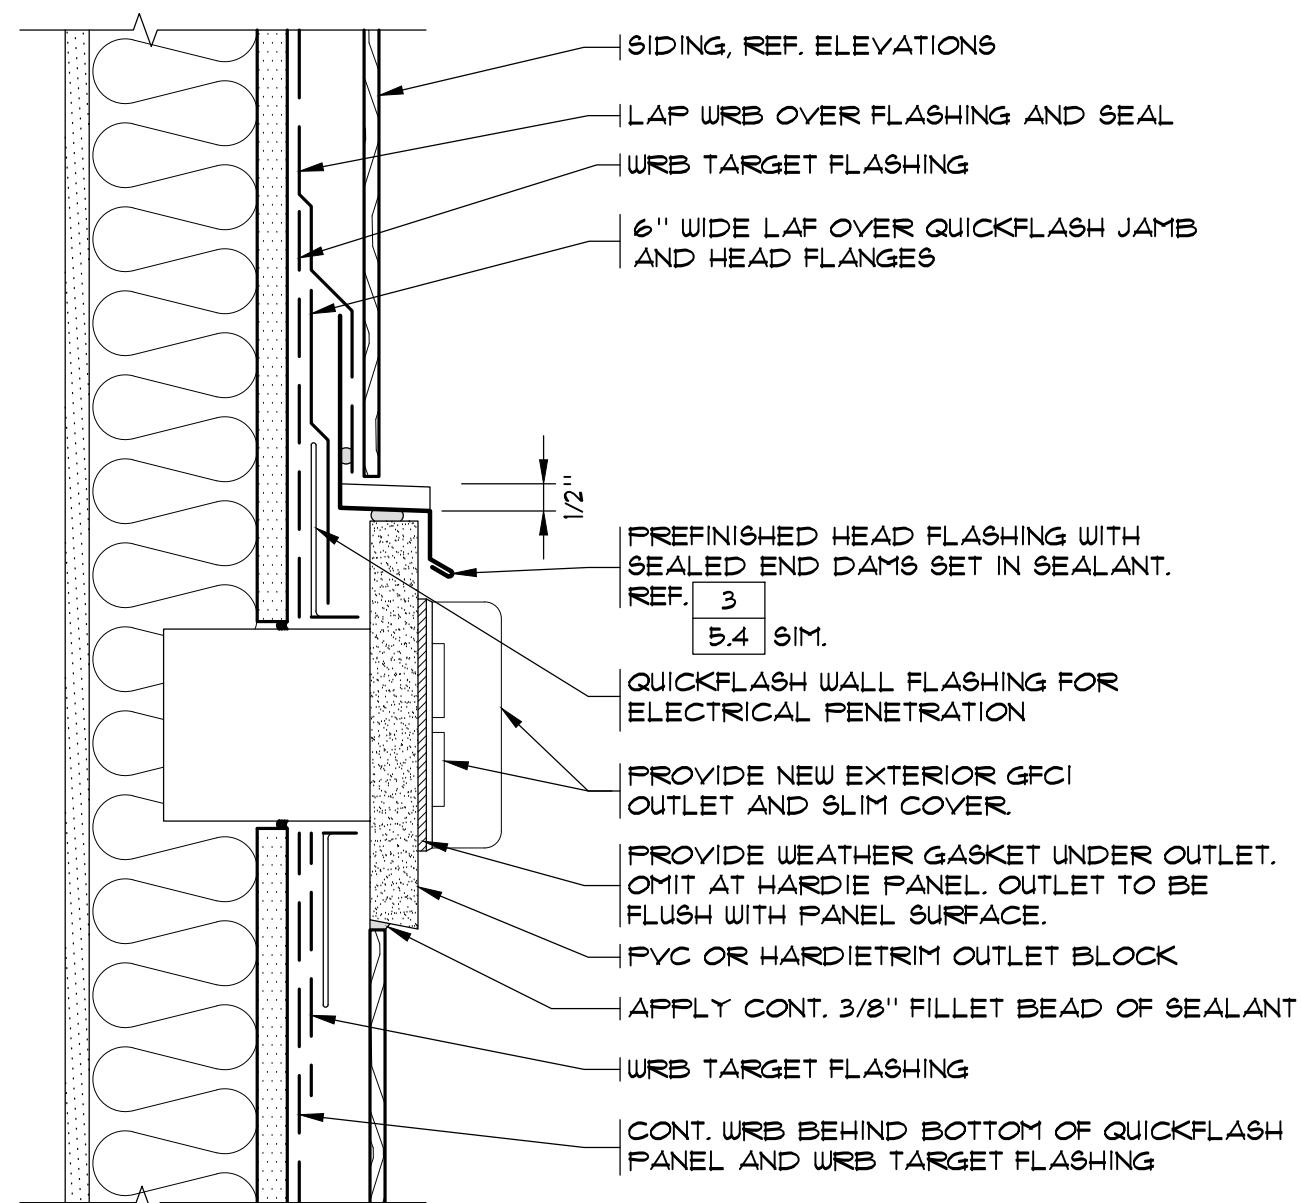
**EXTERIOR OUTLET/ FIXTURE** 4  
SCALE: 3" = 1'-0"

NOTE:  
1. FOR ADDITIONAL INFORMATION, REF. SECTION 2

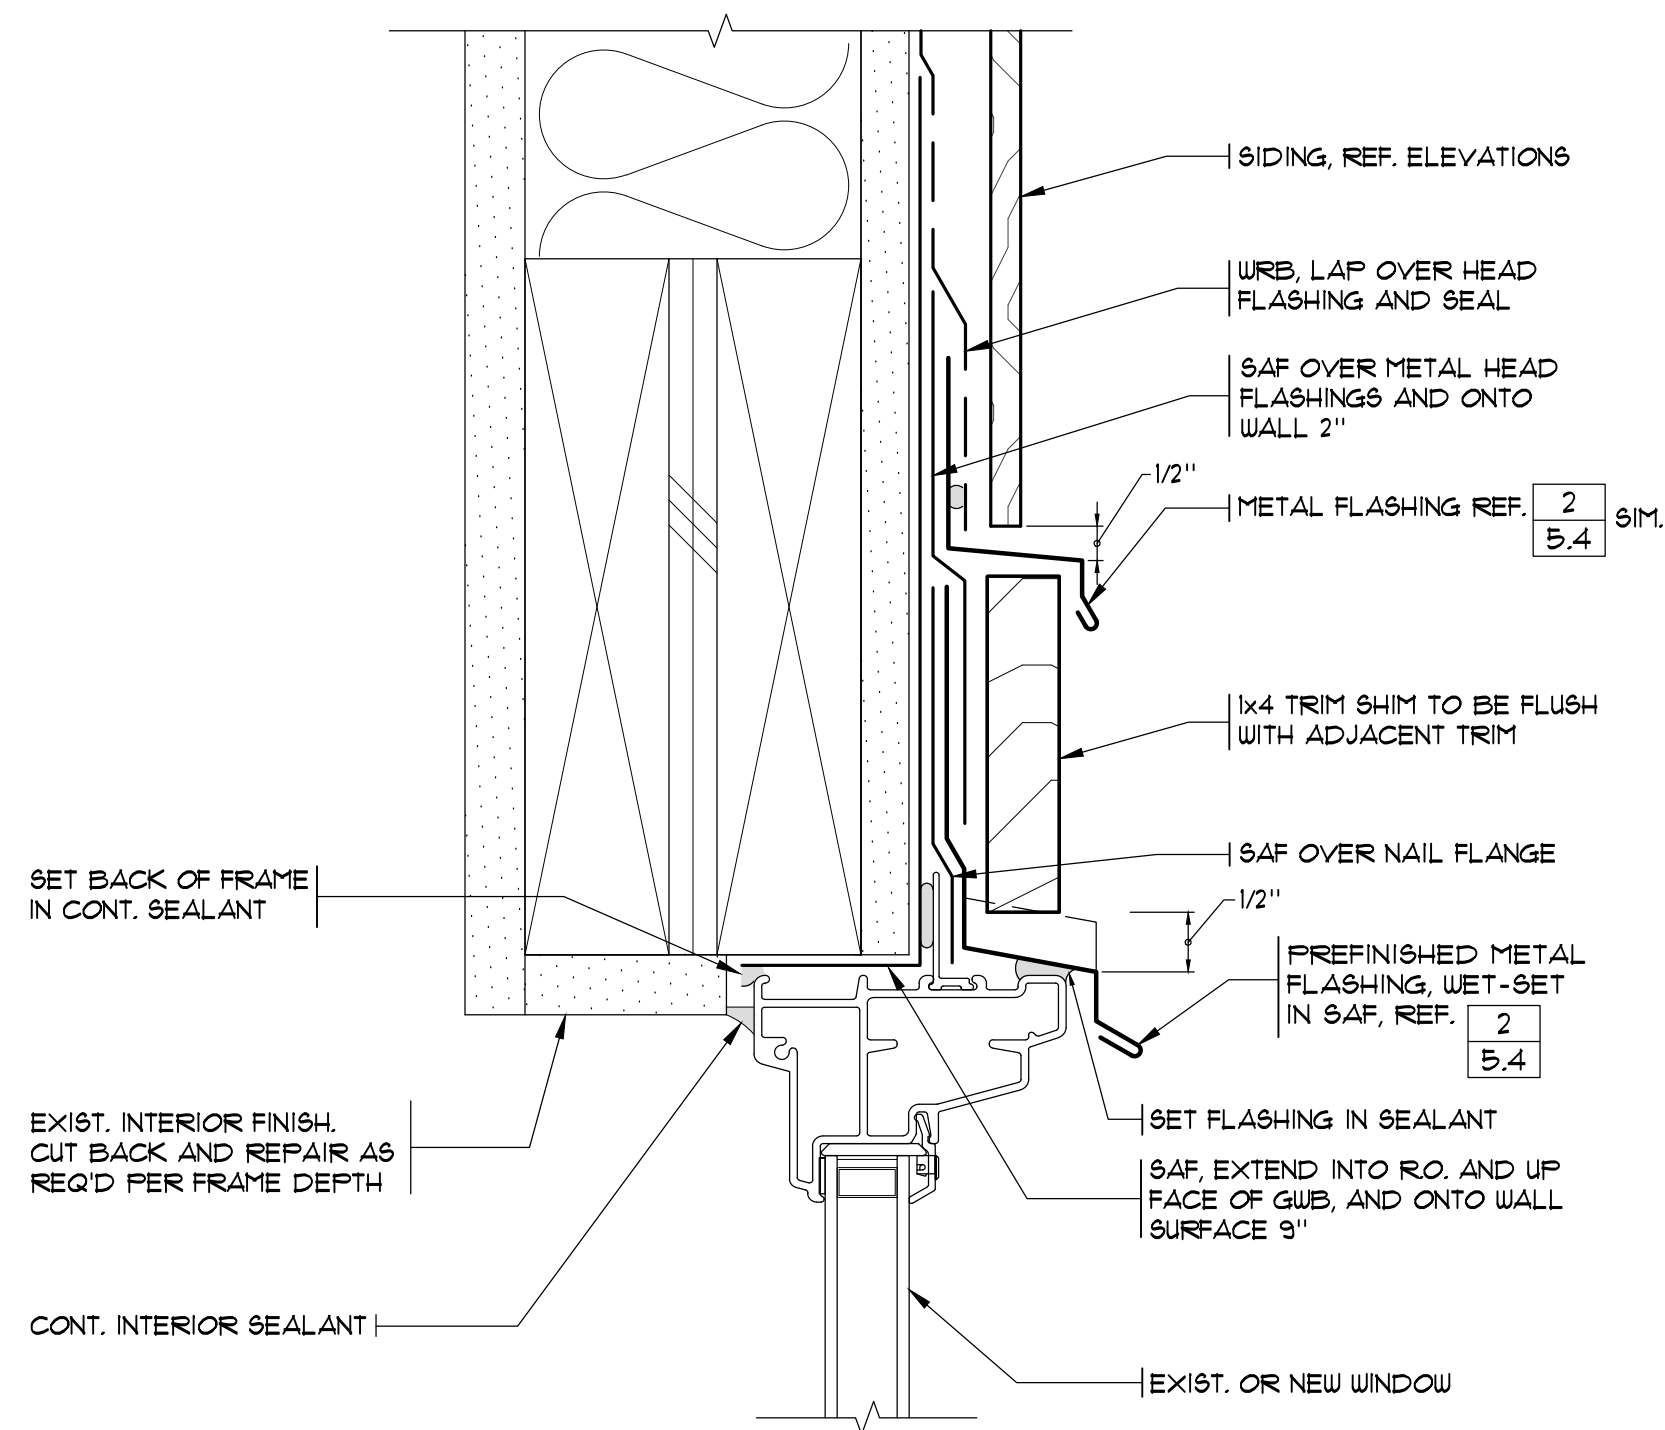
**NEW OR EXIST. FLANGED WINDOW HEAD** 1  
SCALE: 6" = 1'-0"

NOTE:  
FOR ADDITIONAL INFORMATION,  
REF. 1, 5.4

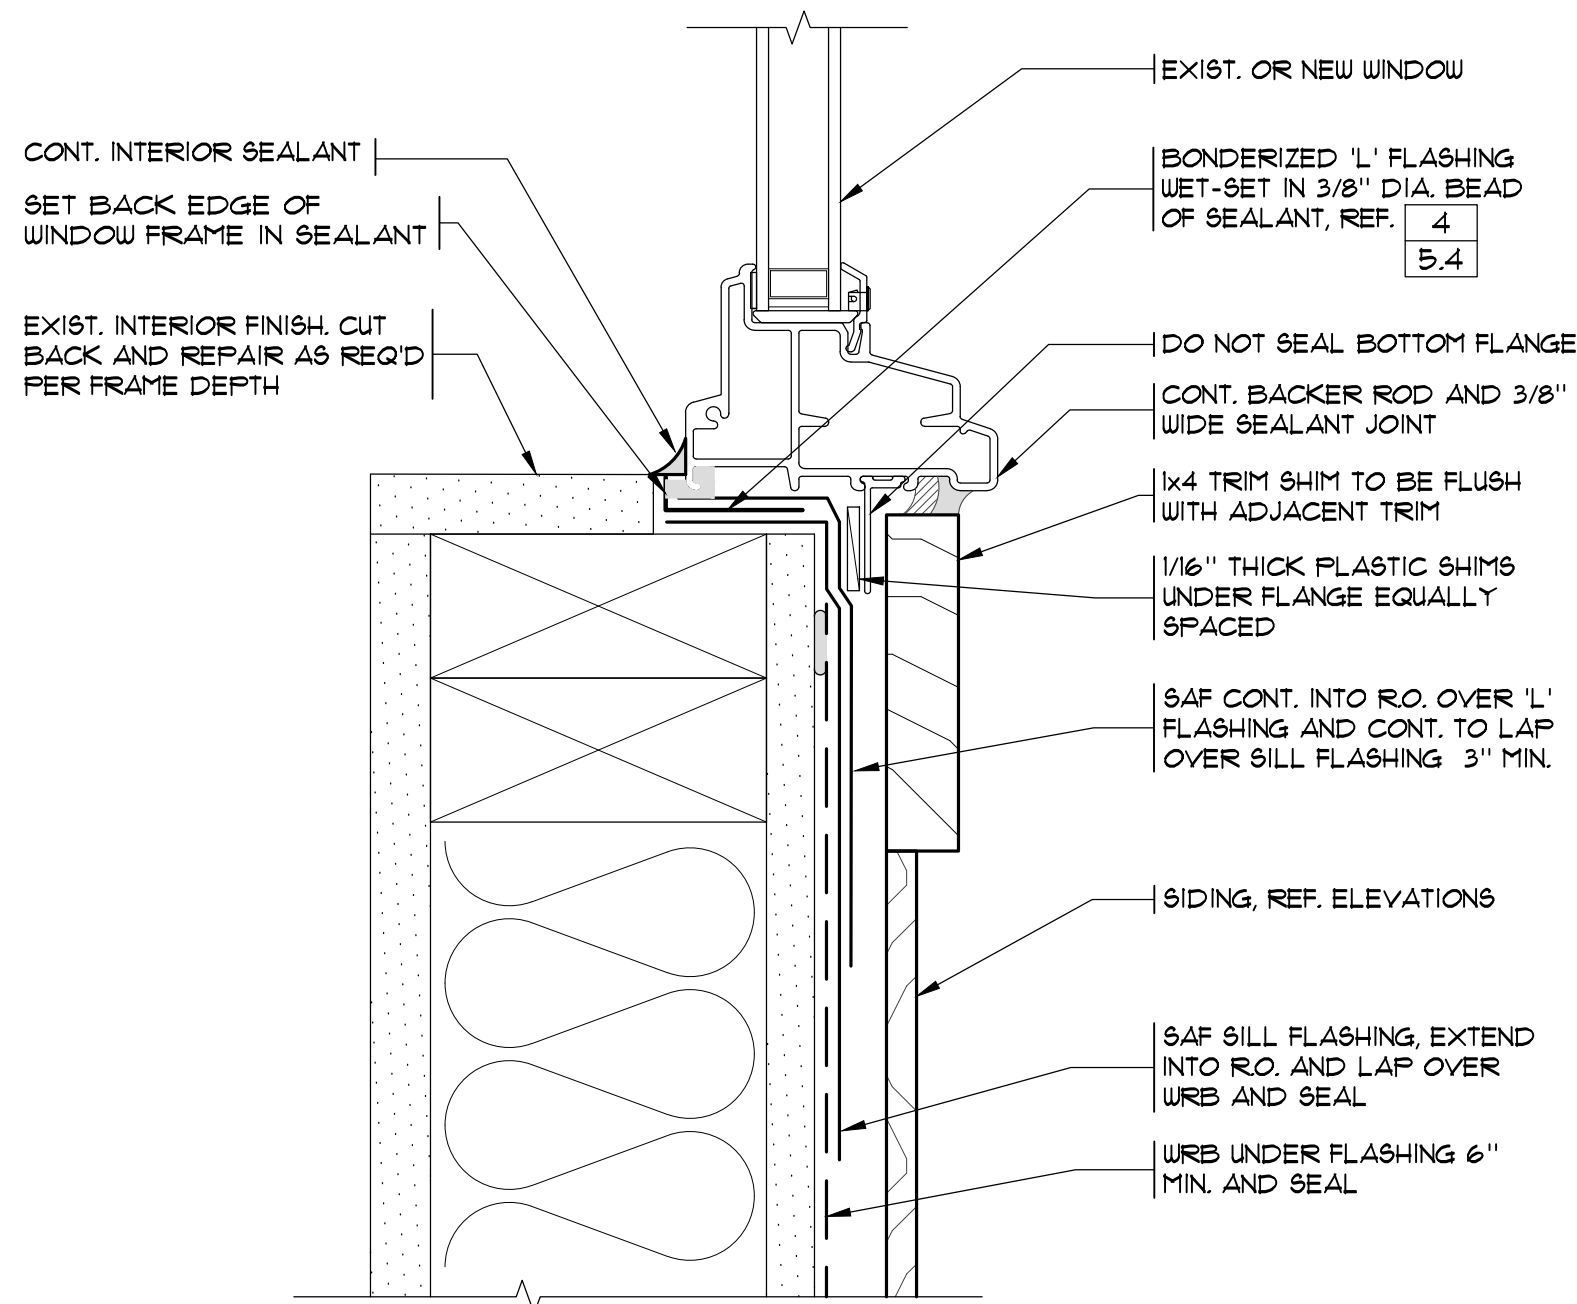
**NEW OR EXIST. FLANGED WINDOW SILL** 2  
SCALE: 6" = 1'-0"

NOTE:  
FOR ADDITIONAL INFORMATION,  
REF. 1, 5.4

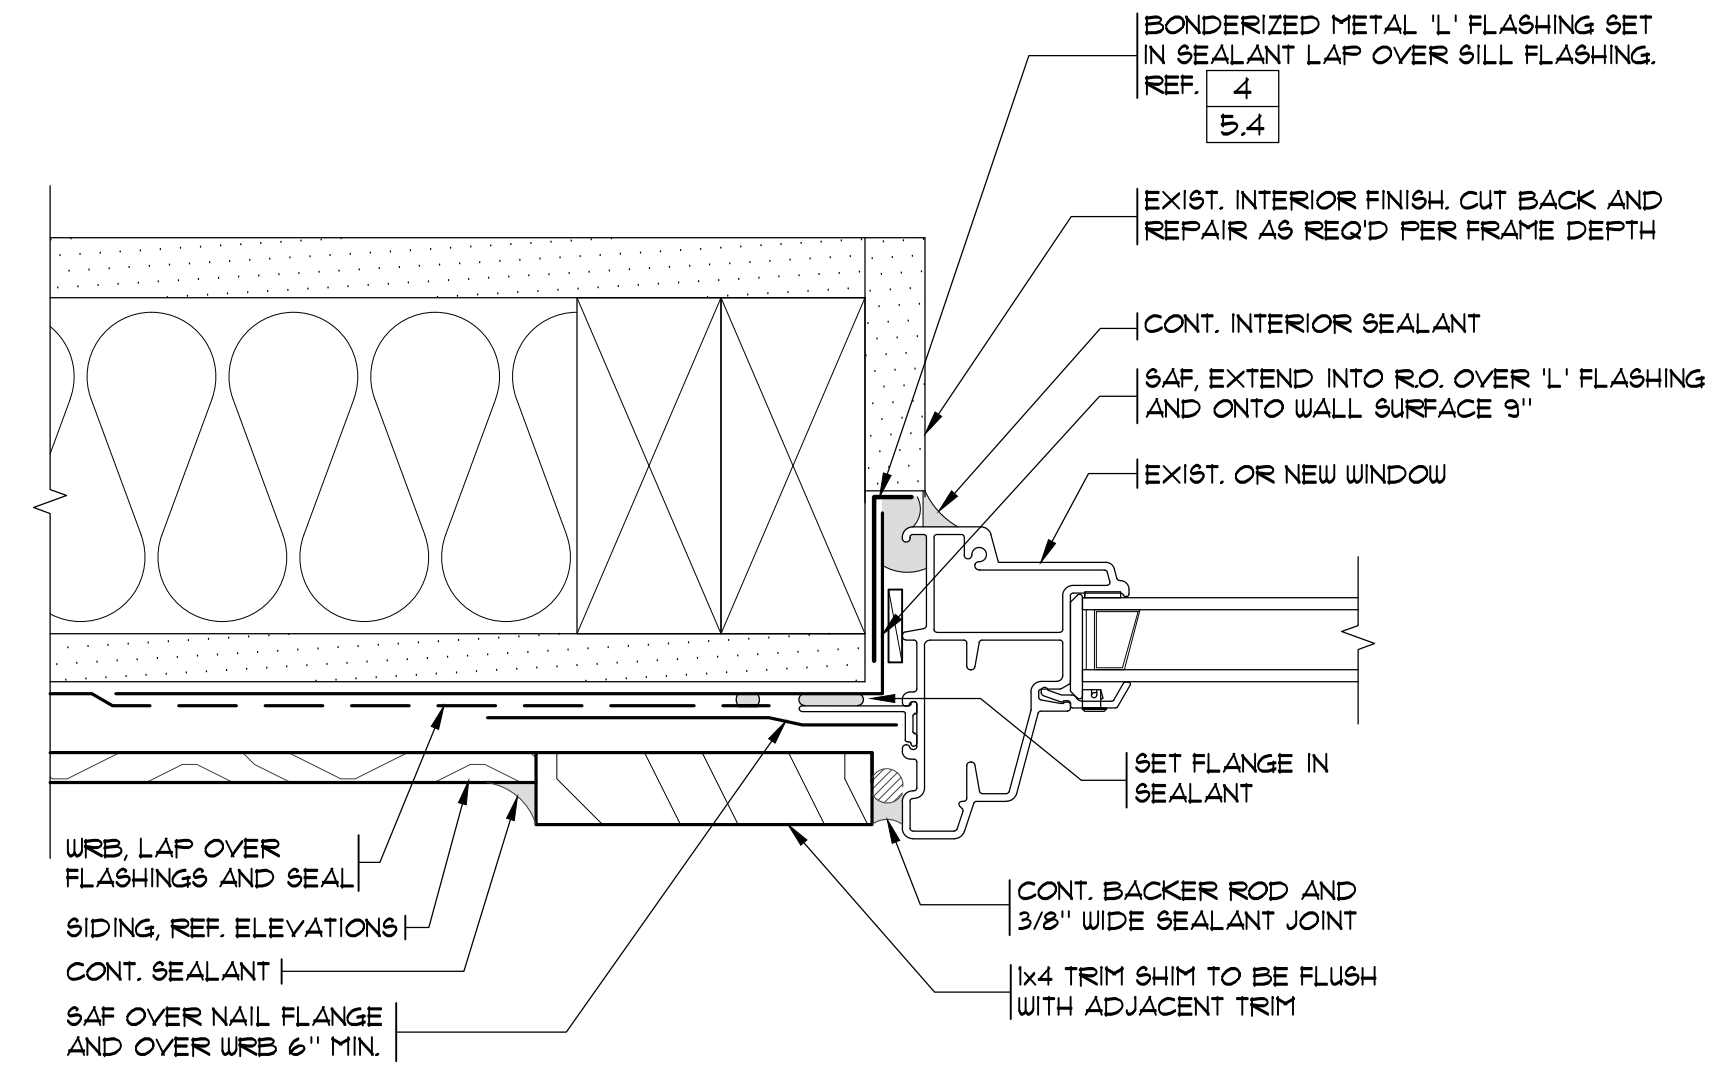
**NEW OR EXIST. FLANGED WINDOW JAMB** 3  
SCALE: 6" = 1'-0"

NOTE:  
FOR ADDITIONAL INFORMATION,  
REF. SECTION 1, 5.4

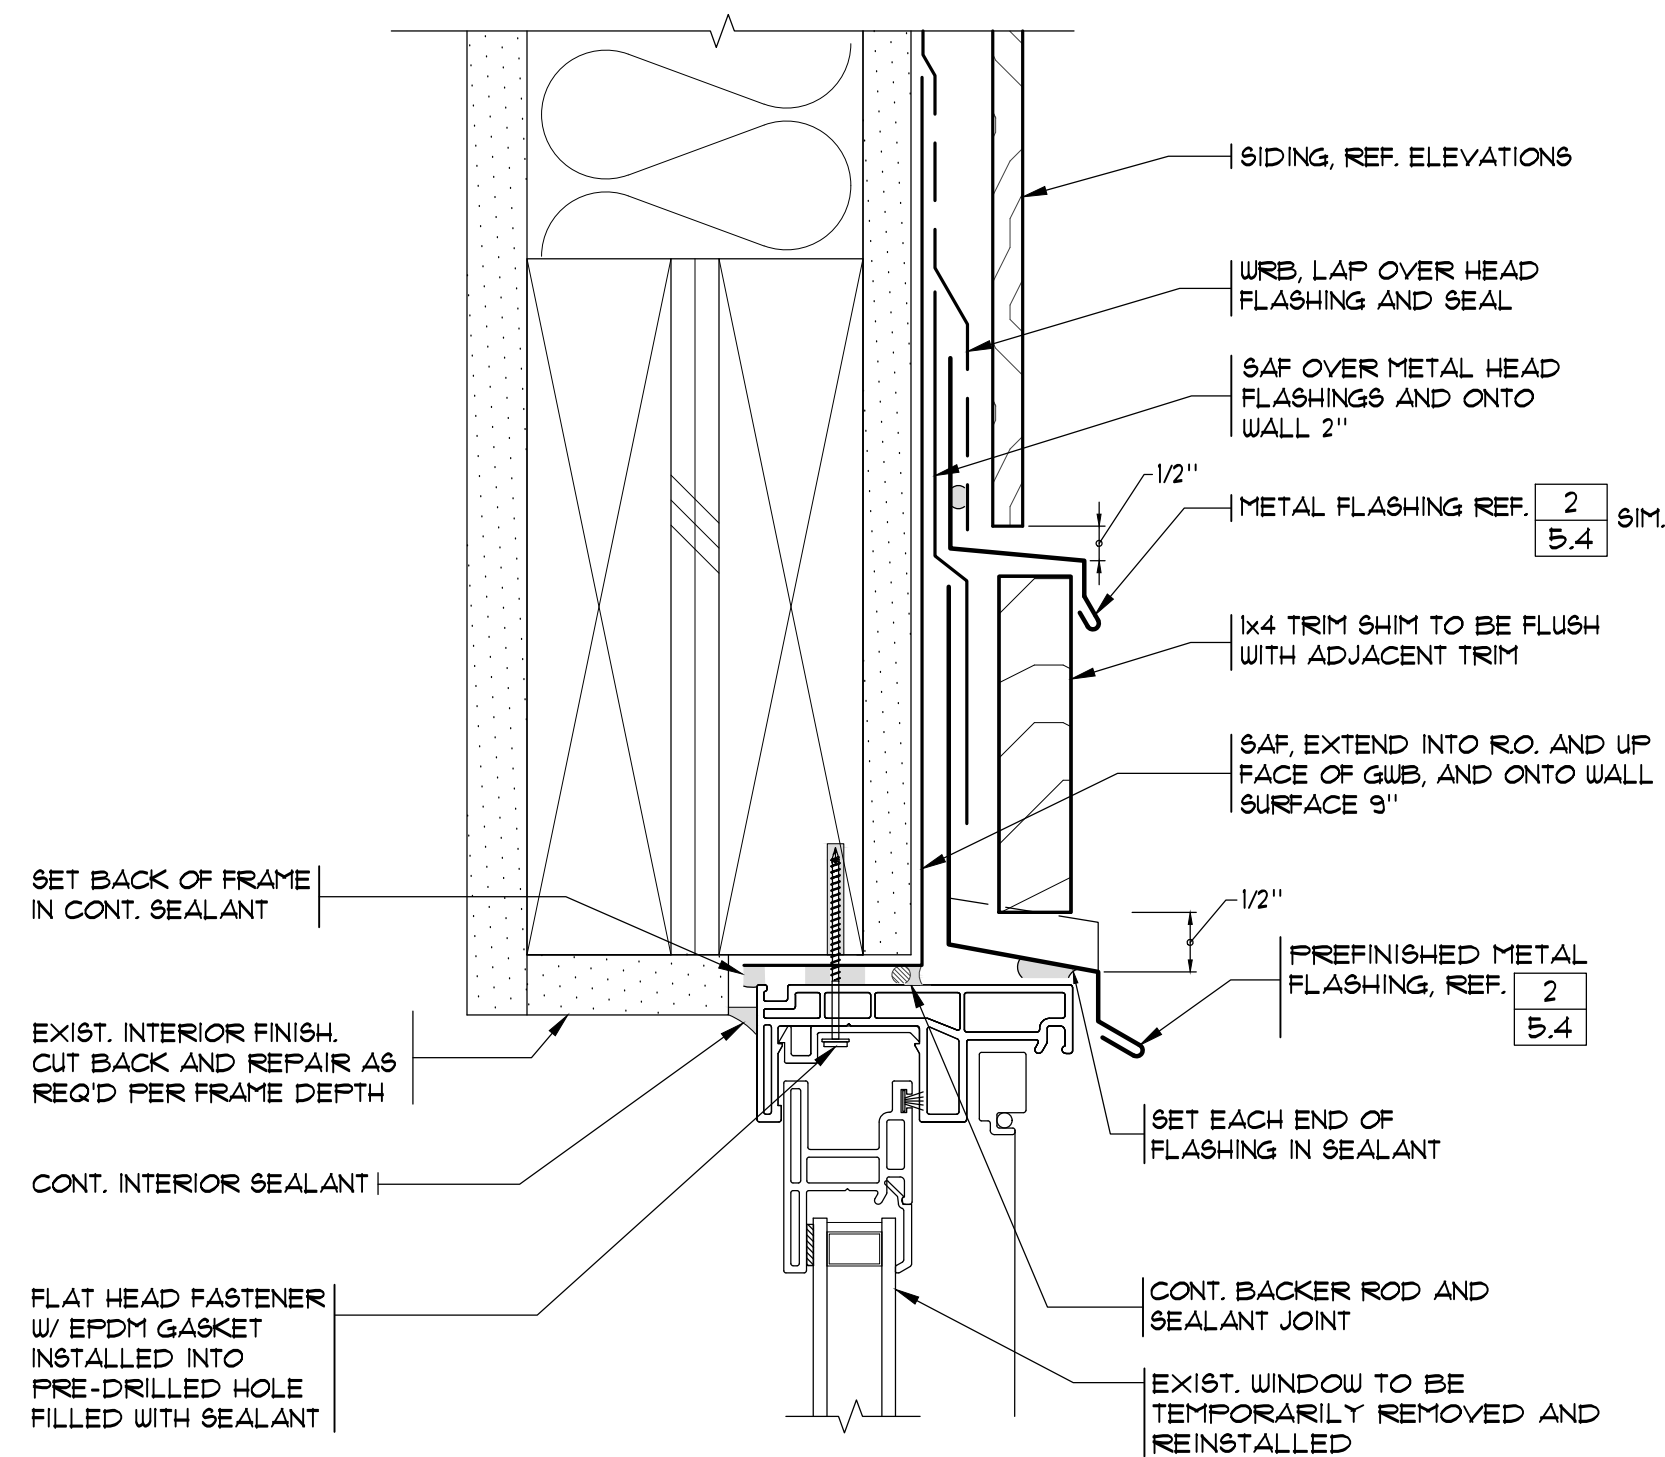
**EXIST. FLANGELESS WINDOW HEAD** 4  
SCALE: 6" = 1'-0"

NOTE:  
FOR ADDITIONAL INFORMATION,  
REF. 1, 5.4, 61M
