# PROJECT MANUAL

**Siding & Exterior Trim Replacement  
Carriage House Apartments – Building E**

**Contract Number: AW2601831**

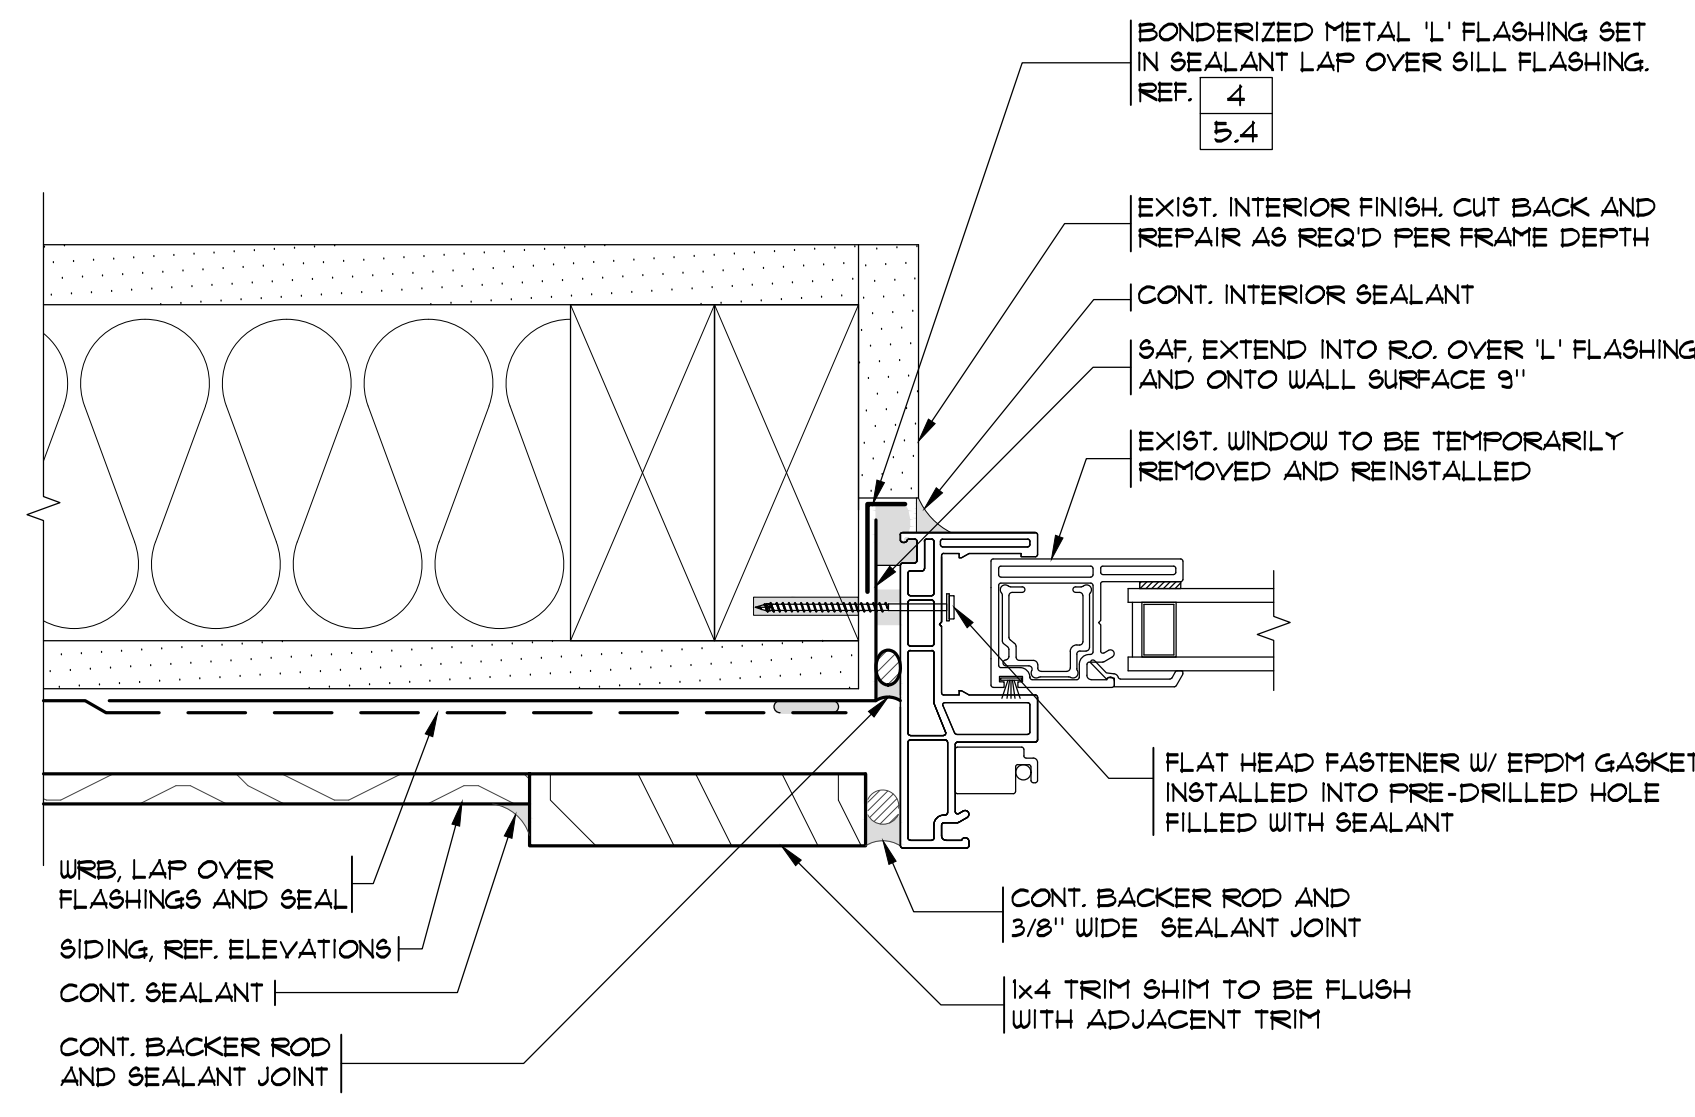
**EXIST. FLANGELESS WINDOW SILL** 5  
SCALE: 6" = 1'-0"

NOTE:  
1. DO NOT INSTALL FASTENERS THROUGH SILL.  
2. CLEAN FRAME AND SEAL ANY EXISTING FASTENER HOLES IN FRAME SILL WITH SILICONE SEALANT.  
3. FOR ADDITIONAL INFORMATION, REF. 1, 5.4, 61M.

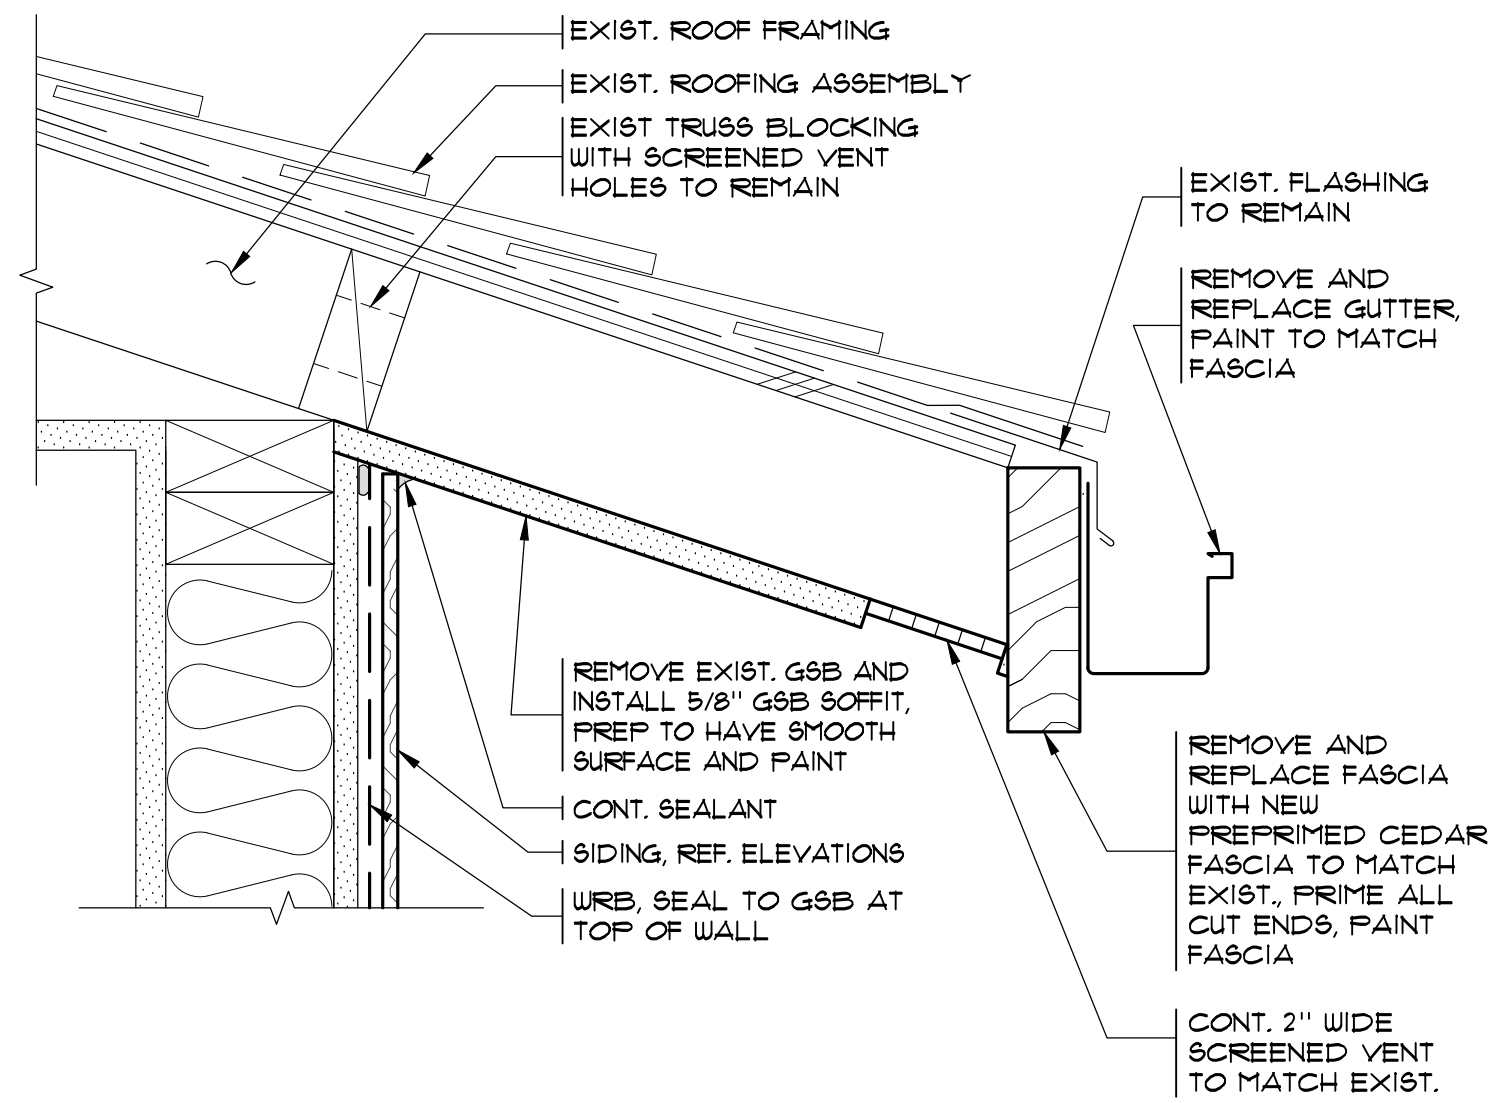
**TYPICAL SOFFIT AT EAVE** 1  
SCALE: 3" = 1'-0"

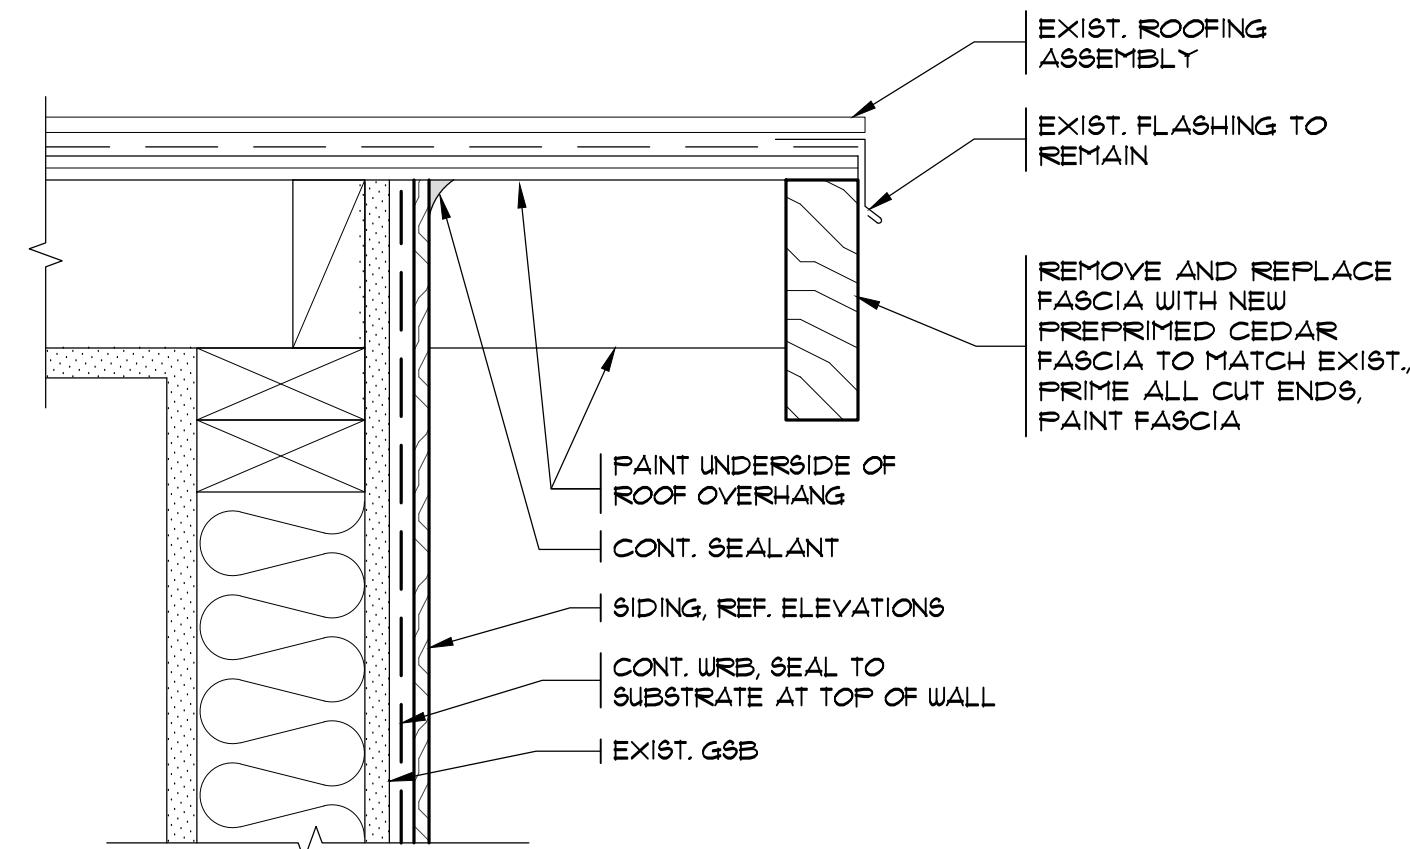
**TYPICAL RAKE TO WALL** 2  
SCALE: 3" = 1'-0"

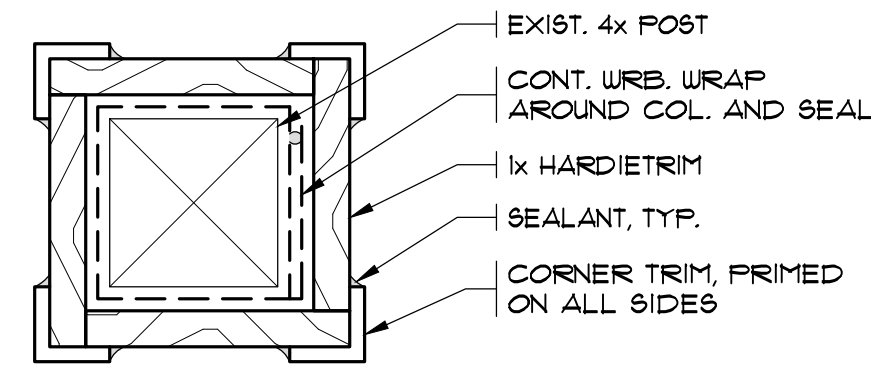
**TYPICAL POST** 3  
SCALE: 3" = 1'-0"

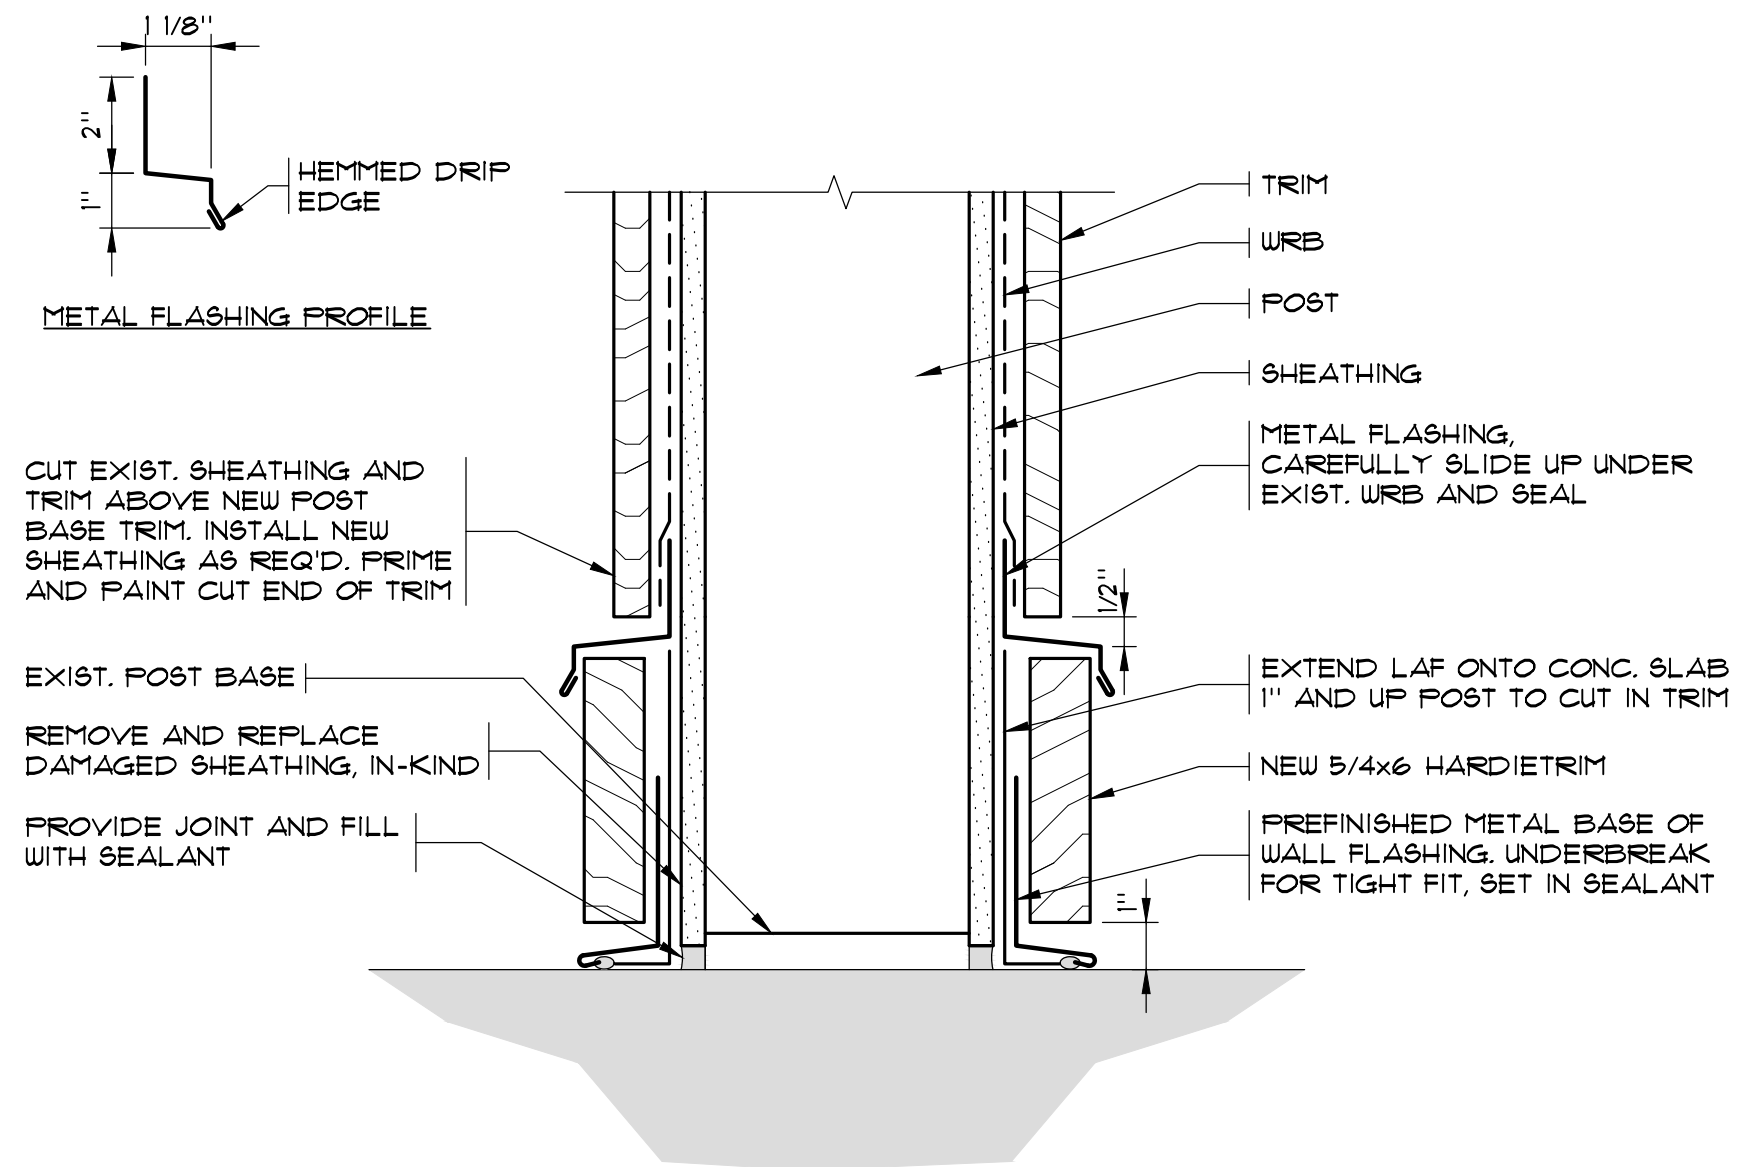
**TYP. POST BASE FLASHING** 4  
SCALE: 3" = 1'-0"

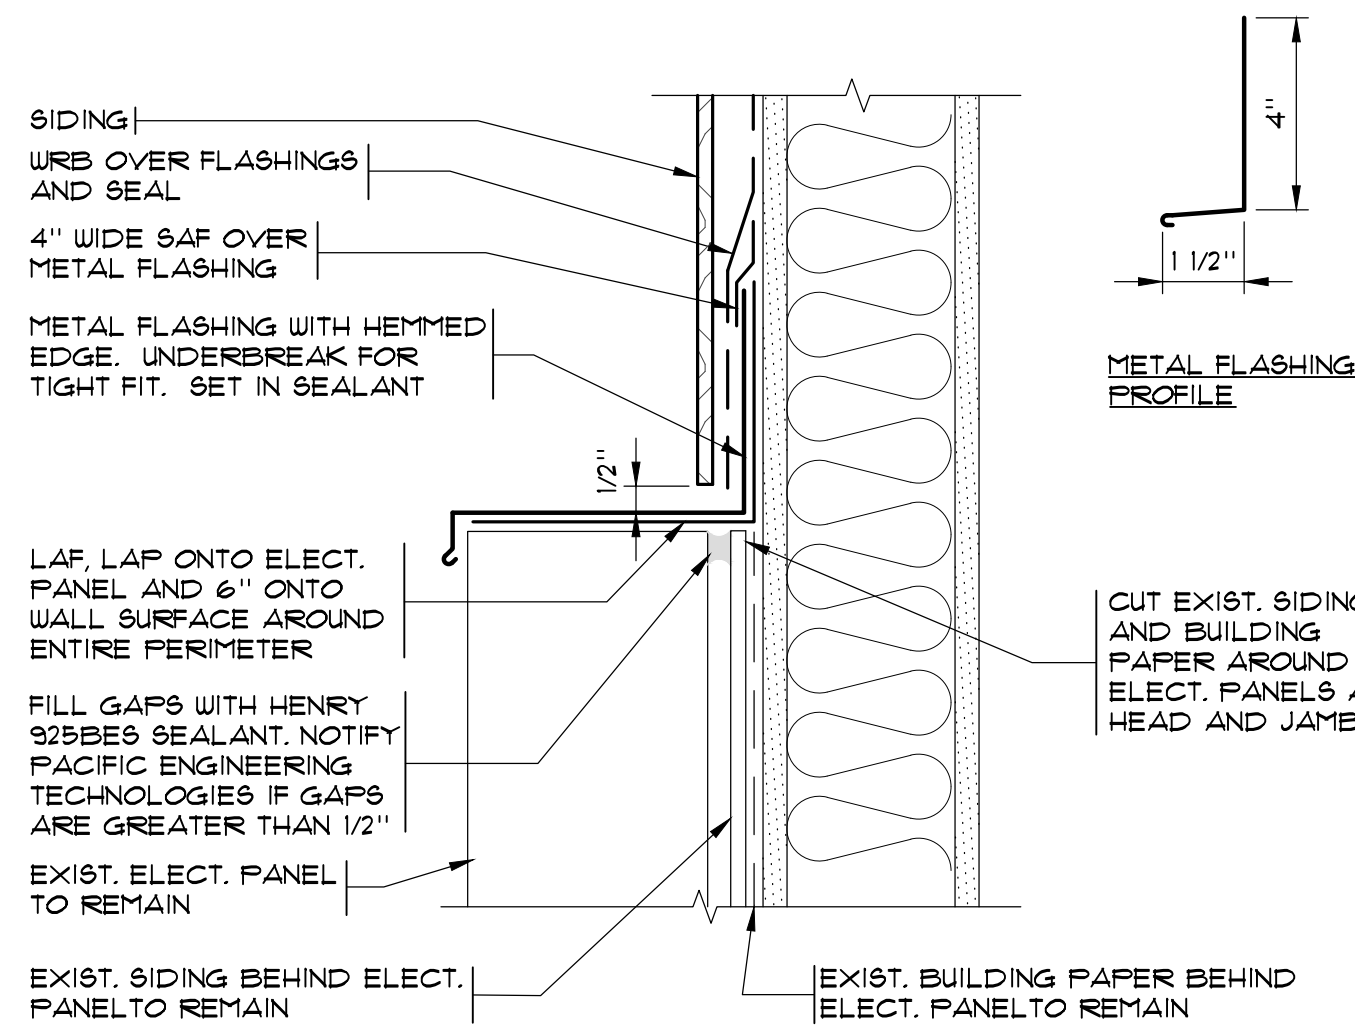
**TYP. ELECTRICAL PANEL HEAD** 5  
SCALE: 3" = 1'-0"

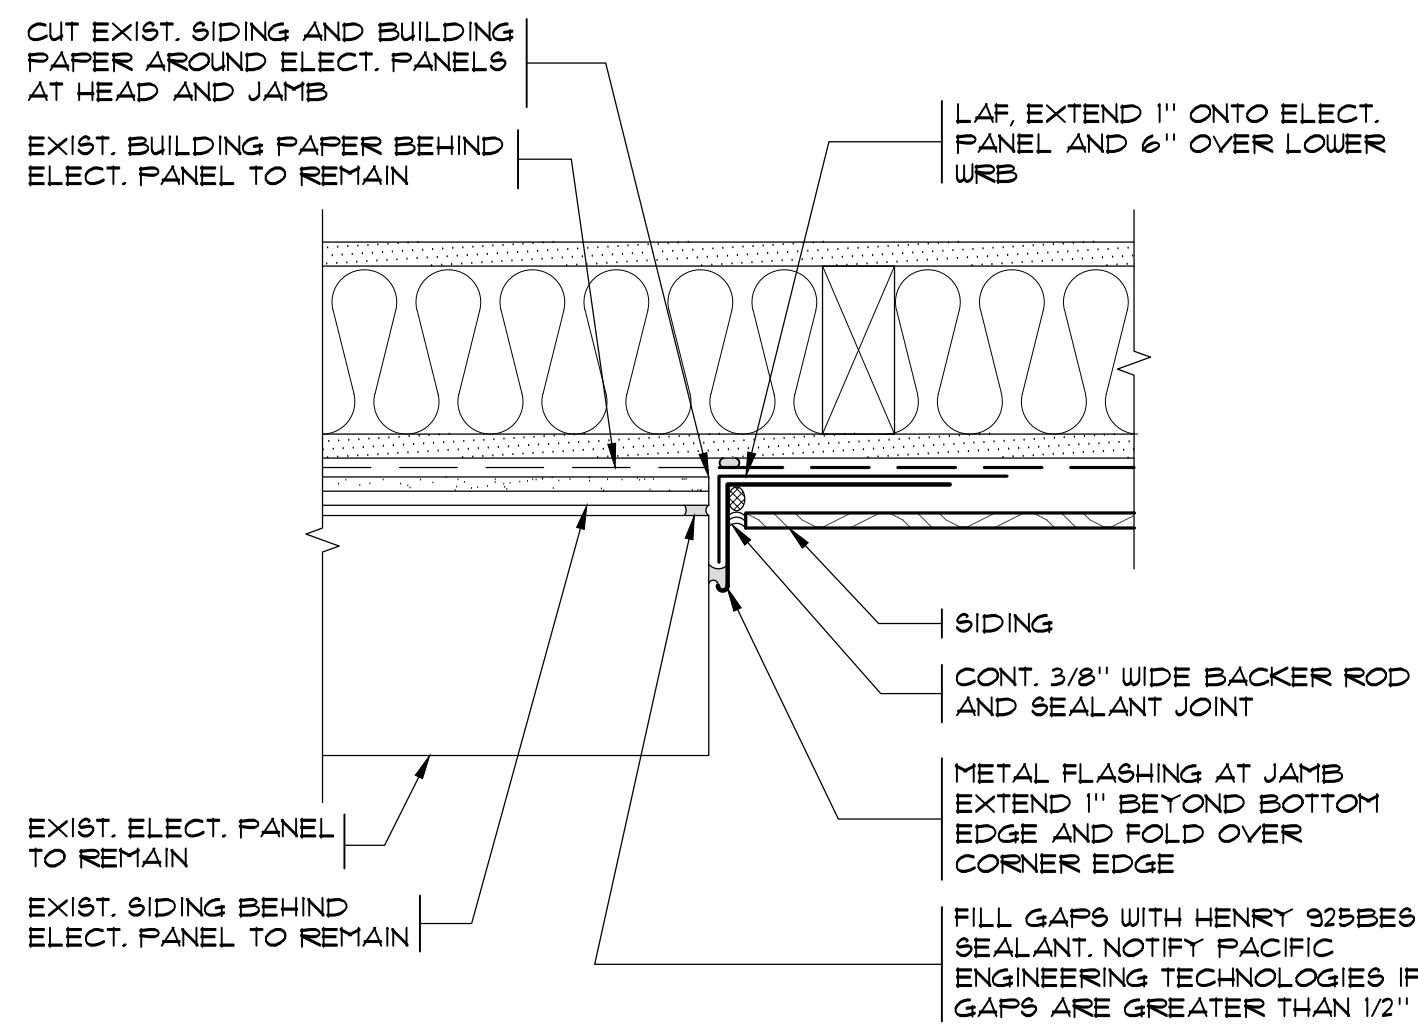
**TYP. ELECTRICAL PANEL JAMB** 6  
SCALE: 3" = 1'-0"

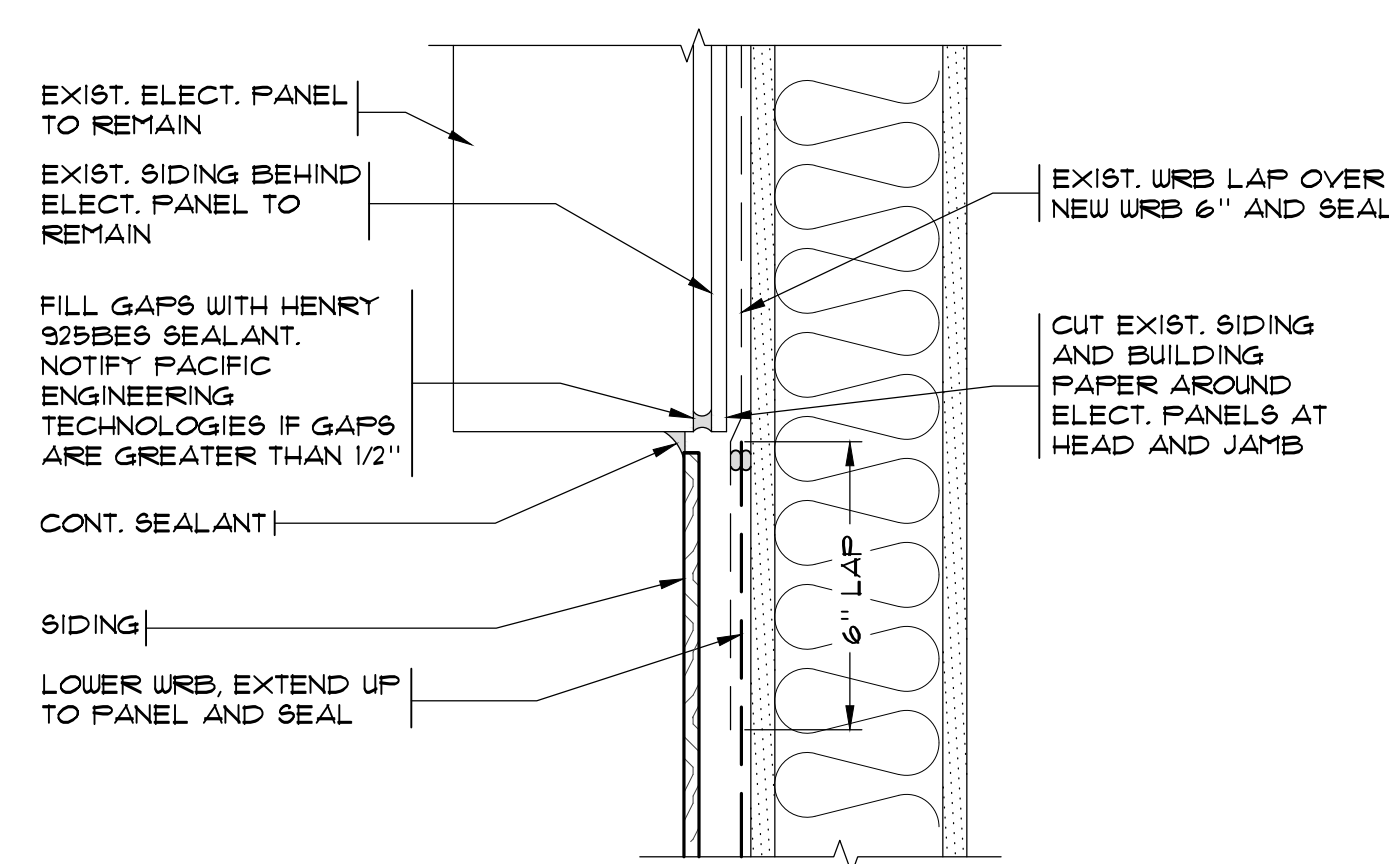
**TYP. ELECTRICAL PANEL SILL** 7  
SCALE: 3" = 1'-0"

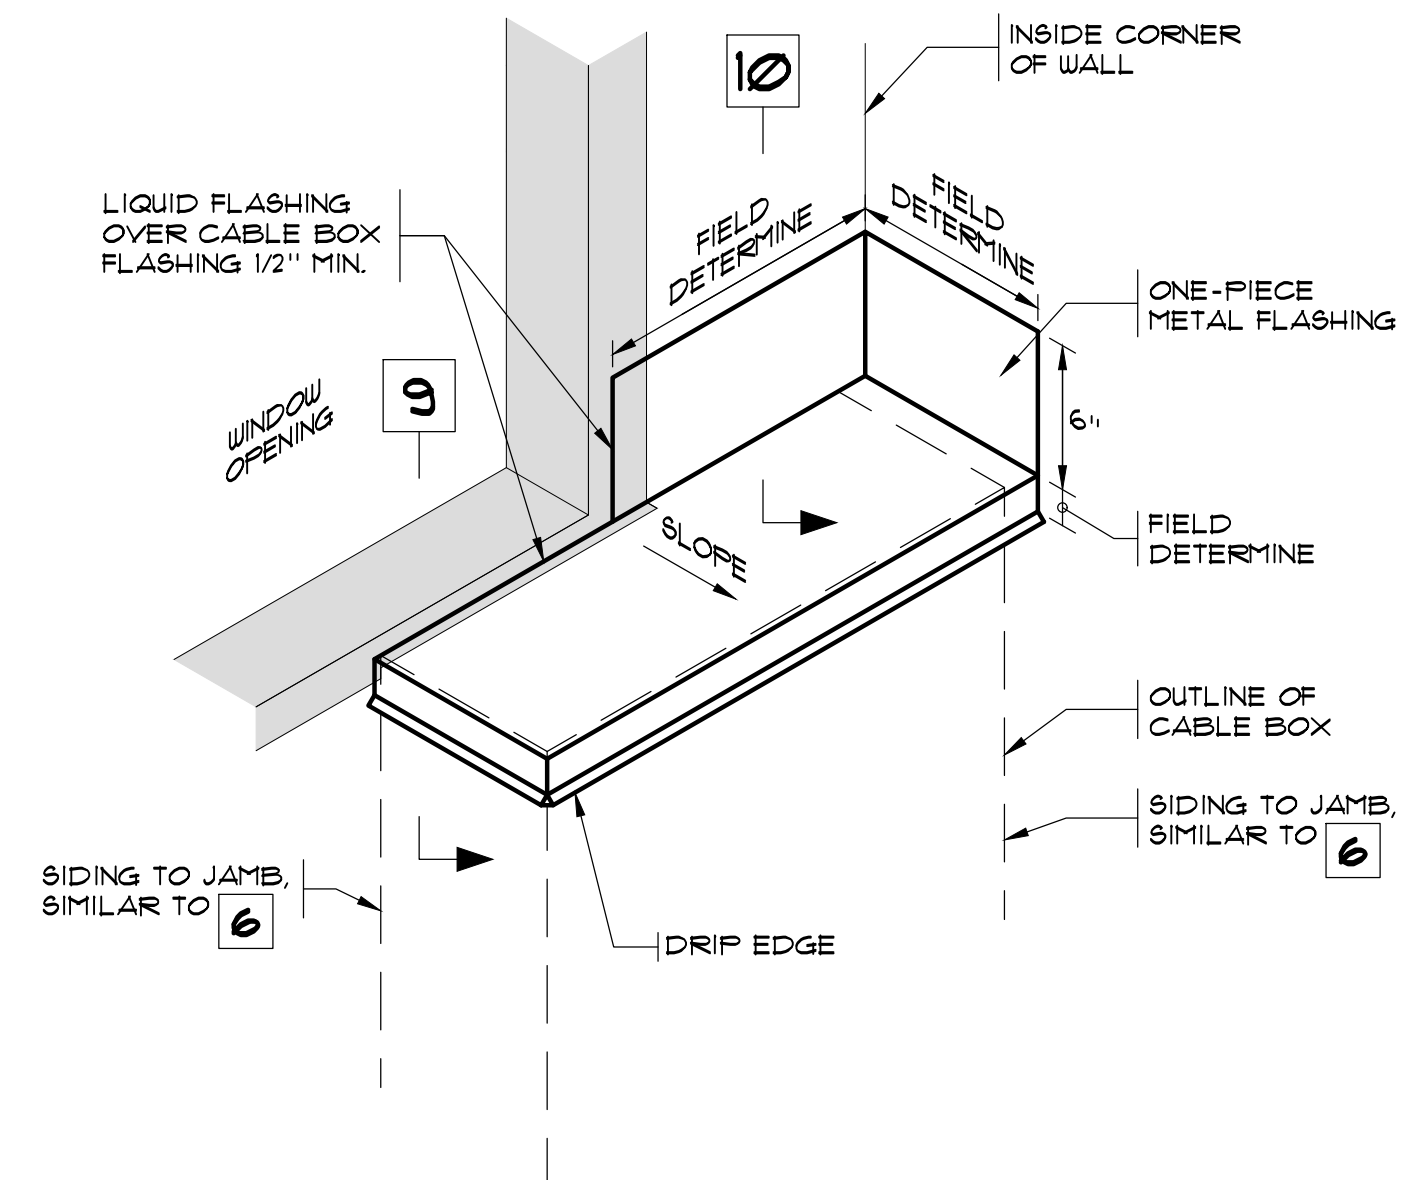
**CABLE BOX METAL COPING** 8  
SCALE: N.T.S.

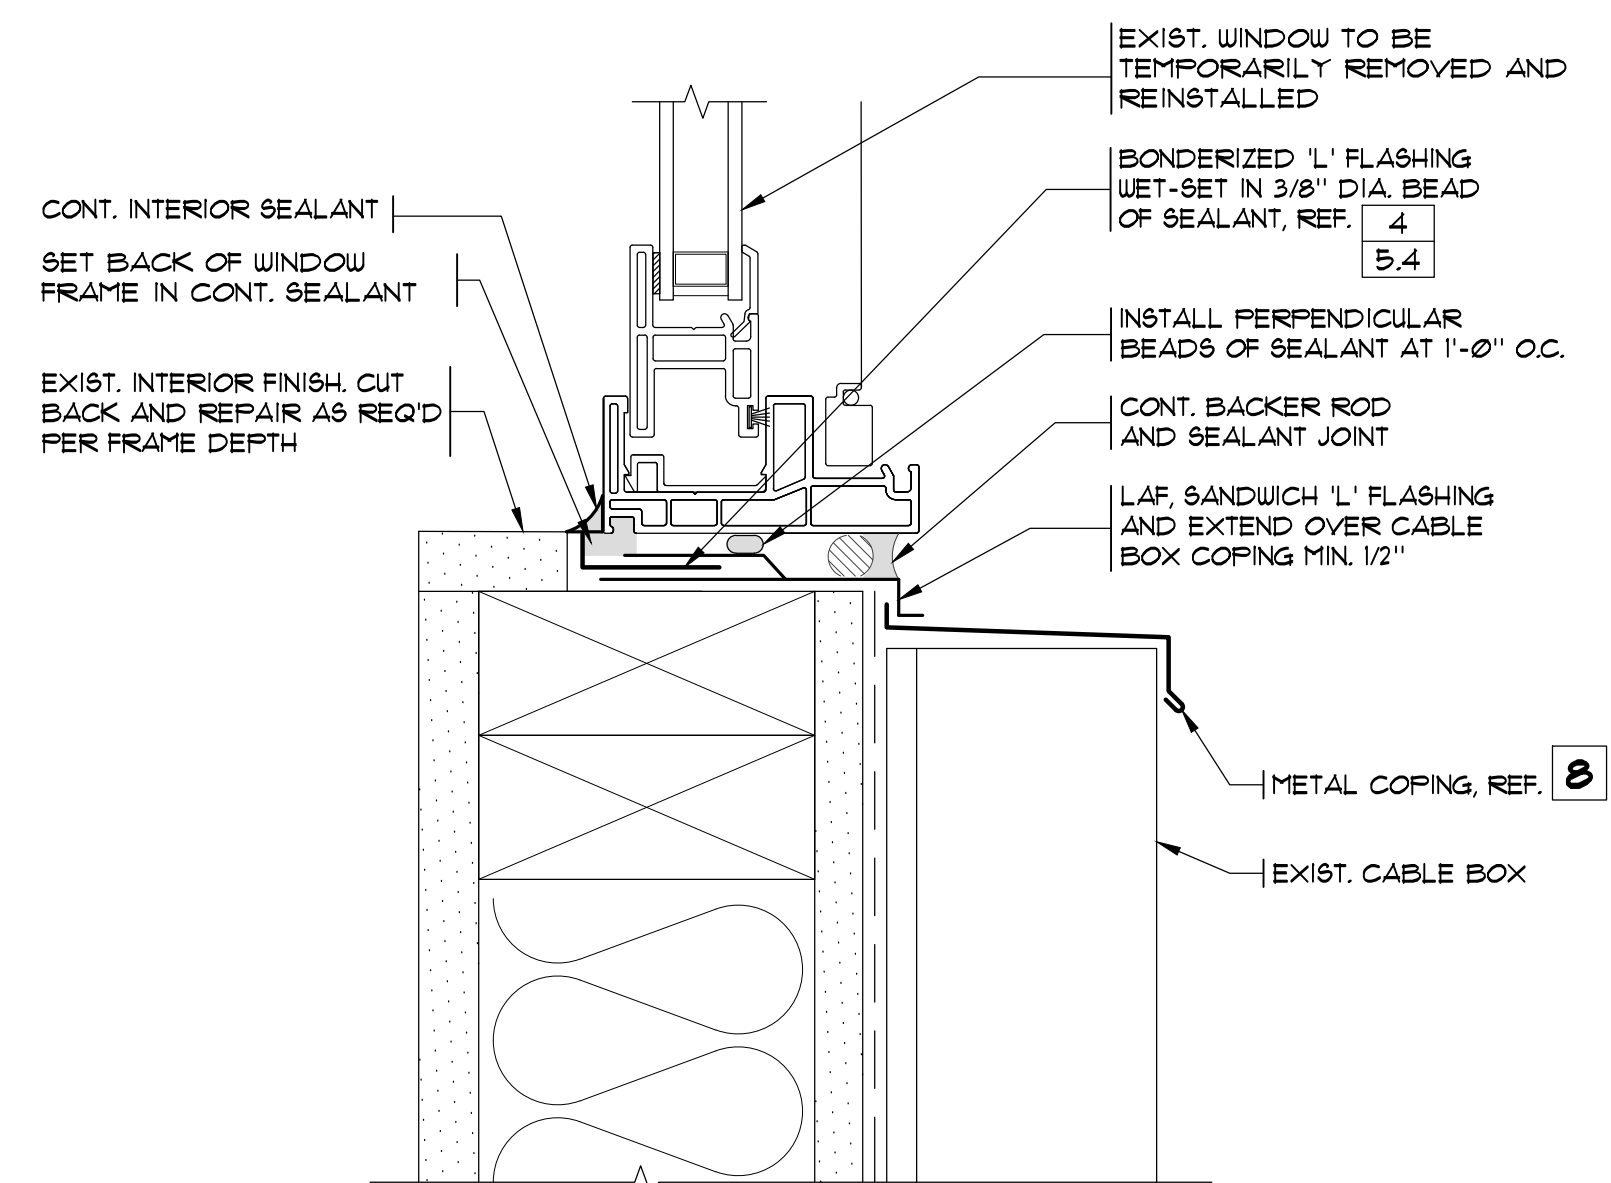
**WINDOW SILL AT CABLE BOX** 9  
SCALE: 6" = 1'-0"

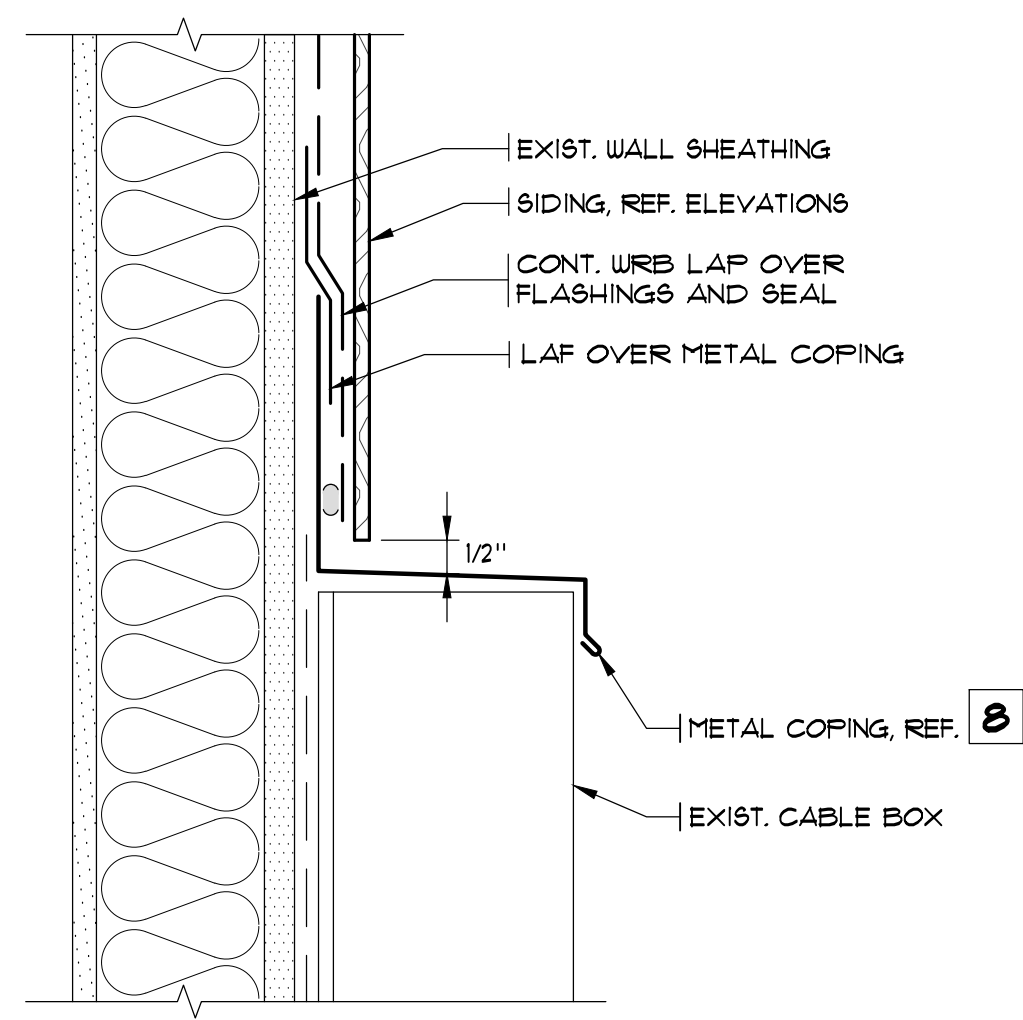
**CABLE BOX HEAD AT SIDING** 10  
SCALE: 6" = 1'-0"

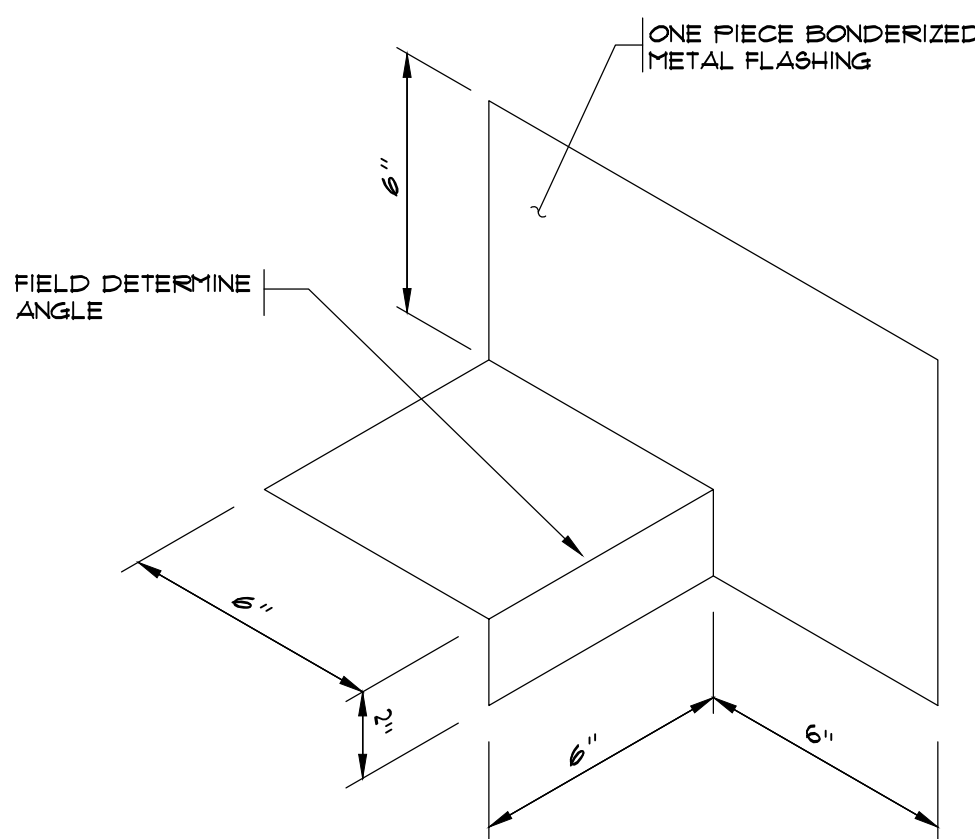
1. SADDLE FLASHING TO BE INSTALLED FIRST  
PRIOR TO OTHER DECK SURFACE FLASHINGS.
2. REF. MATERIAL SPECIFICATION FOR  
ADDITIONAL INFORMATION
3. PLACE FLASHING OVER TARGET FLASHING  
STRIPS (WRB)

### DECK SADDLE CORNER FLASHING 2

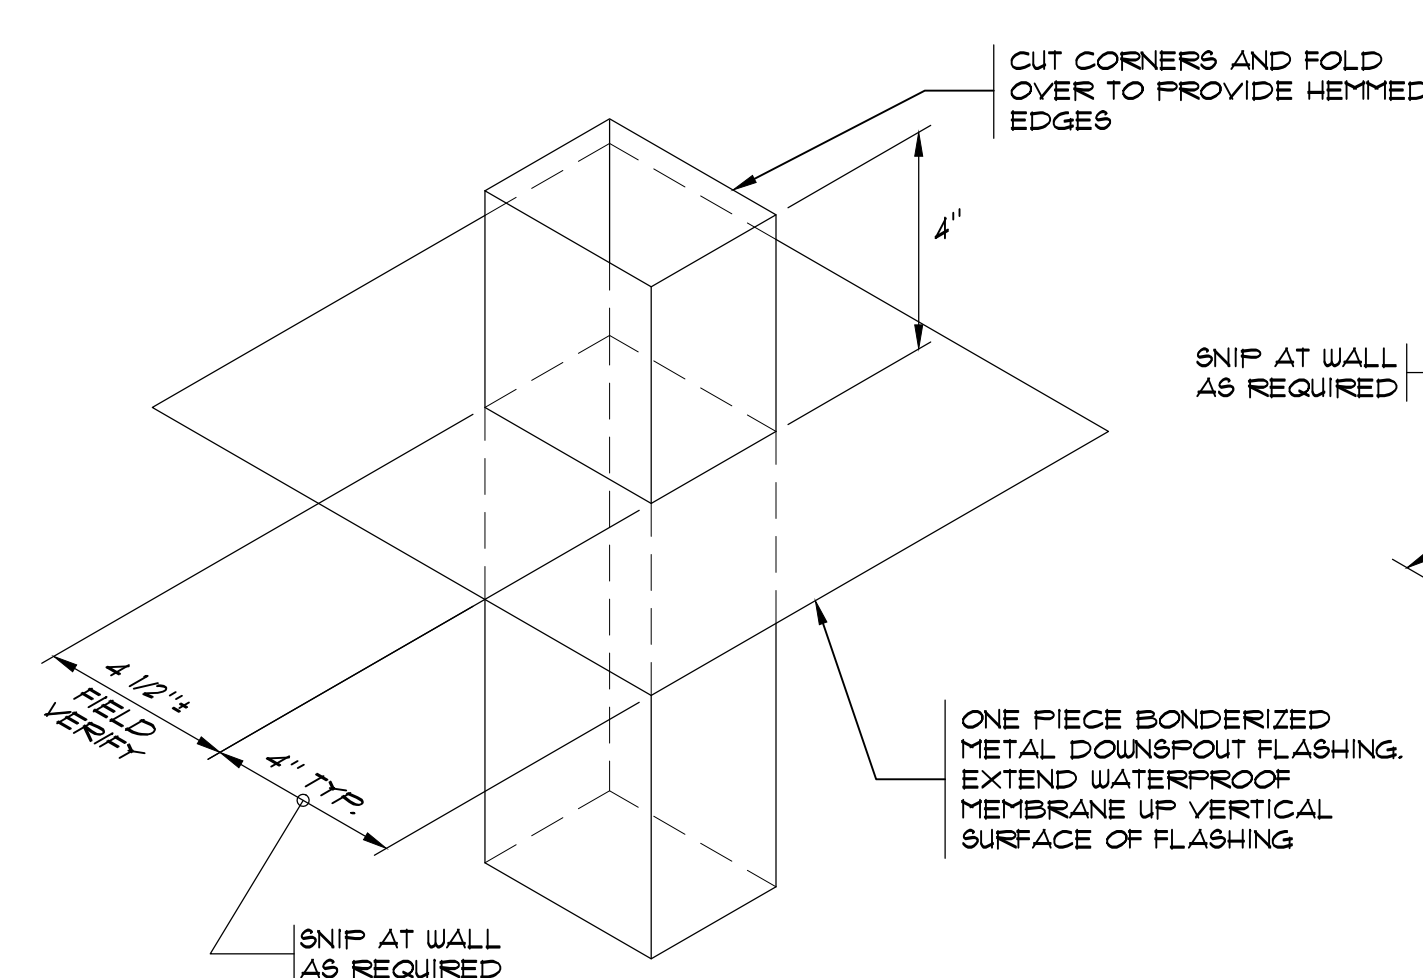
PIECE 'A'

CUT CORNERS AND FOLD  
OVER TO PROVIDE HEMMED  
EDGES

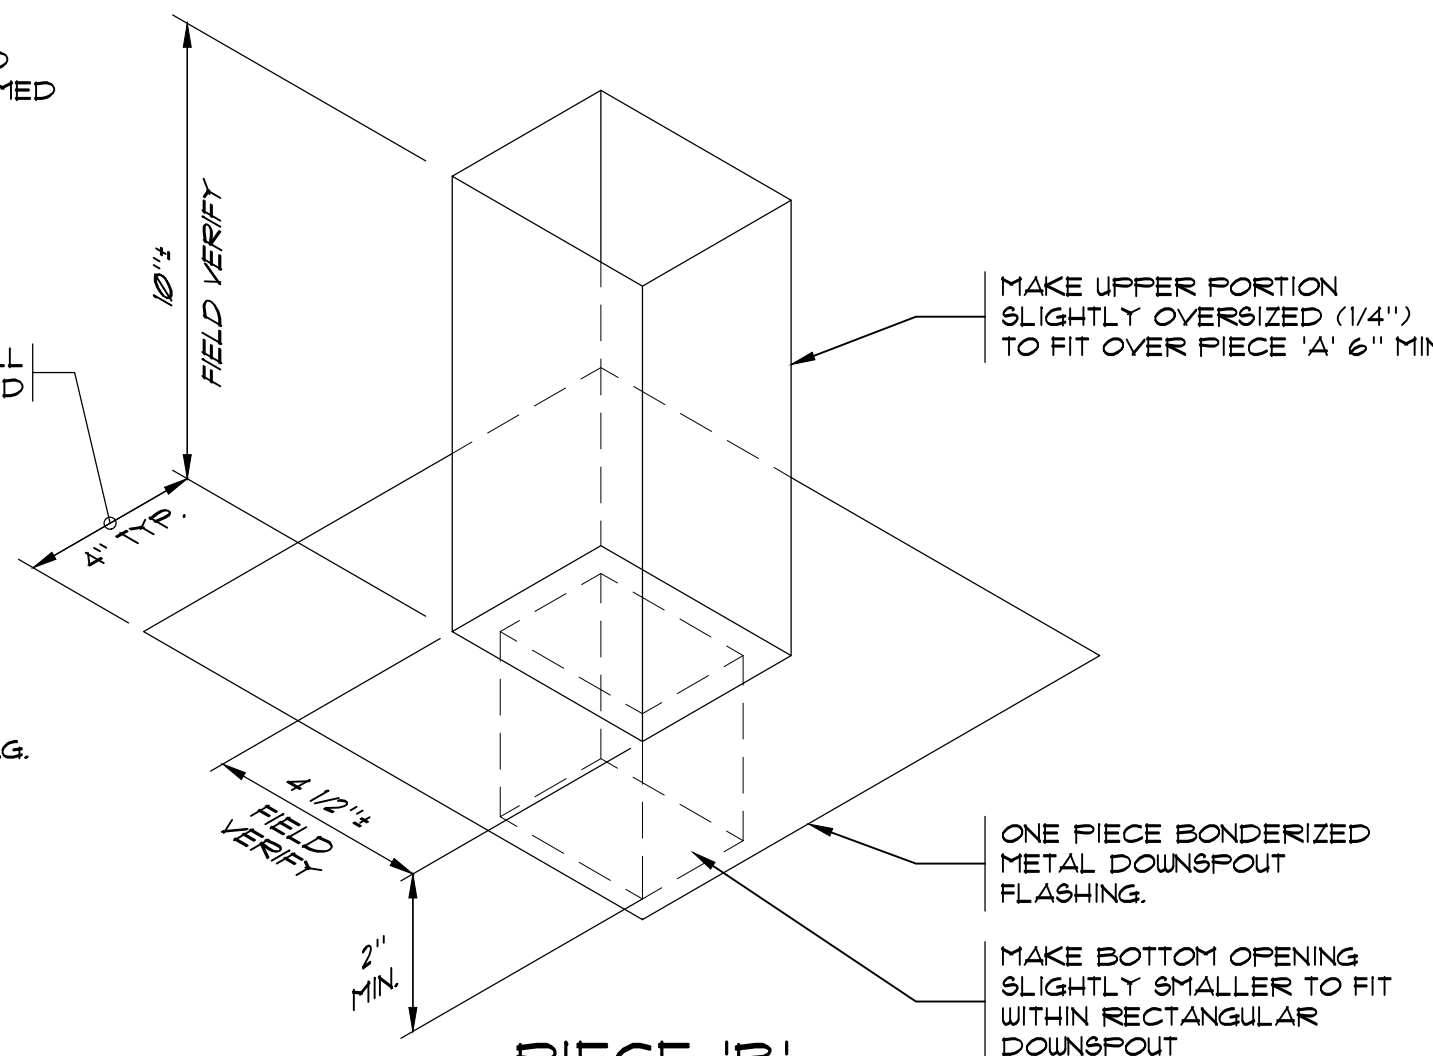
PIECE 'B'

MAKE UPPER PORTION  
SLIGHTLY OVERSIZED (1/4")  
TO FIT OVER PIECE 'A' 6" MIN.
