# PROJECT MANUAL

**Siding & Exterior Trim Replacement  
Carriage House Apartments – Building E**

**Contract Number: AW2601831**

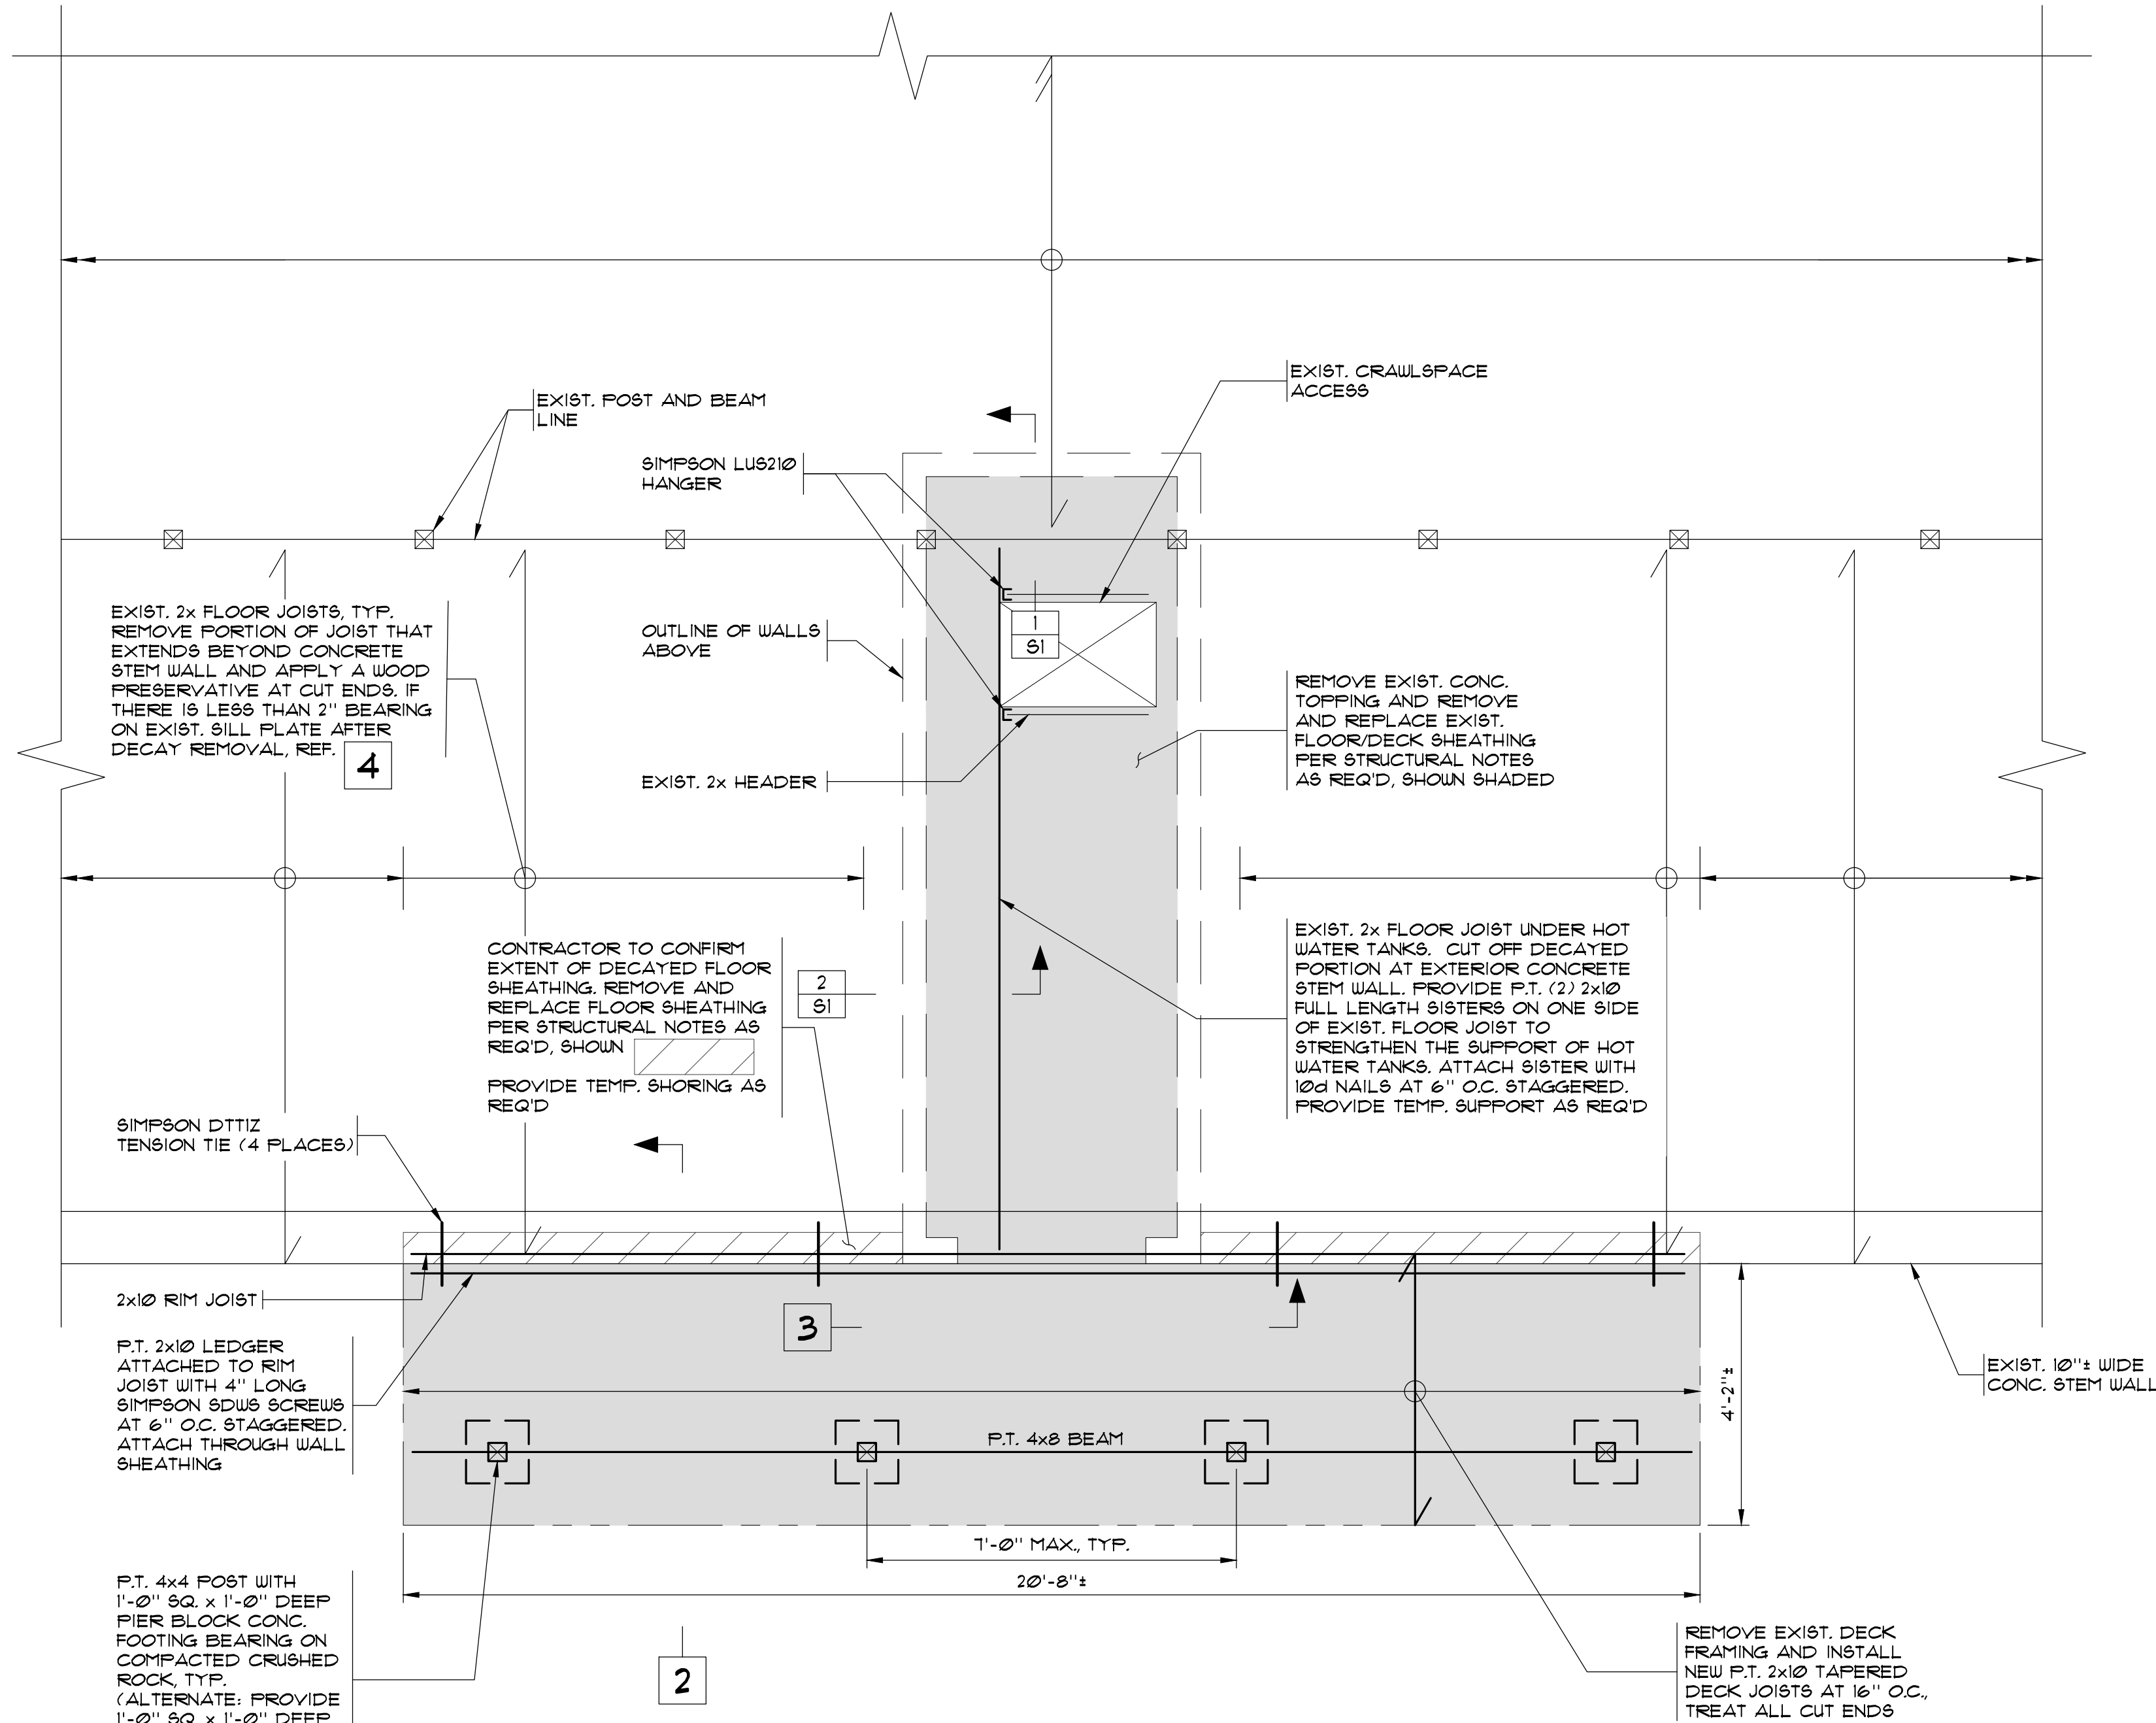
**OPTION A**  
**TYP. FIRST FLOOR ELECTRICAL ROOM/DECK REPAIR PLAN**  
 SCALE: 1/2" = 1'-0"

NOTE:  
 PROVIDE TEMP. SUPPORT  
 AS REQ'D TO PREVENT  
 MOVEMENT/SETTLING

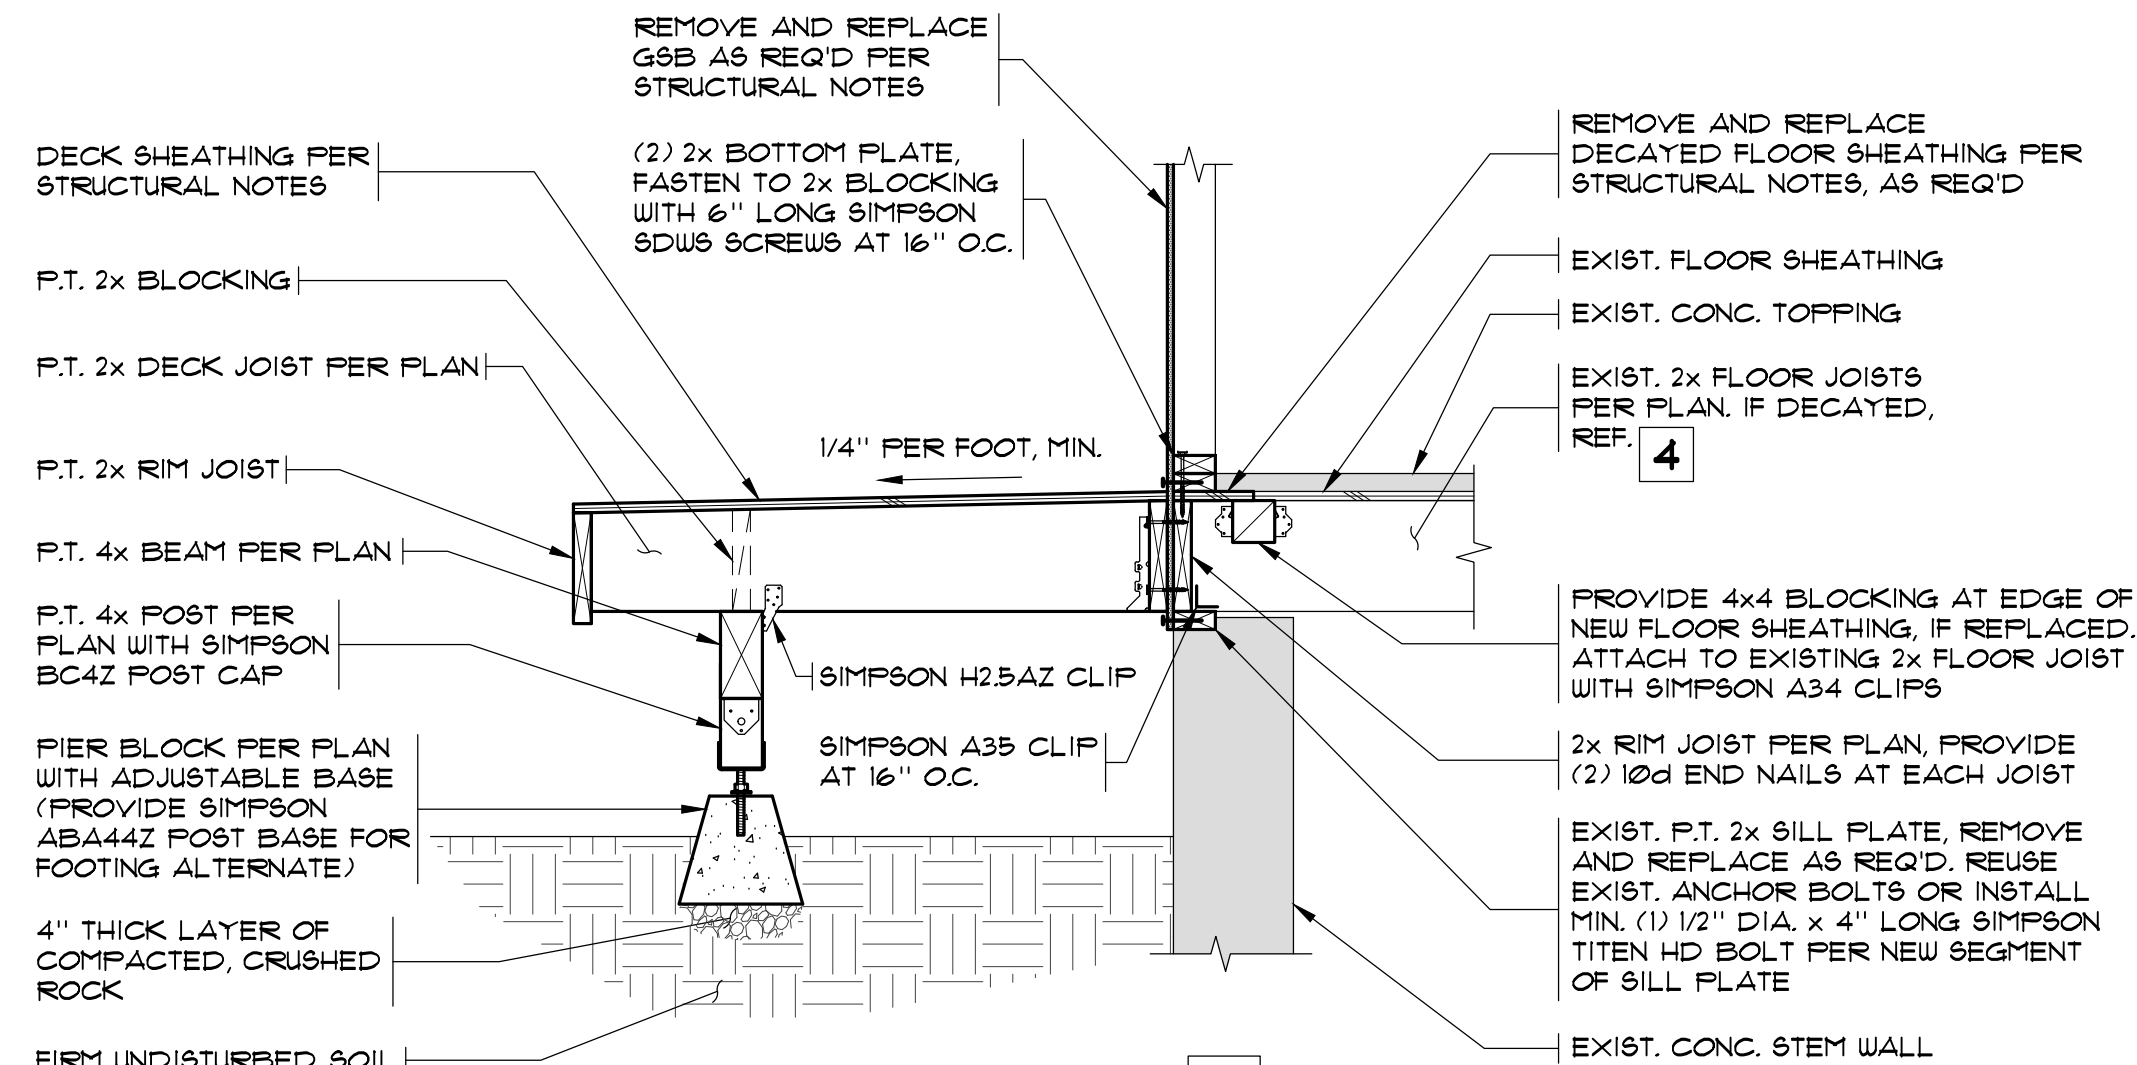
**SECTION 2**  
 SCALE: 3/4" = 1'-0"

NOTE:  
 REINSTALL OR REPLACE WALL  
 AND FLOOR INSULATION AS  
 REQ'D, NOT SHOWN FOR CLARITY

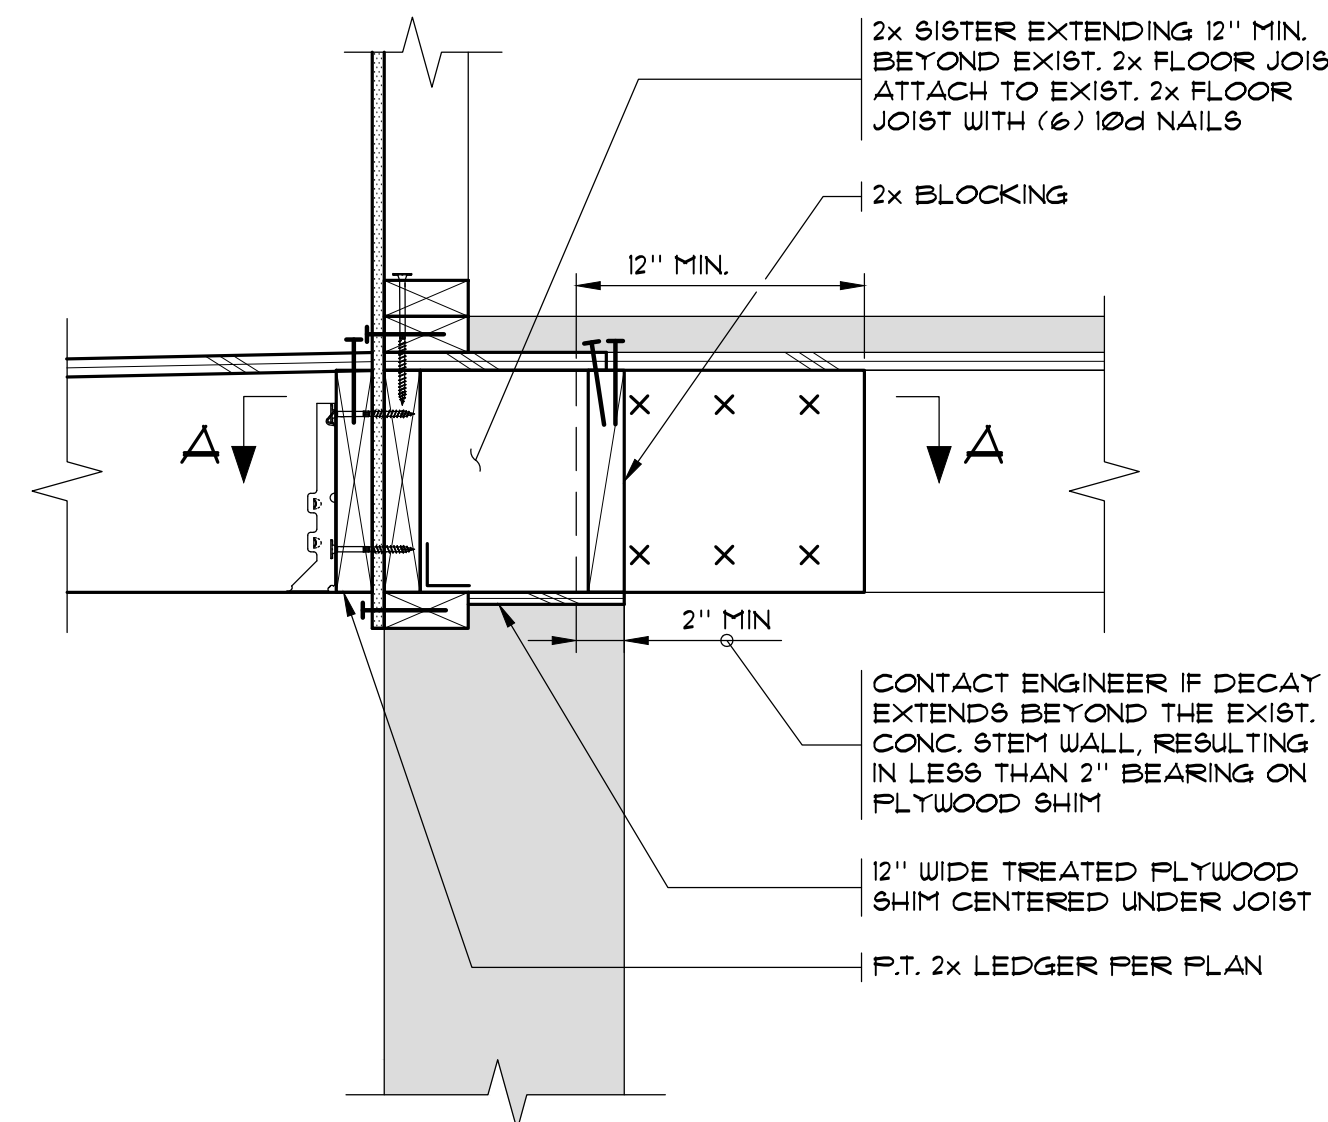
**SECTION 4**  
 SCALE: 1/2" = 1'-0"

NOTE:  
 FOR ADDITIONAL INFORMATION  
 NOT SHOWN, REF. 2

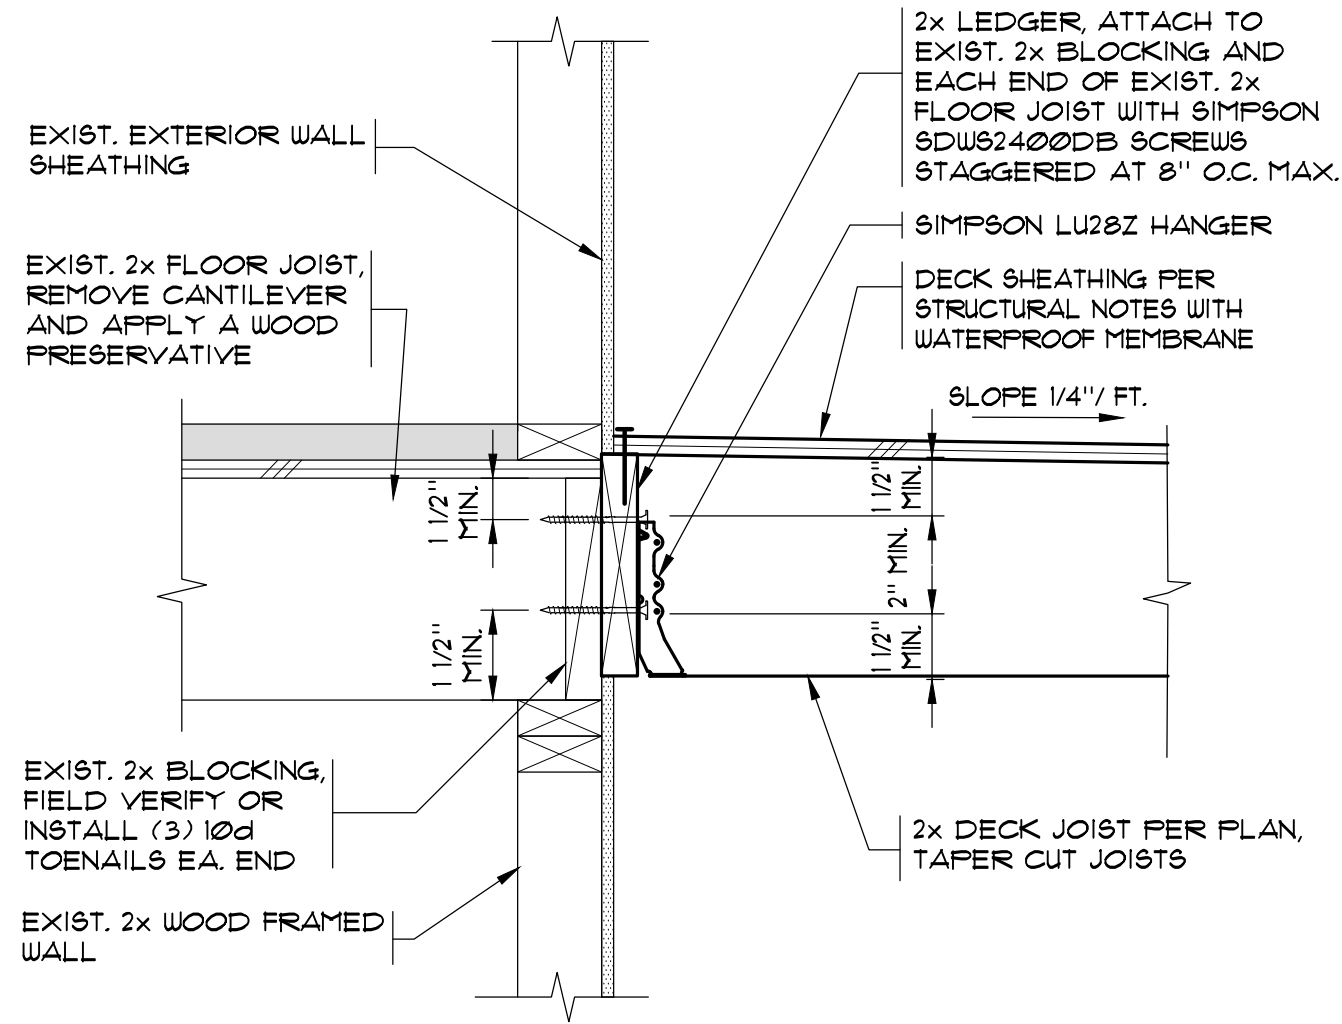
**SECTION 1**  
SCALE: 1 1/2" = 1'-0"

NOTE:  
FOR ADDITIONAL INFORMATION  
NOT SHOWN, REF. **6**  
**A5.8**

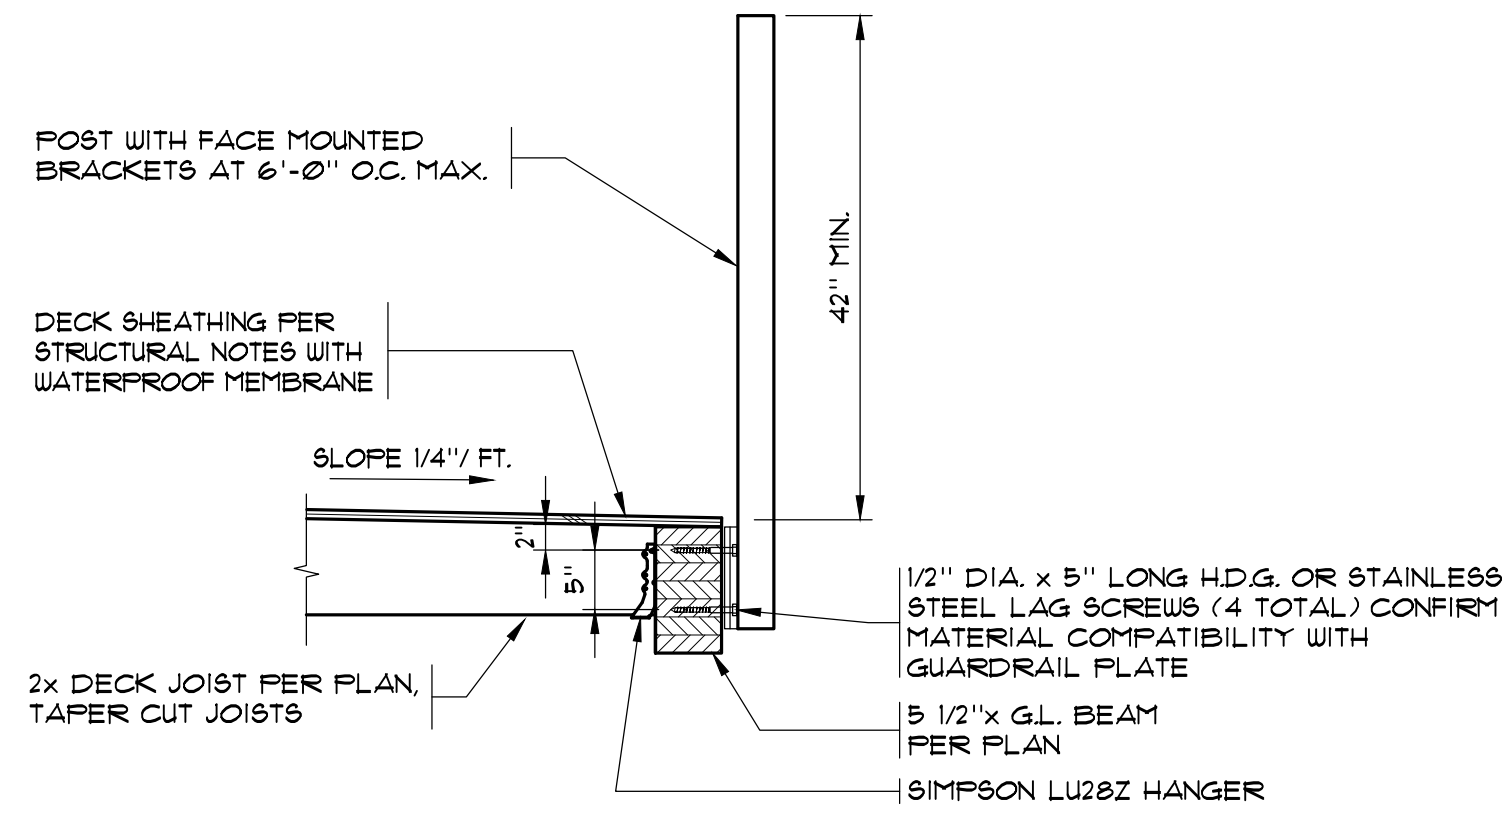
**SECTION 2**  
SCALE: 3/4" = 1'-0"

NOTE:  
FOR ADDITIONAL INFORMATION  
NOT SHOWN, REF. **3**  
**A5.8**

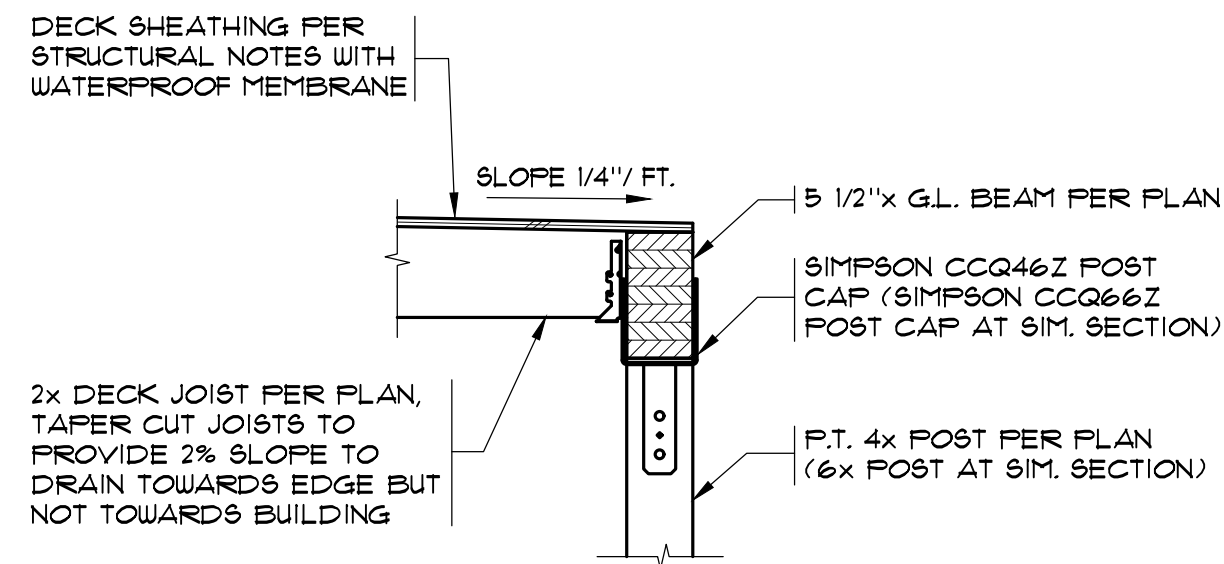
**SECTION 4**  
SCALE: 3/4" = 1'-0"

NOTES:  
1. PROVIDE SOFFIT TO MATCH EXISTING, NOT SHOWN FOR CLARITY.  
2. GUARDRAIL NOT SHOWN FOR CLARITY, FOR ADDITIONAL INFORMATION REF. SECTION **2**

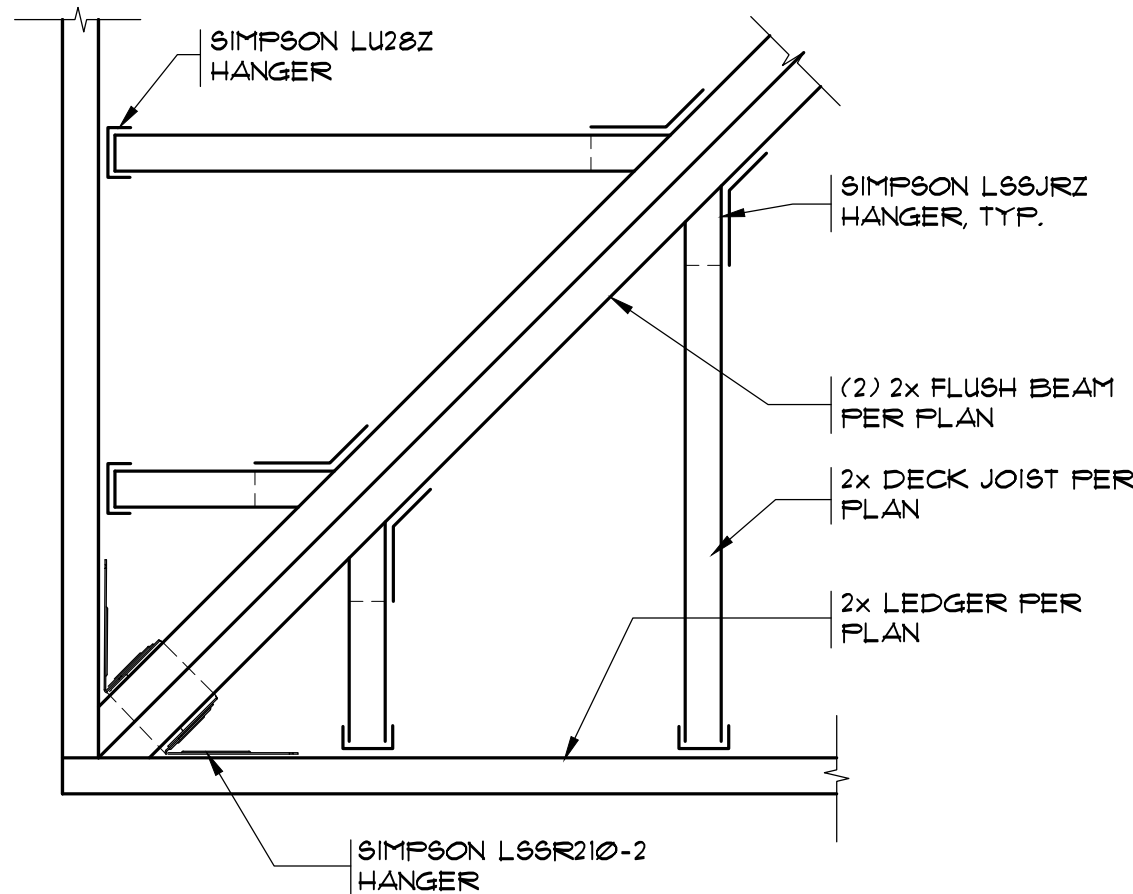
**SECTION 5**  
SCALE: 1 1/2" = 1'-0"

**PLAN VIEW**

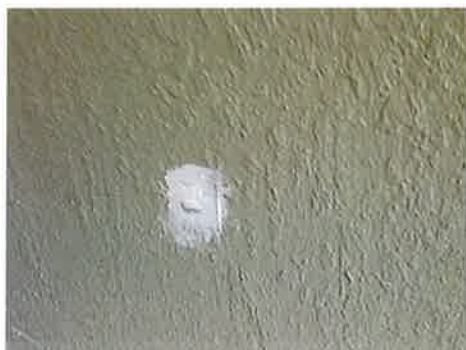
3. **Texture with paint (Friable)**

*Sample number: 2016-0206-(A/B/C/D/E)-1-29 thru 1-33*

There is a total of approximately 17,500 square feet (3500 square feet per bldg.) of asbestos containing texture with paint associated with the GWB walls/ceilings of the mailbox room and all the exterior hallways (by the unit's entrances) of bldg. A thru bldg. E.
