KING COUNTY HOUSING AUTHORITY  
LEAD-BASED PAINT TESTING REPORT

PROJECT NO: WA2-08

AVONDALE MANOR

## LEAD IN PAINT TEST RESULTS

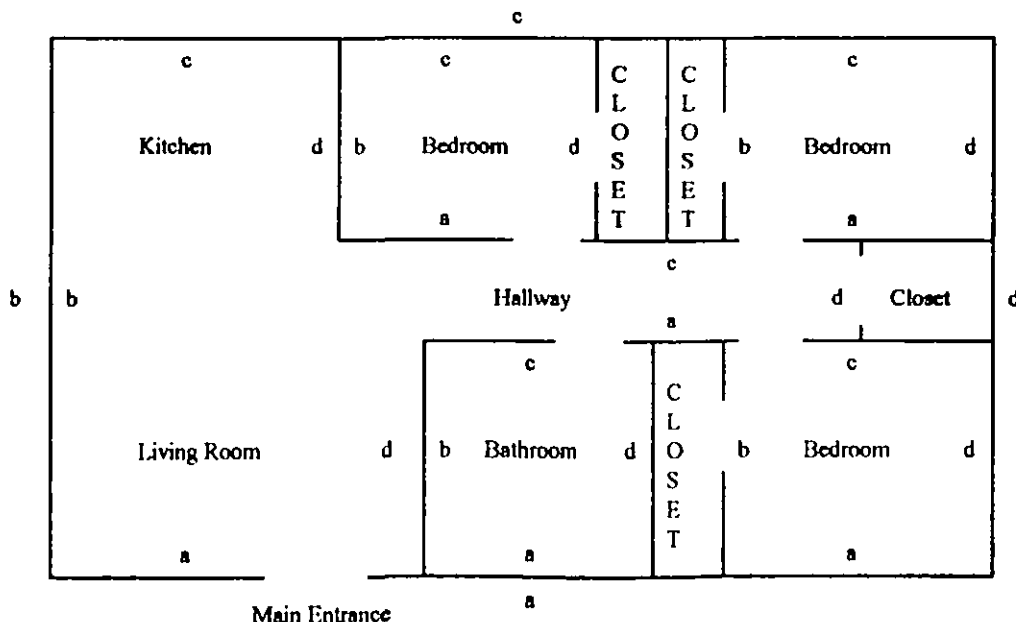
*Detail Reporting System:* Room locations are given only if there are two or more of a particular type. The most common are bedrooms and bathrooms. A code of up to three letters can be used to locate the room. The simplest example would be a three bedroom, single story unit as shown below. In the detail report these bedrooms would have locations of "FR" (front right), "RR" (rear right), and "RL" (rear left). If the unit were a multi-story, the third letter code would be added for upper and lower floors.

The main entrance of the unit is a key by which all building components are located. This eliminates the need for any reference to North/South/East/West directions, or any other point in the project or building. This main entrance wall is listed as the "A" wall in the "Side" field of the detail report. Moving clockwise to the "B, C, & D" walls, respectively. The "A" wall of each room, area, or closet is the same as the main entrance.

A building component is first located by the wall it is on, then by where it appears on the wall (left, center, right). A third code letter can be used for upper and lower, if needed. In the sample above, the hallway door casing leading to the rear left bedroom would be reported as "CL" (C wall, left) in the side field of the detail report.

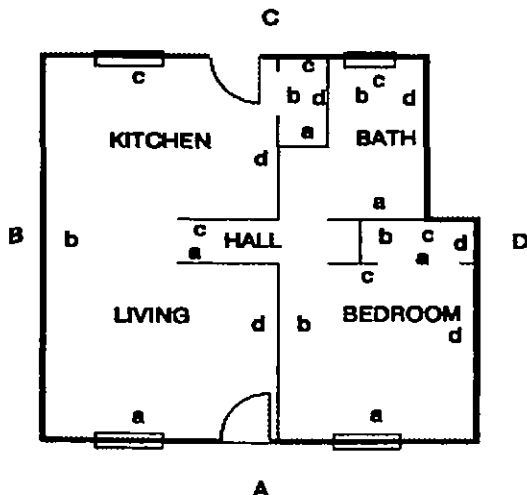
The first letter indicates the wall location within the room.

A = Front      B = Left      C = Rear      D = Right

Note: The "A" wall of the unit is the wall that contains the front, (or main entrance ) door. In each room, closet, hall, etc., the "A" wall is also the same side as the front door.

If a second or third letter appears it indicates where an item is located on the wall.

L = Left      C = Center      R = Right      U = Upper      D = Lower

Example: The bedroom of the sample unit has 2 doors, both located on the "C" wall. The left is to the hallway and the right is to the closet. The hallway door was analyzed and is reported as "CL".
