KING COUNTY  
HOUSING AUTHORITY  
NIKE MANOR ROOF REPLACEMENT

NIKE MANOR  
35xx S. 240TH ST.  
KENT WA 98032

A1.0

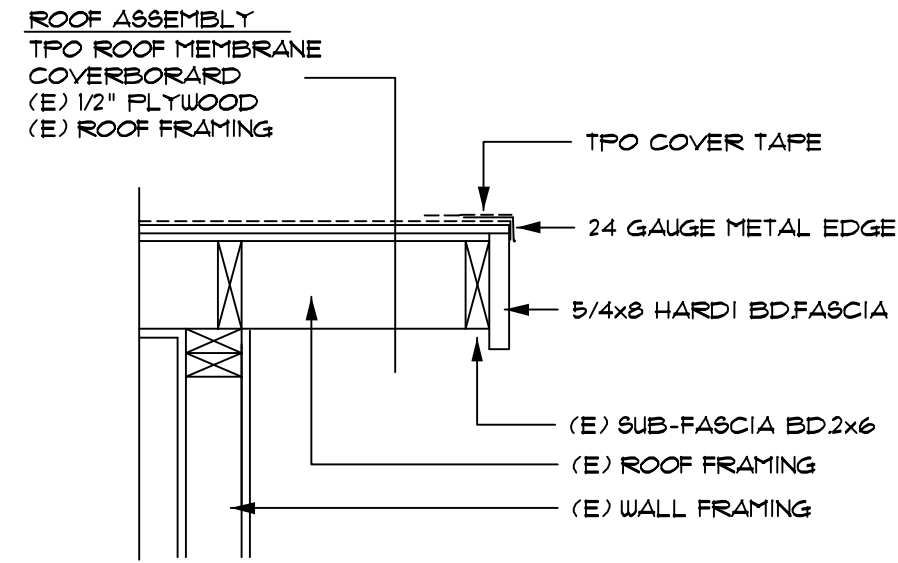
AA  
AI

RAKE-FASCIA BD. TYP.

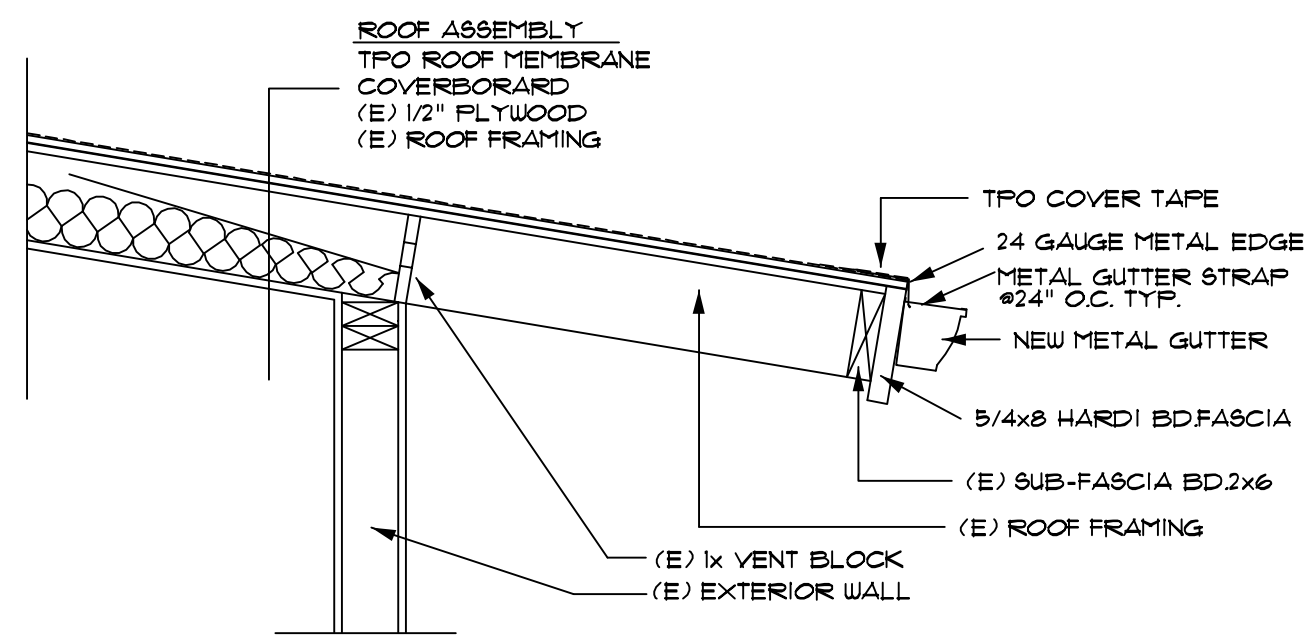
BB  
AI

EAVE CONDITION TYP.

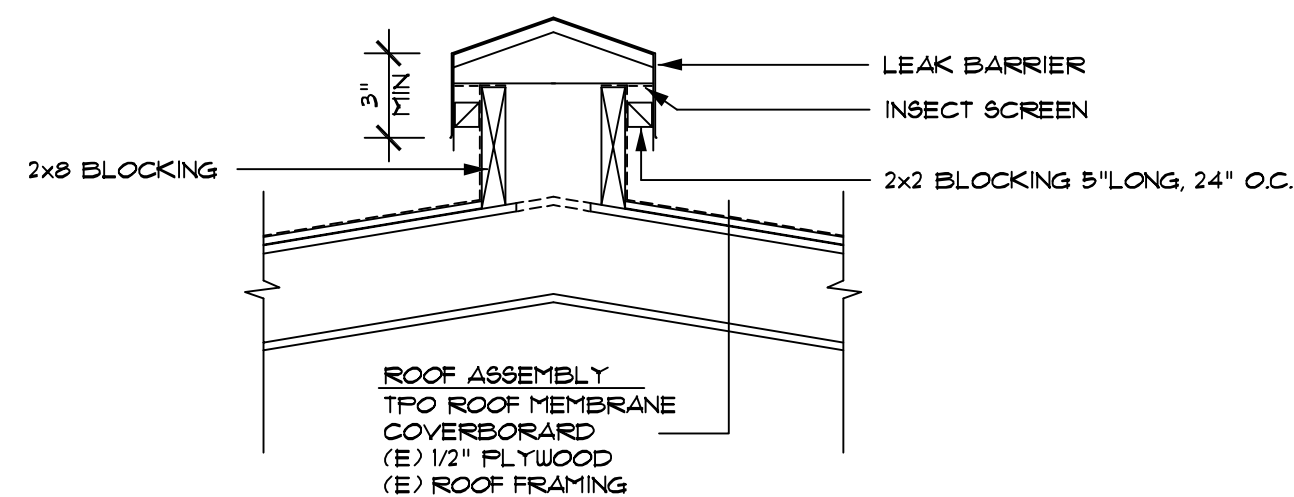
CC  
AI

RIDGE VENT TYP.

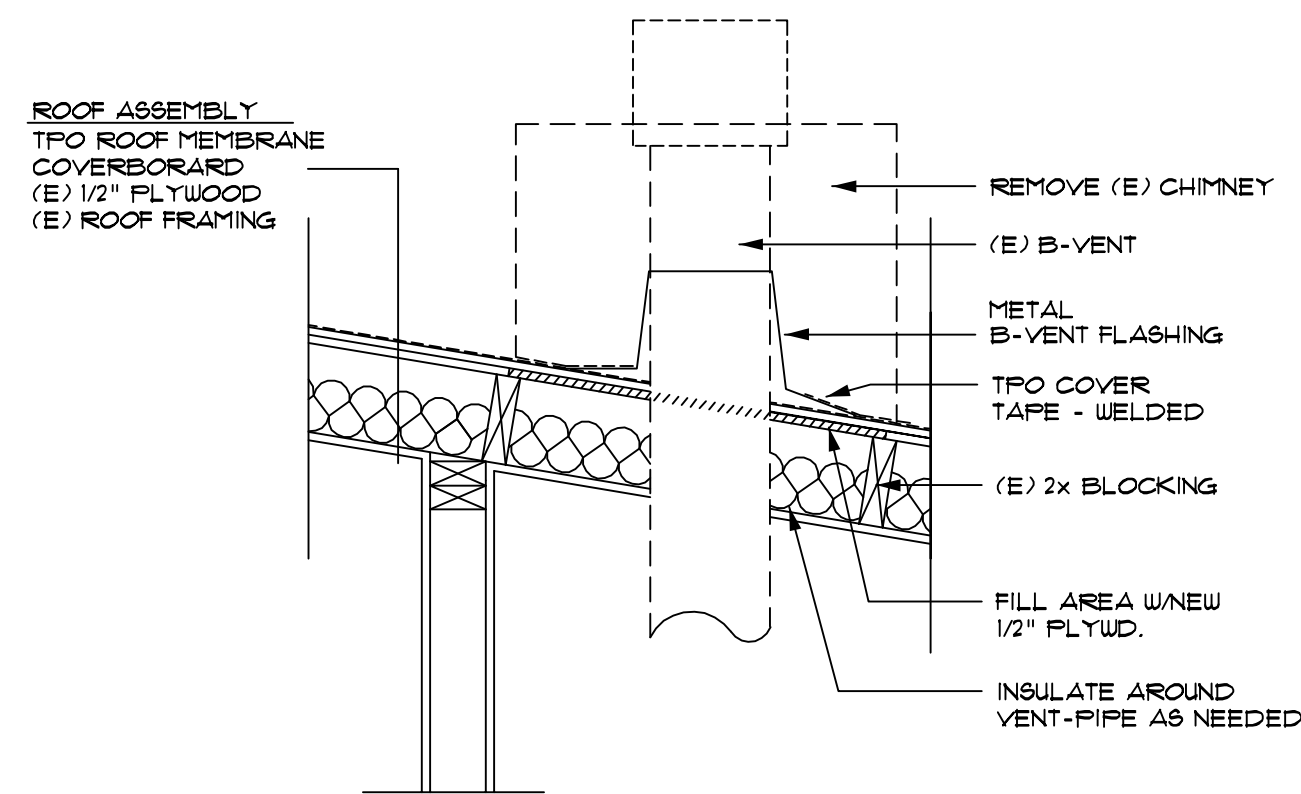
DD  
AI

CHIMNEY / B-VENT

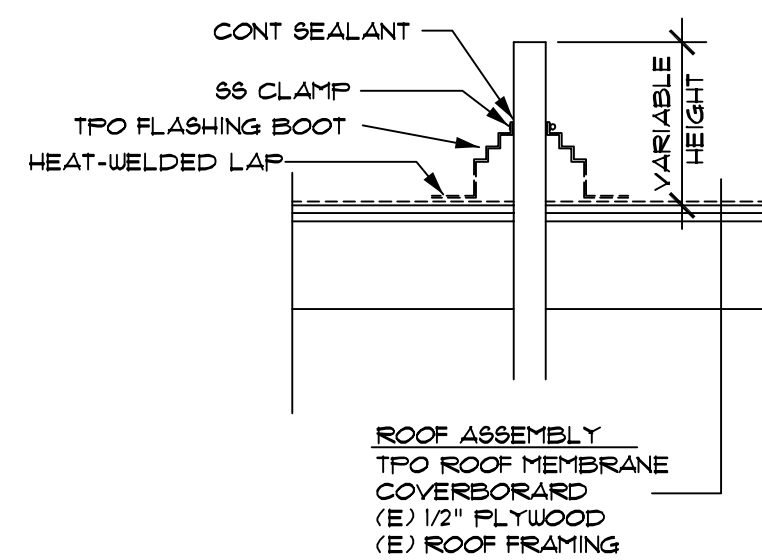
EE  
AI

PIPE - VENT FLASHING TYP.

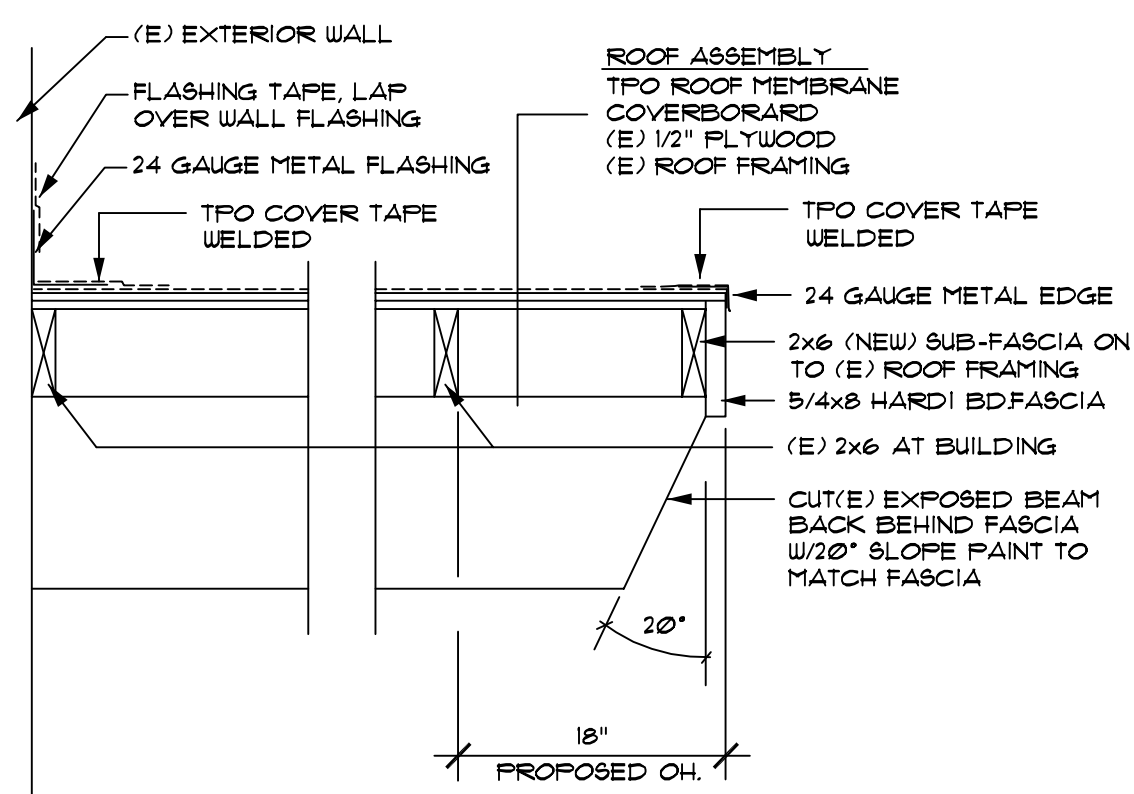
FF  
AI

NOTE:  
CUT EXISTING OVERHANG BACK, EXISTING OVERHANG IS ABOUT 30" WITH CANTILEVERED BEAMS. FASCIA/SUB-FASCIA IS PLACED ON BEAM TAILS. EXISTING BEAM HAVE DRY-ROT DAMAGE THATS NEEDS TO BE REMOVED PER DETAIL FF/AI. NEW 2x6 SUB-FASCIA NEEDS TO BE PLACED ON EXISTING RAFTER/LOOK-CUTS AFTER ROOF STRUCTURE HAS BEEN CUT BACK TO 18" OH. SOME BEAM ENDS MAY NEED TO BE REPAIRED DUE TO DAMAGE FAST PROPOSED 20" ANGLE CUT SHOWN IN DETAIL FF/AI.

OVERHANG @ CAR-PORT

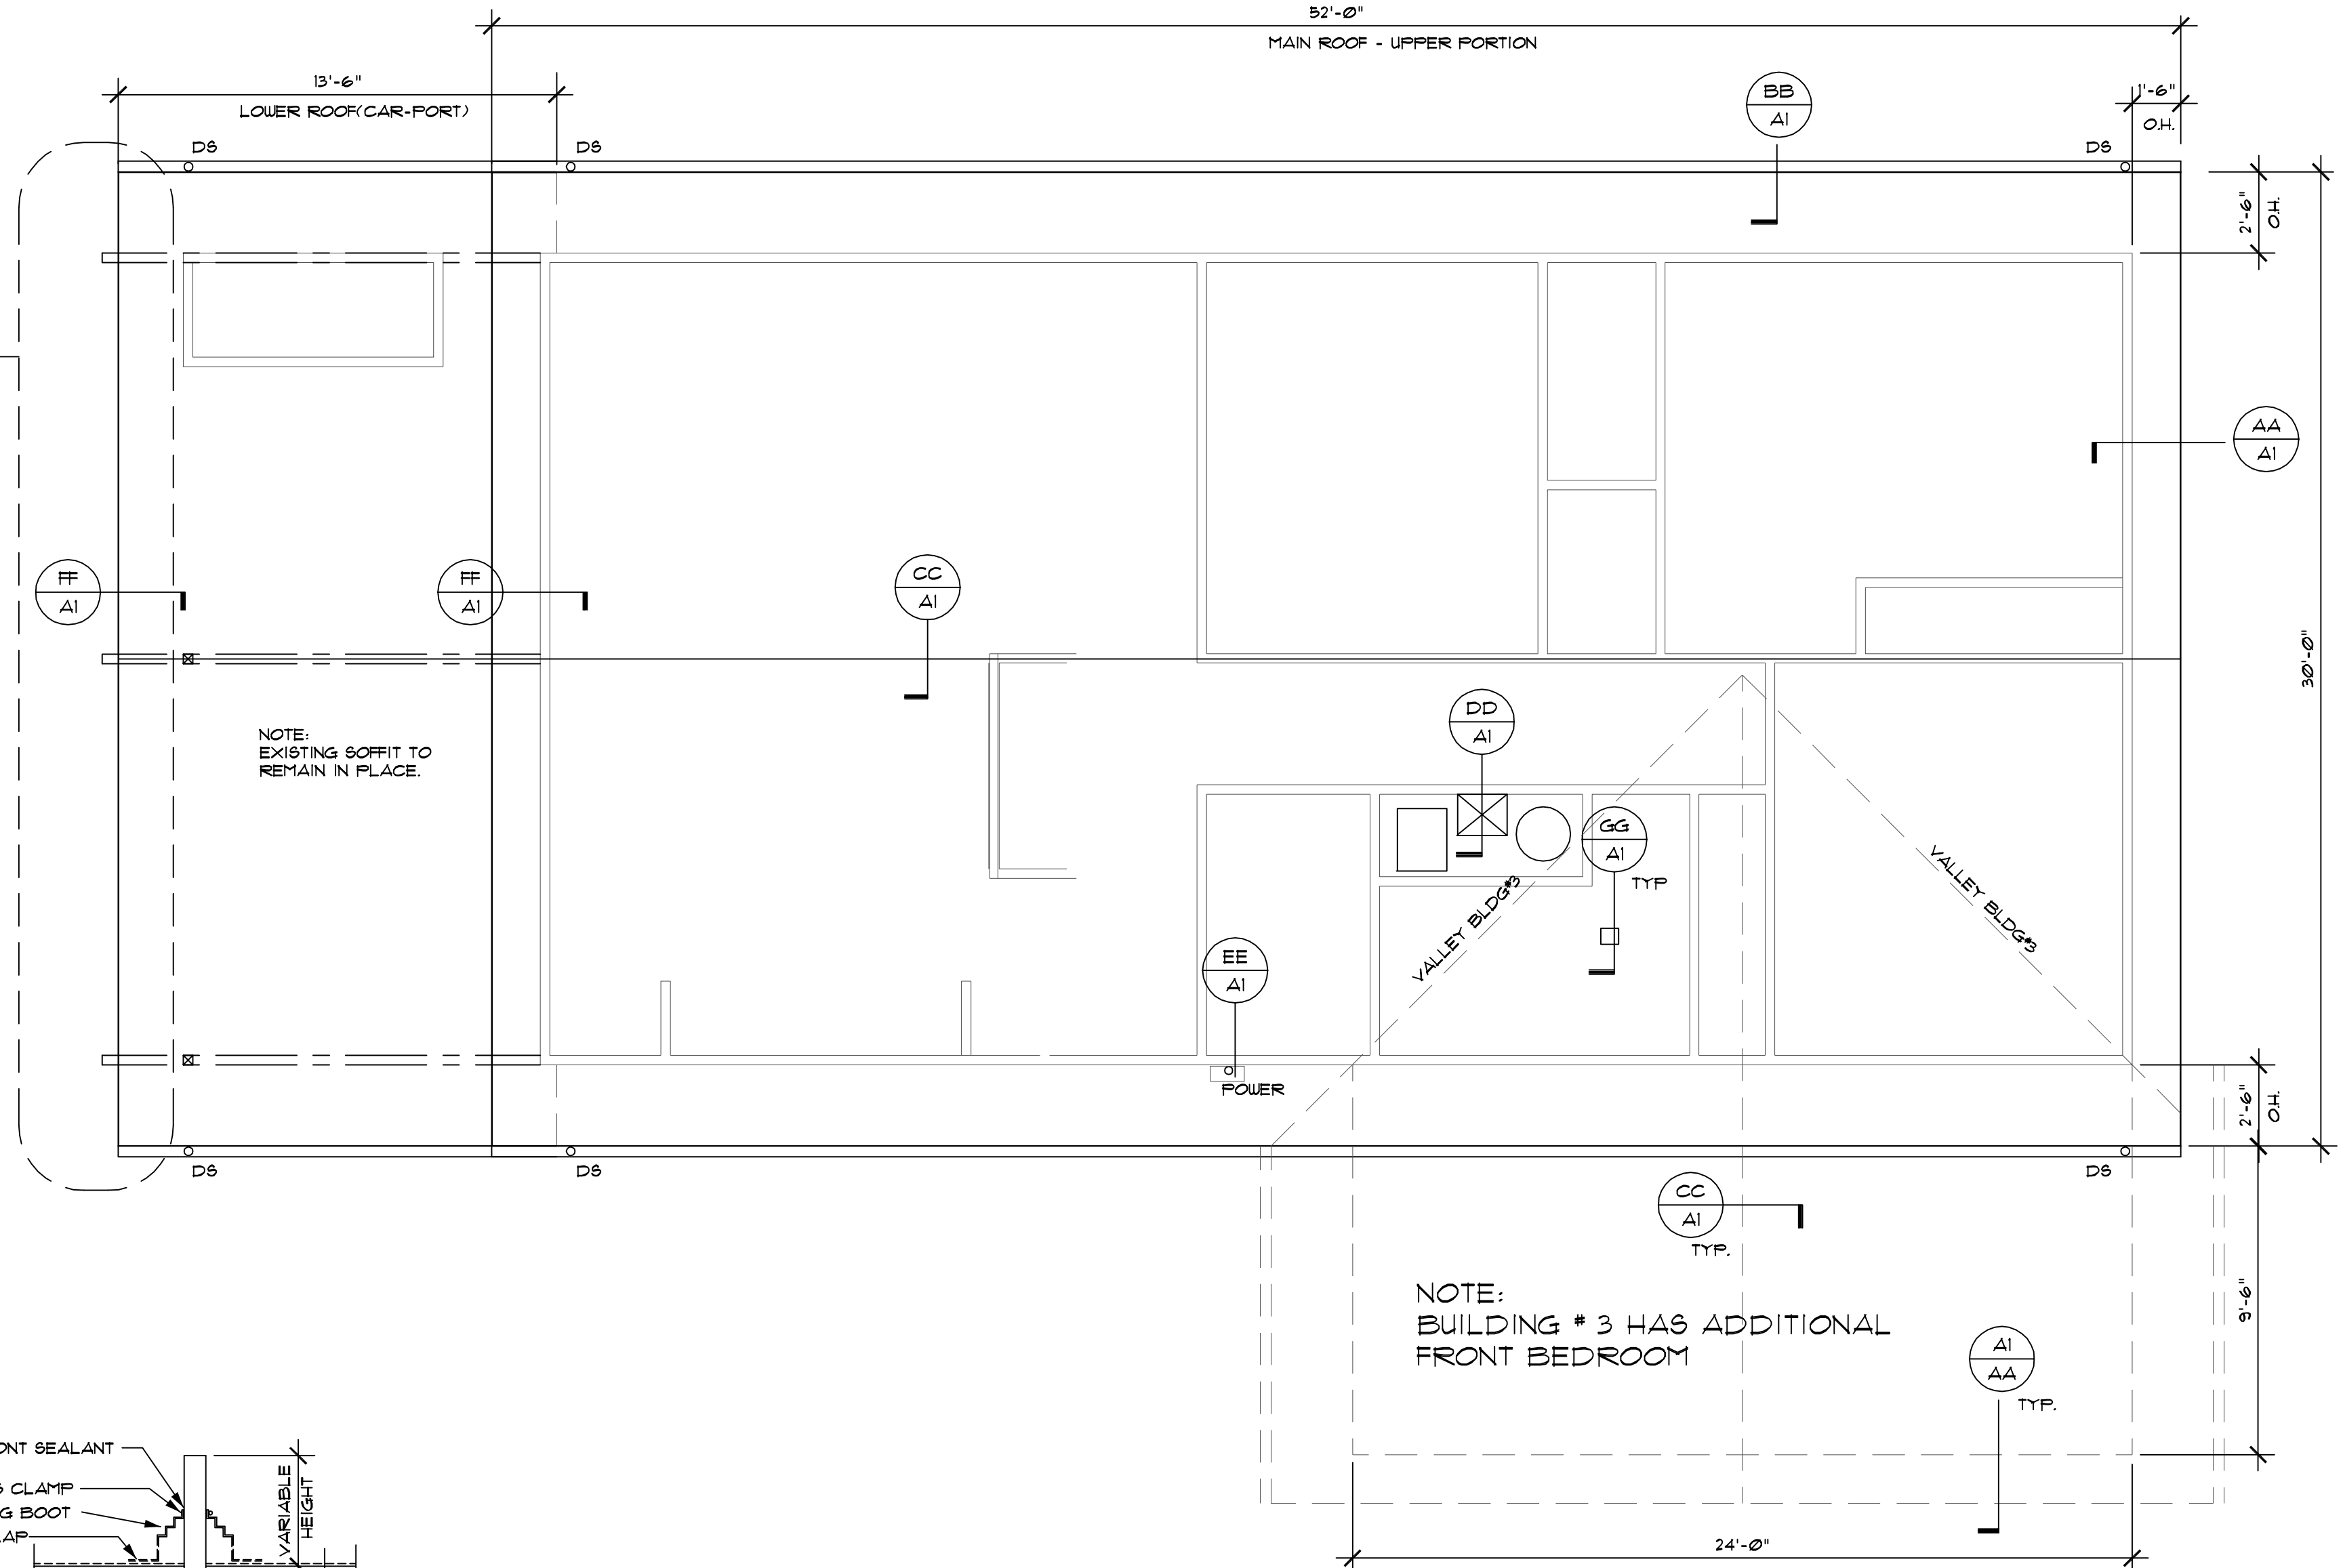
ROOF PLAN

SCALE: 1/4" = 1' - 0"

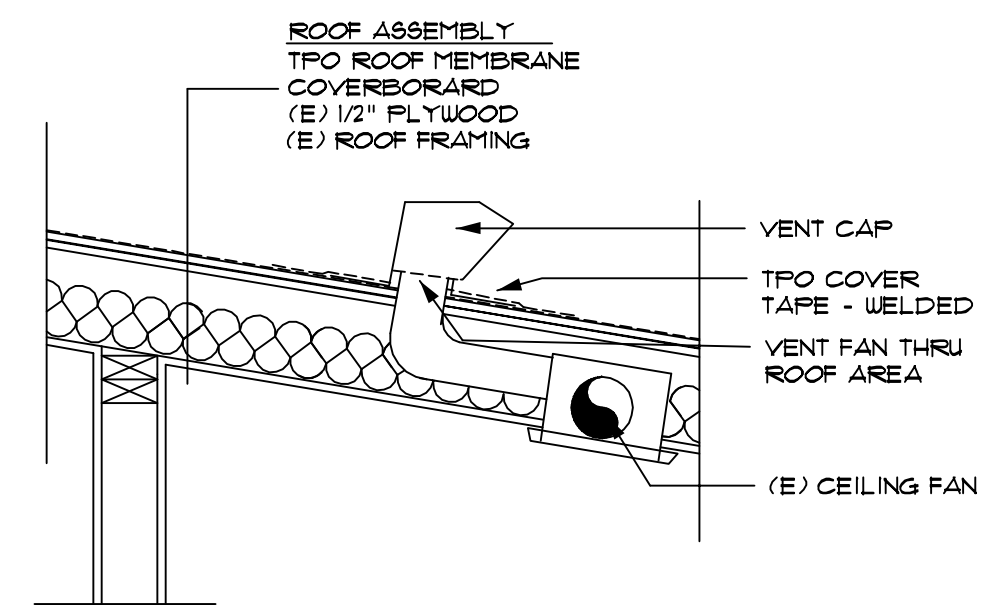
GG  
AI

FAN- VENTING TYP.
